# PLYMC – Poland Library

Poland Library Building Assessment

BSHM Architects, Inc.

1/23/24

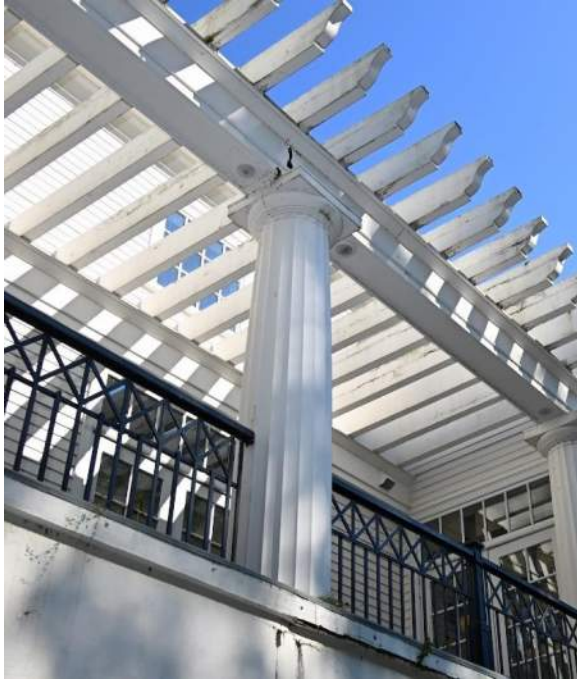
The balcony paver detail from base to finish includes a Rubber membrane, 1" bed of Sand and the Brick paver finish. The pavers currently are uneven and have moderate moss growth. In some locations as in **(Figure 2)**, pavers are missing or damaged. The current detail also includes weeps for the removal of water. The weeps get clogged from excessive buildup and therefore cannot perform as intended.

**Figure 1:** Balcony view from the Lower Level.

Remove, clean and salvage existing Brick pavers. Remove the waterproof membrane and replace it with a new membrane. Provide new flashings and counter flashings at edges, and new fascia panel. Provide new 1"x3 1/2" trim mold. Install a new drain system utilizing concrete plank core.

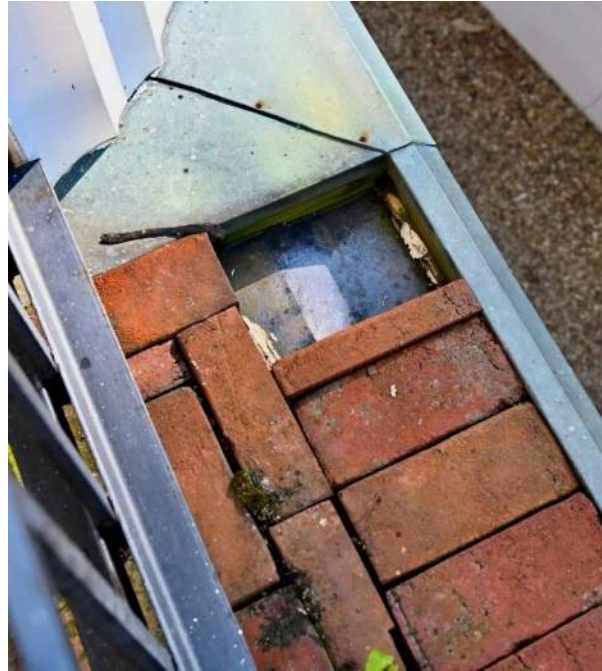
**Figure 2:** Northeast Balcony shows missing pavers and moss growth.

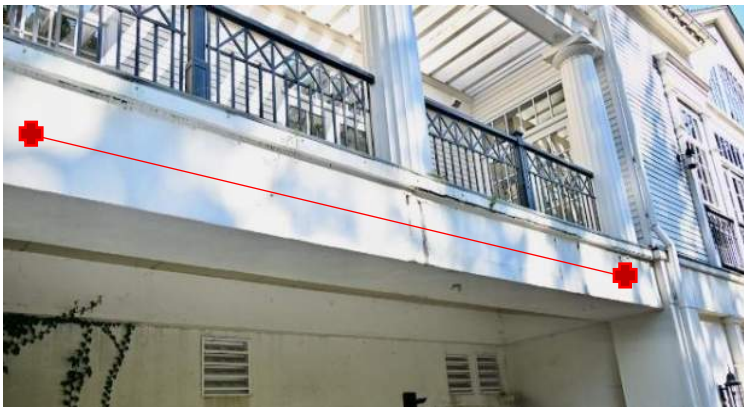
**Figure 3:** Base of the Northeast Balcony, accessible from the Main Floor. The symbol “

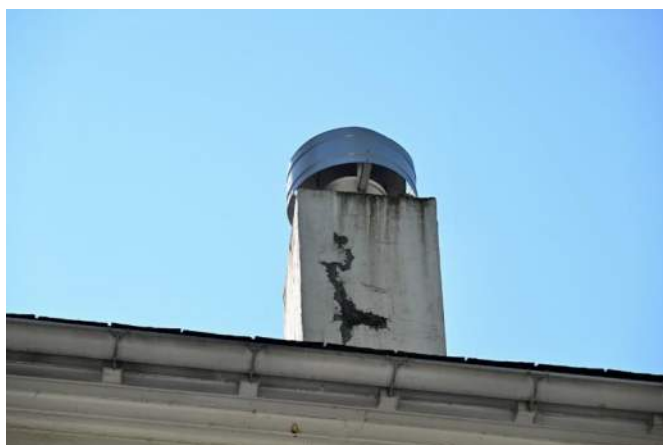
**Figure 9:** Stucco chimney visible from the Main Entrance.

The **Stucco chimney** repair will require a new exterior stucco finish as well as stepped flashing and counter flashing (**Figure 9**).

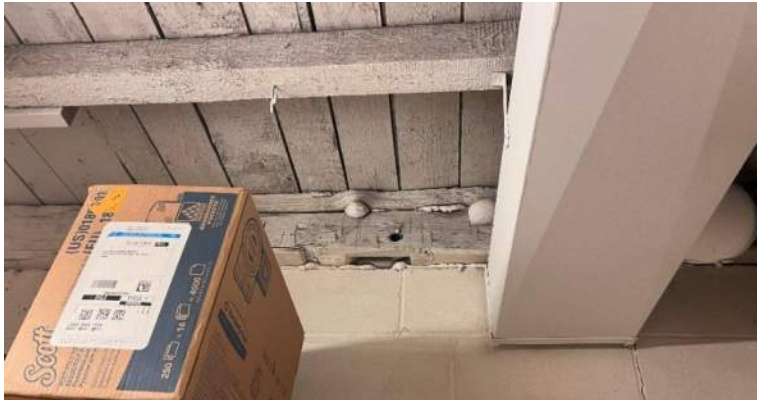
Along the North foundation wall of the Dormitory Building, just off the Mechanical Room has evidence of contact moisture. There are areas of chipped paint and discoloration on the CMU wall. From the Elevation view, The CMU foundation wall is exposed near the raised entry to the building. The uneven soil distribution exposes the CMU wall in the landscaped area, as well as the base trim showing signs of wear.

**Figure 1:** Foundation CMU wall and wood beam connection. Location of both wall and wood trim exposure.

Provide waterproofing to the CMU wall and place a foundation drain to prevent moisture leakage onto the foundation wall. Repair any elements from landscaping, brick and railing above.

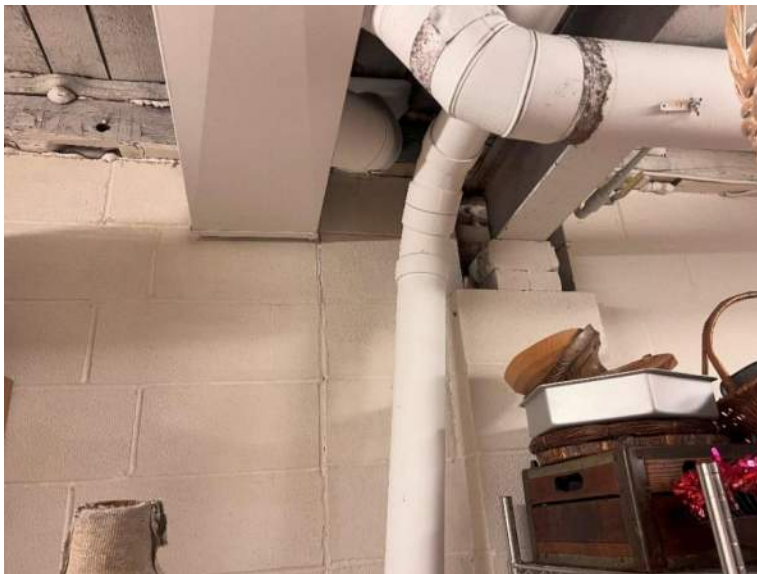
**Figure 2:** Sanitary line shown in proximity to foundation wall.

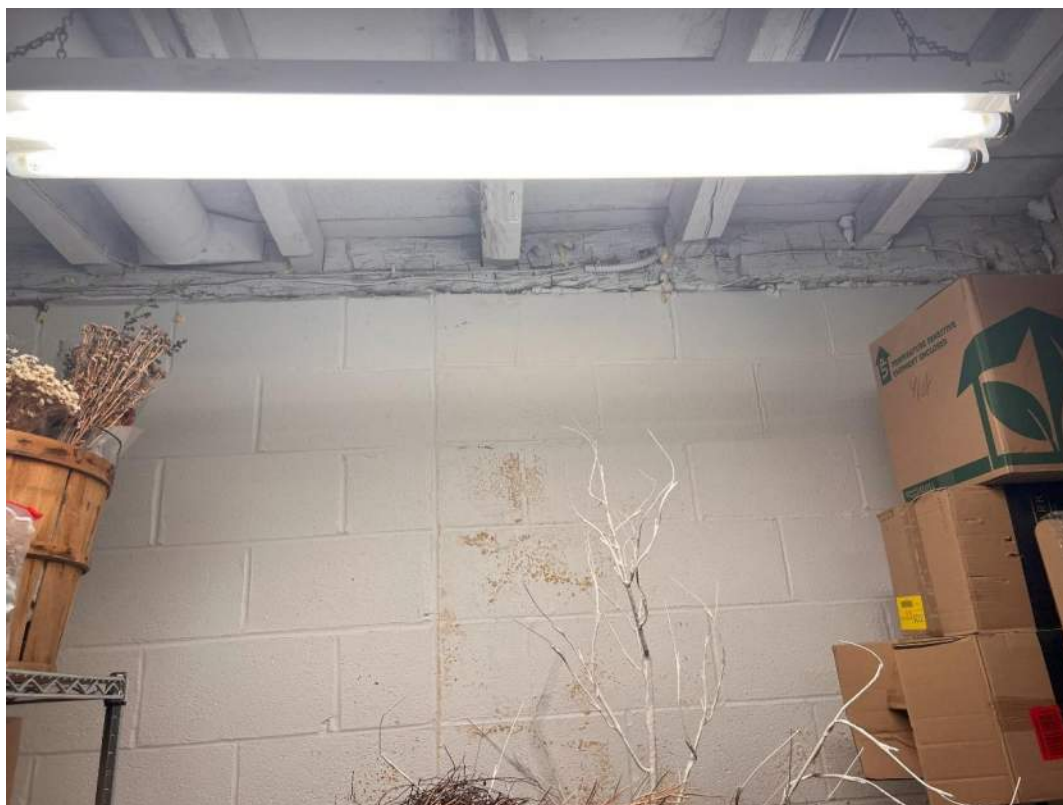
**Figure 3:** Wall discoloration to the left of the foundation wall referenced below (4).

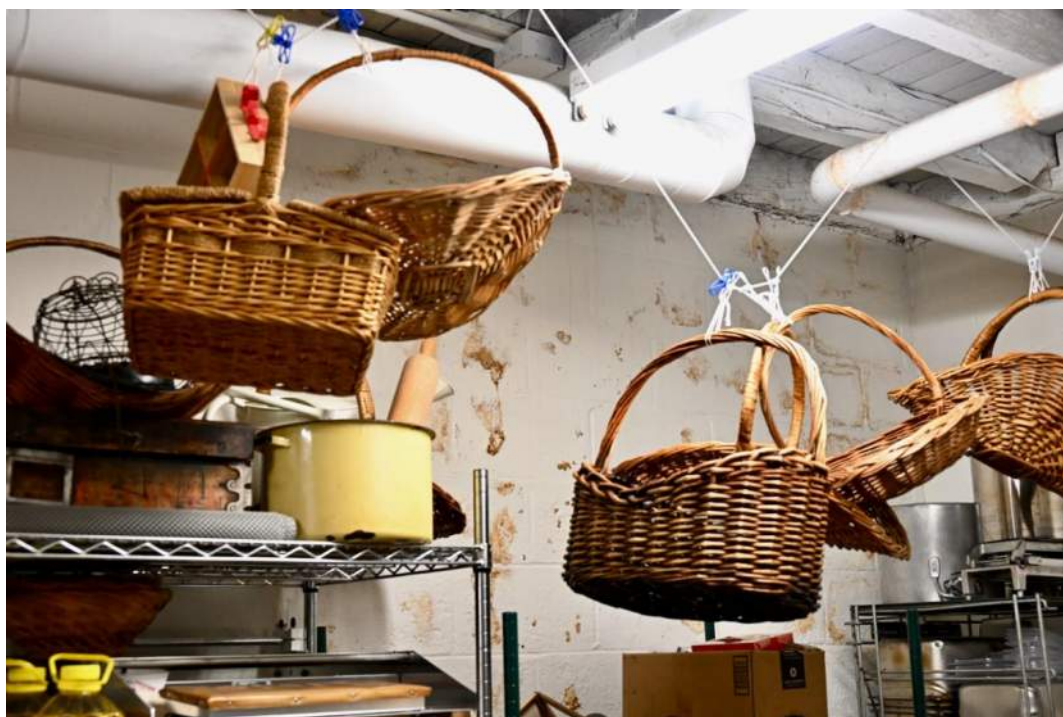
**Figure 4:** Discoloration of foundation wall.

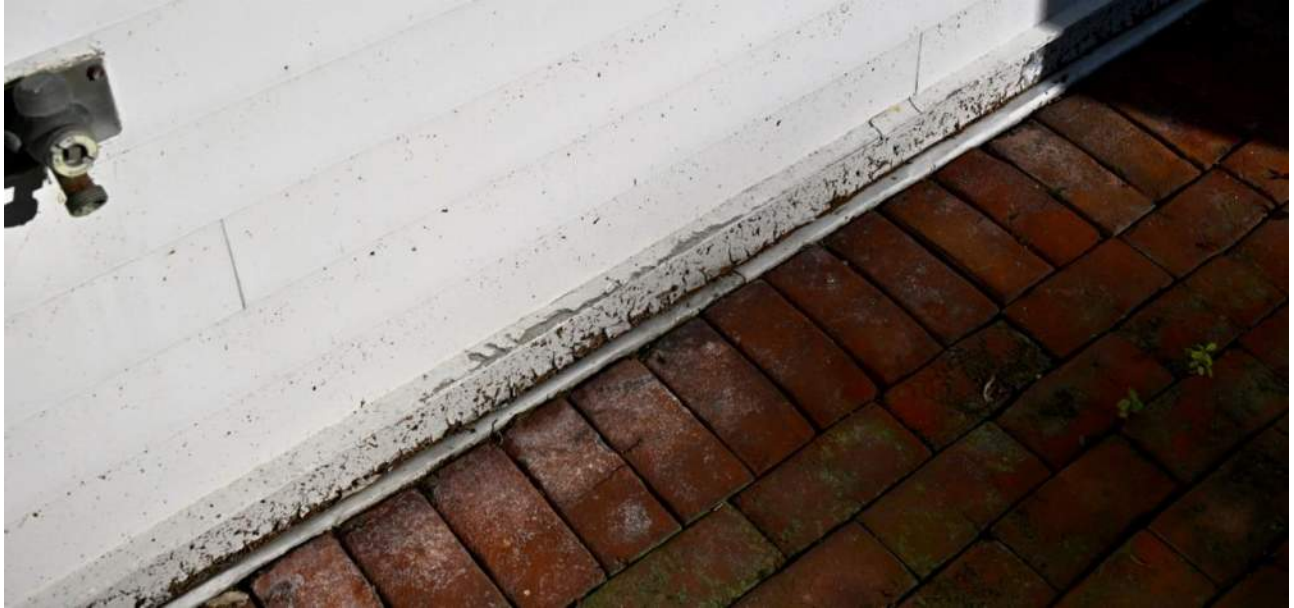
**Figure 1:** Condition of the trim on the Southern balcony.

Replace Horizontal siding base repair around the entire perimeter of the building where it has not been restored. The locations of replacement are shown on plans and the pictures below: **Figures 1,2,3,13,14,16,18,19,20.**

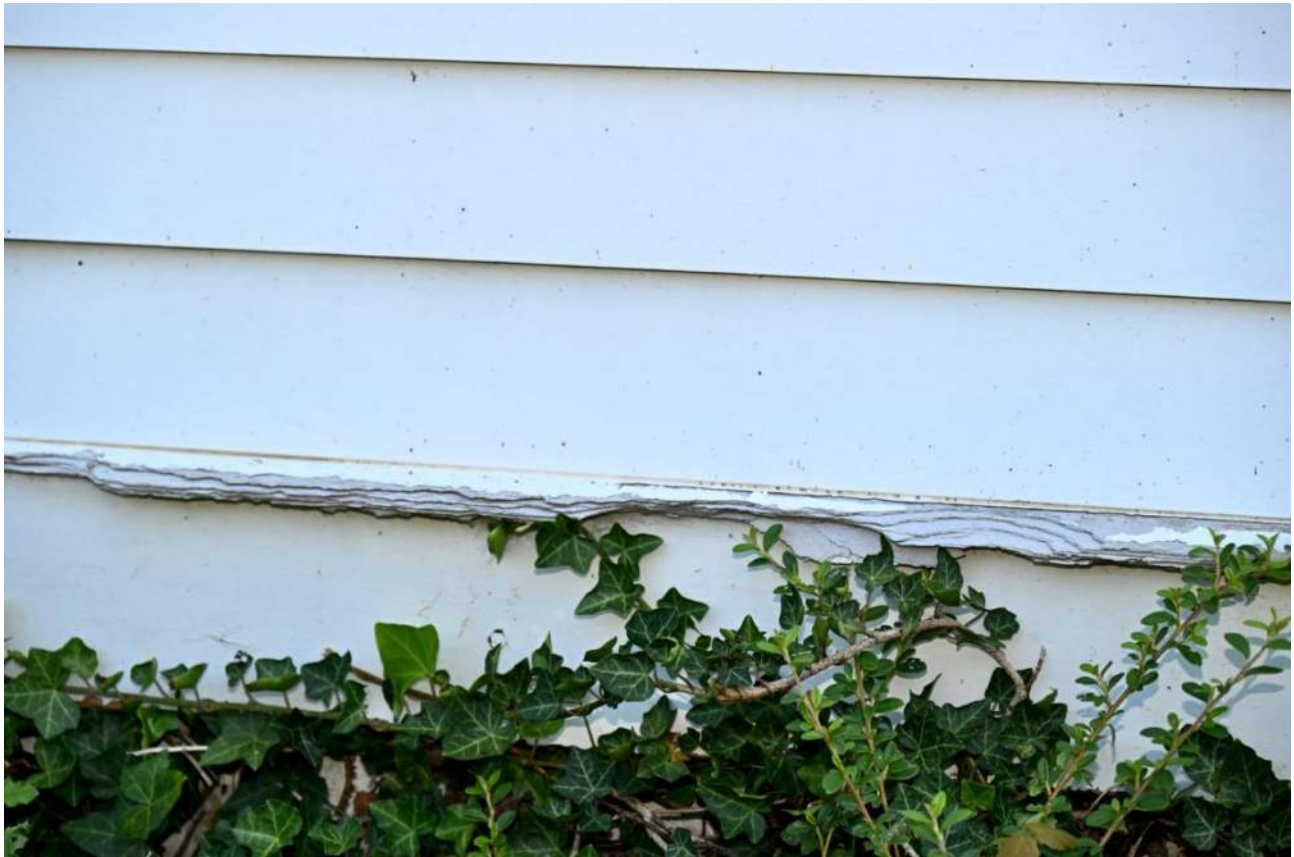
**Figure 2:** Wood trim on the North Elevation of Dorm. Bldg.

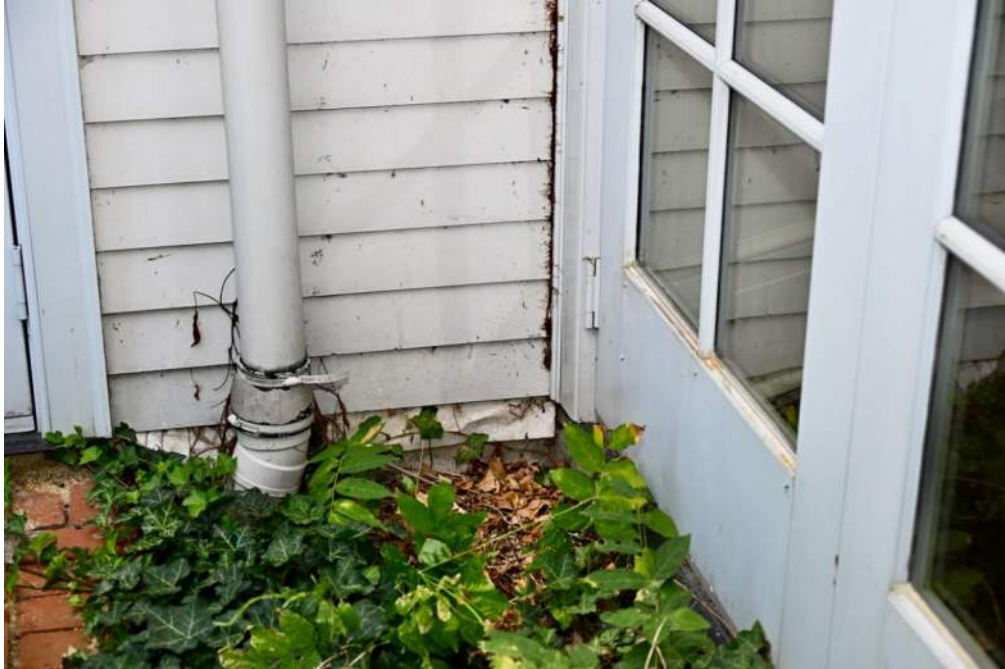
**Figure 3:** Northeast patio siding damage.

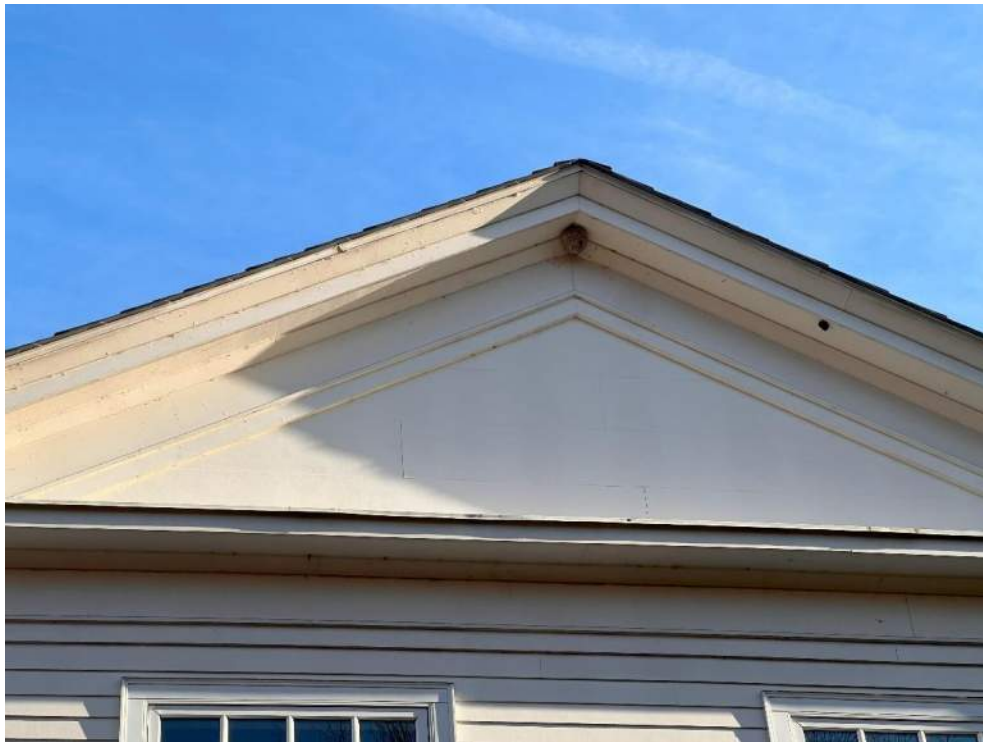
**Figure 4a:** Pediment on the Northwest corner of the building.

Replace the tympanum wood finish material while trying to maintain the exposed wood trim on the pediment. If demolition requires both trim and tympanum to be removed, replace in-kind. Provide weather barrier and flashings at base of the trim.

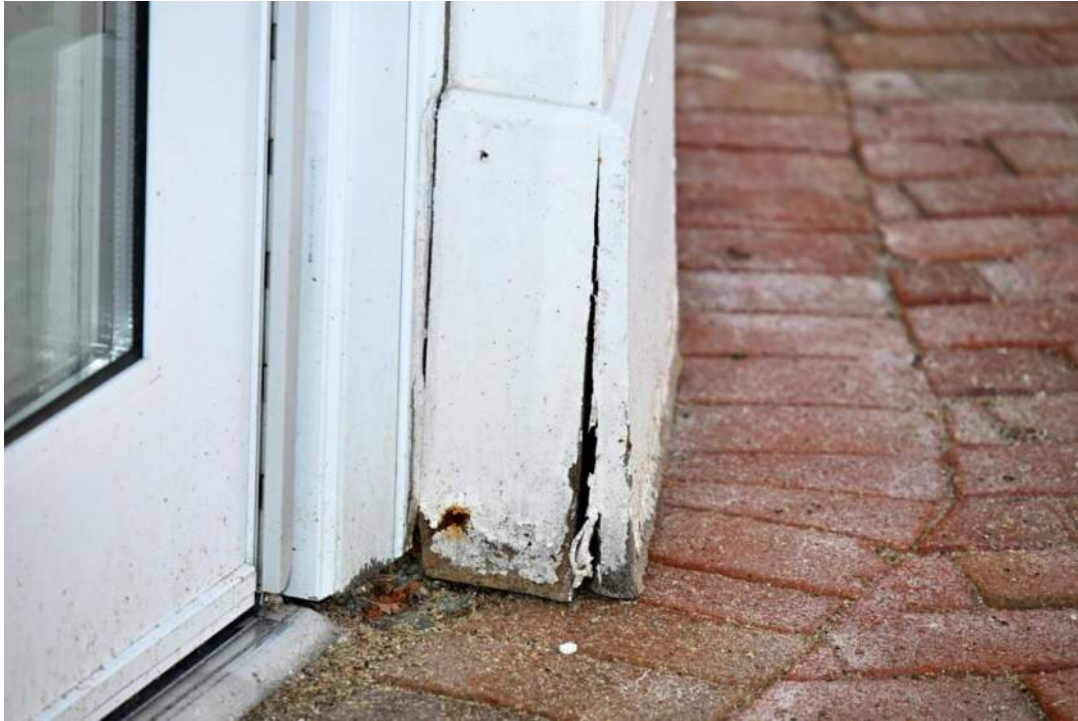
**Figure 6:** Typical repair of pilaster base at the main entrance.

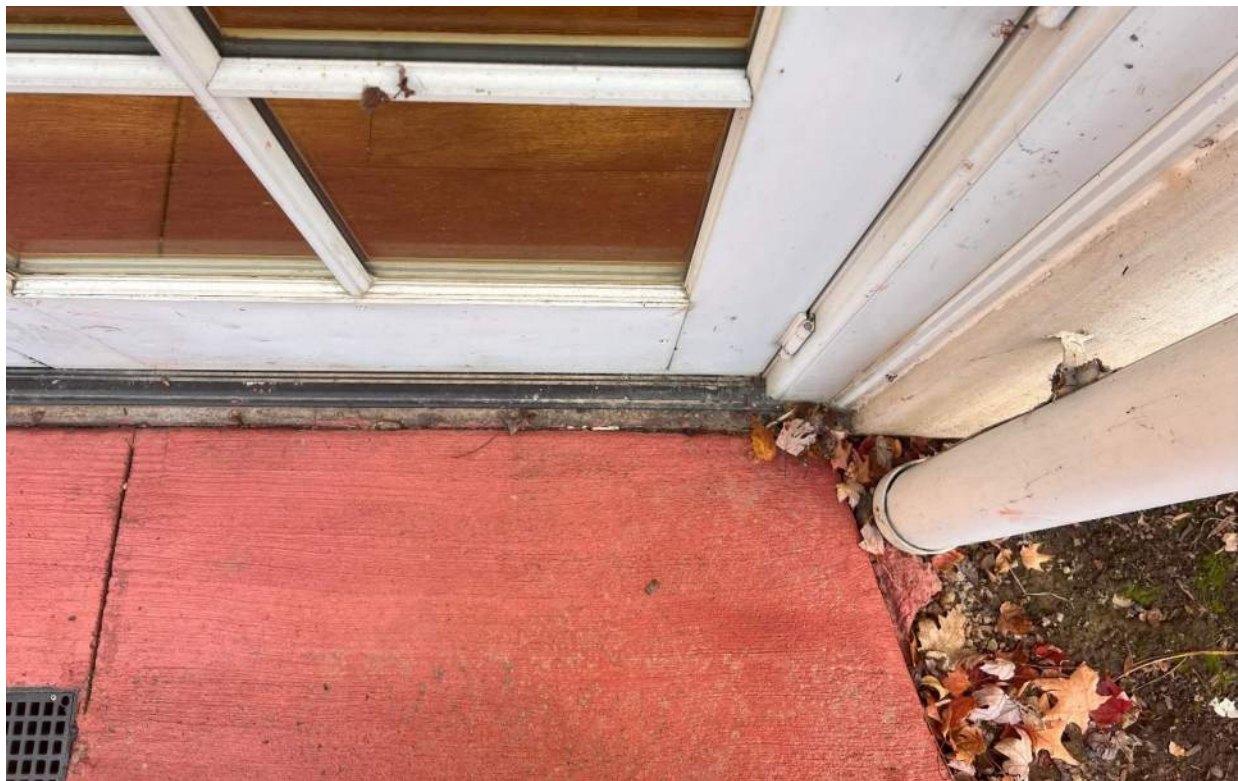
**Figure 7:** Active door sill at South Elevation.

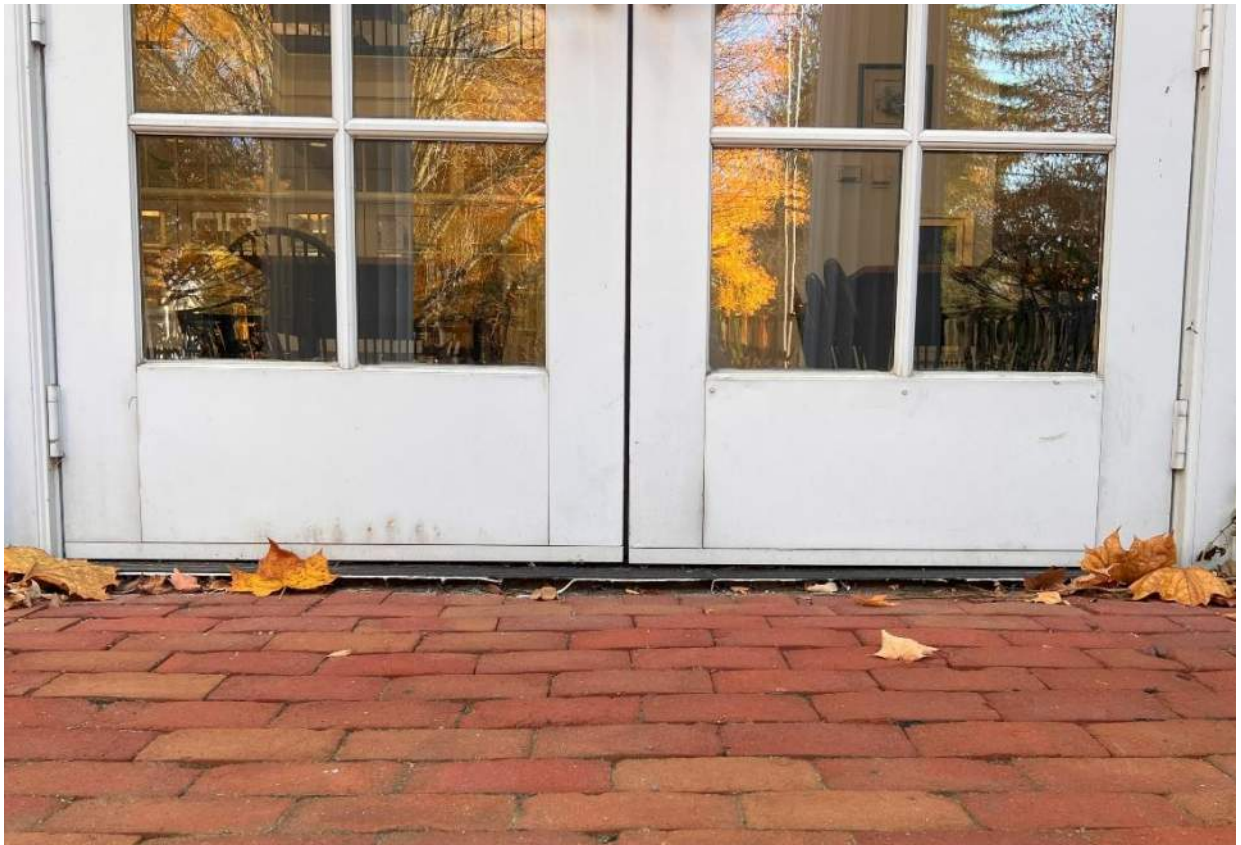
**Figure 9:** Egress doors at central patio. Note broken sill.

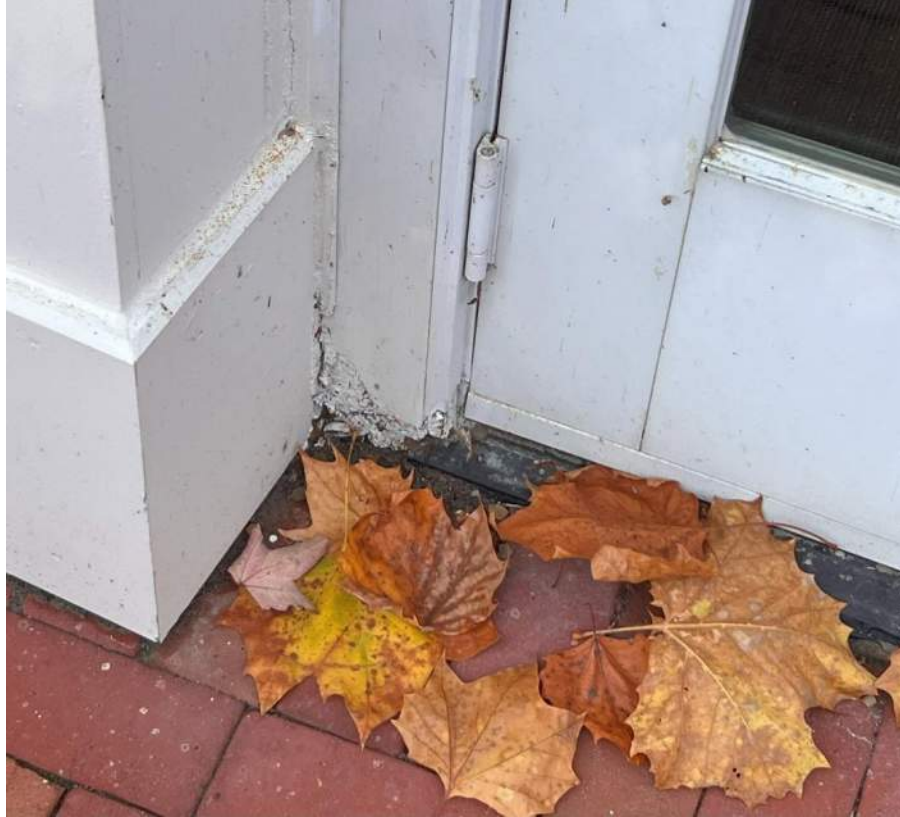
**Figure 10:** Door trim base rotting at West Elevation.

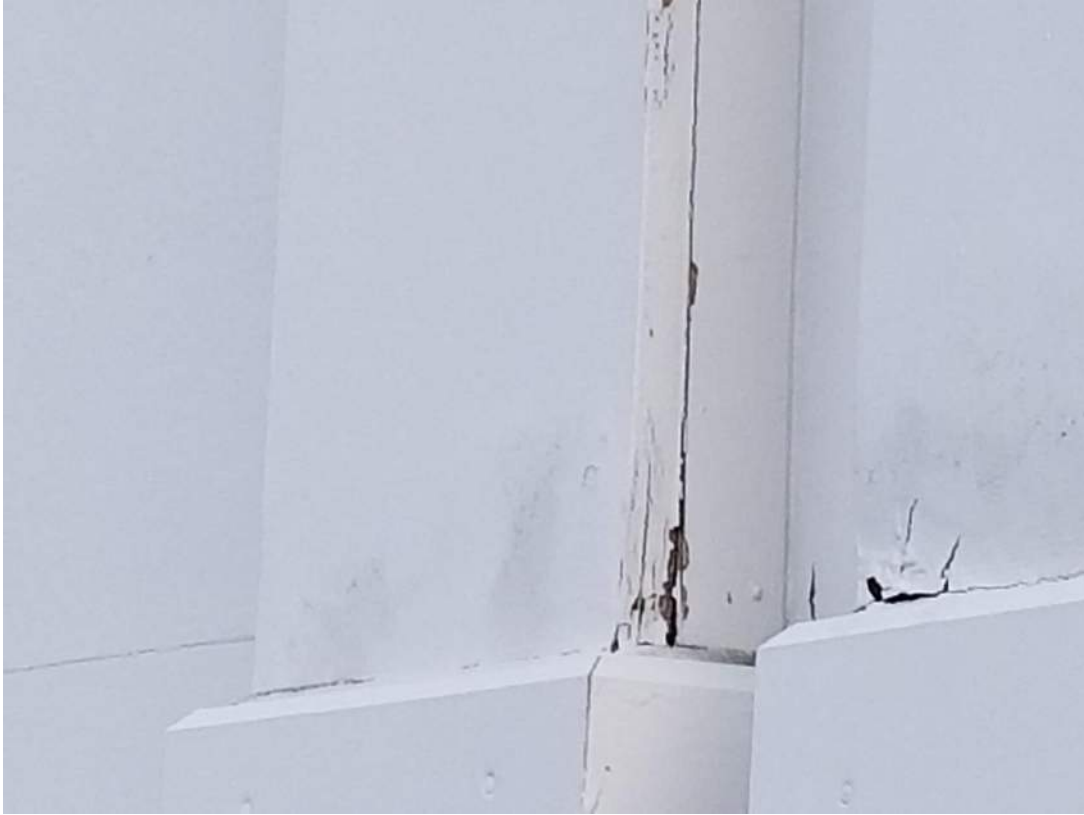
**Figure 18:** Cupola pilaster cracks from rot.

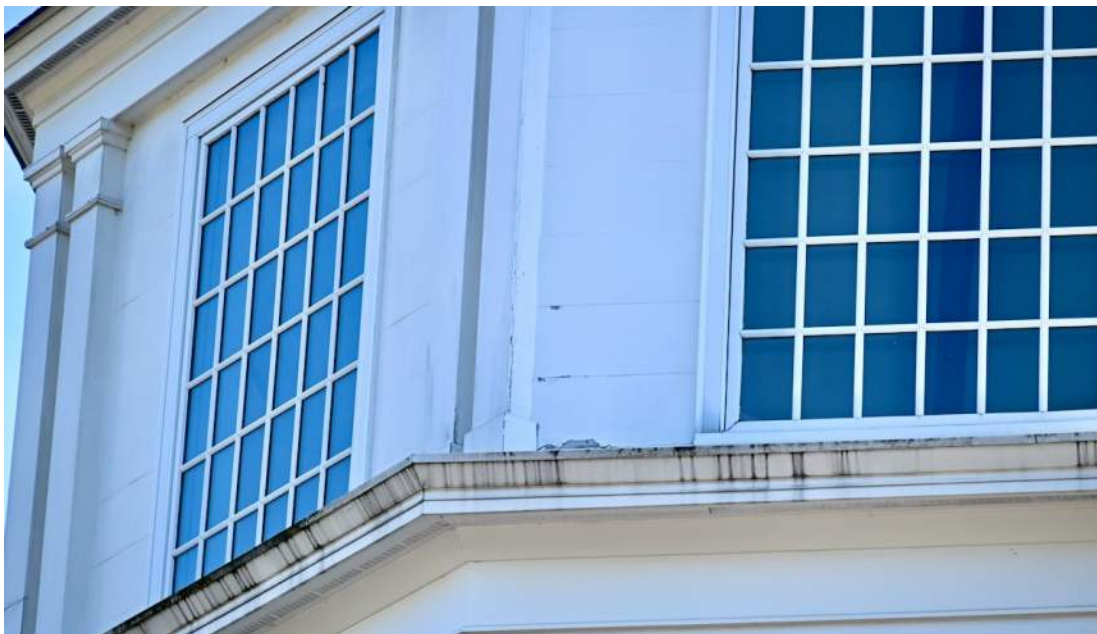
**Figure 19:** Center cupola trim and pilaster issues.

Provide new weather barrier and transition membrane at flashing and open locations. Verify the condition of existing flashing. Profiles and design to be per existing documentation and existing built cupola **(Figure 19 & 20)**.

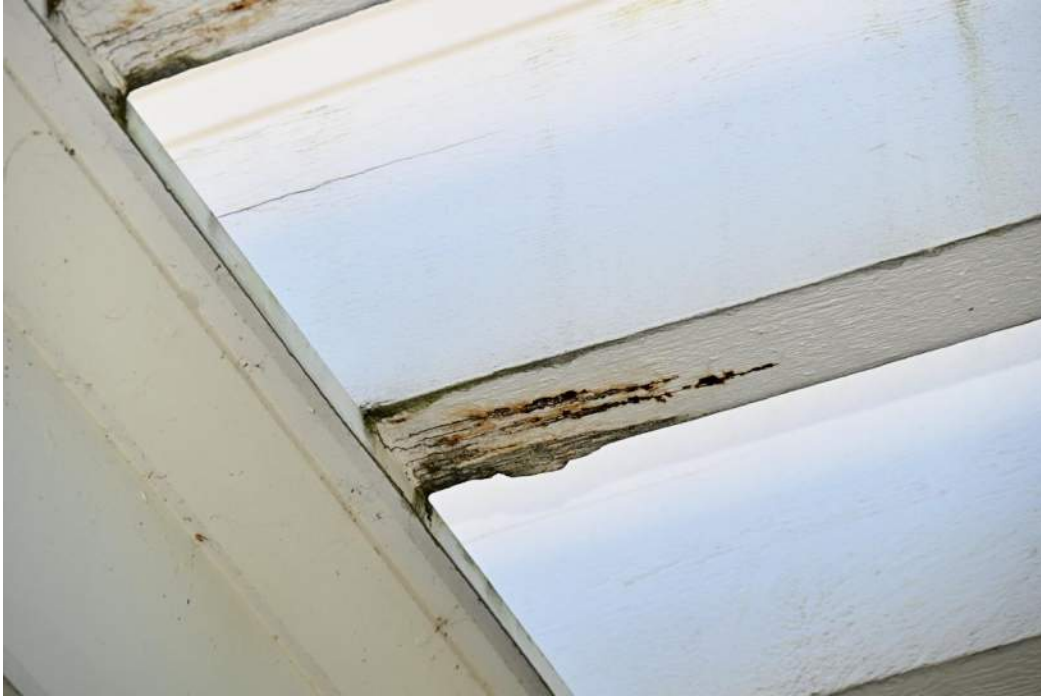
**Figure 3:** Pergola wood joists highlighting rot and metal trim beneath.

Total Pergola replacement will be required for balconies and patios. All Pergola repairs will coincide with paver replacements and new retention supports for column load distribution.

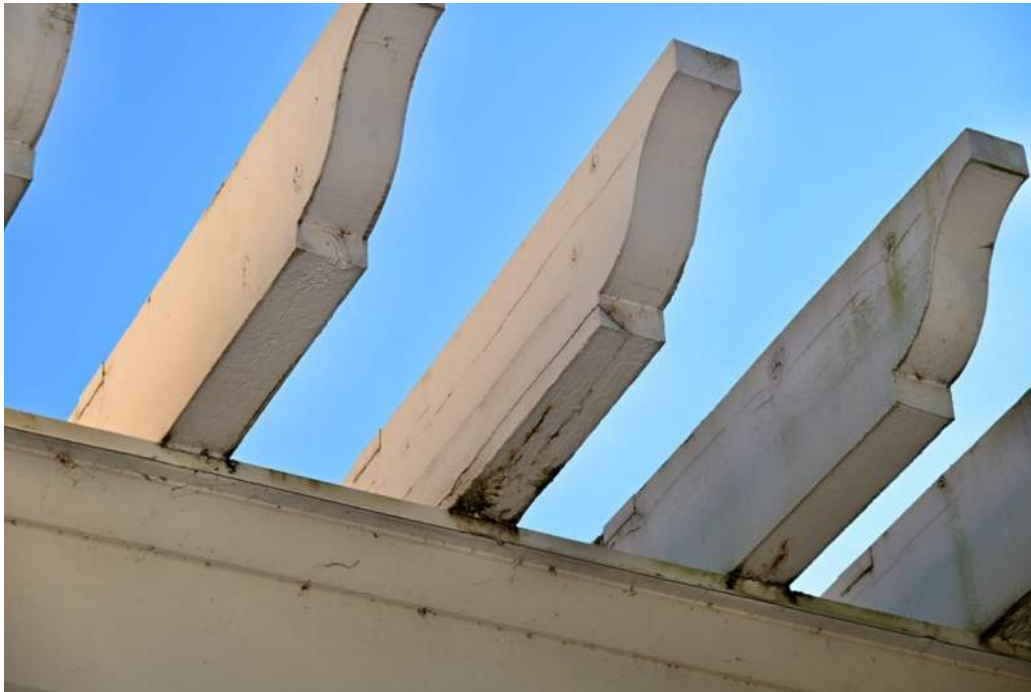
**Figure 4:** Pergola wood joist resting on beam. Notice weathering and decay of wood members.

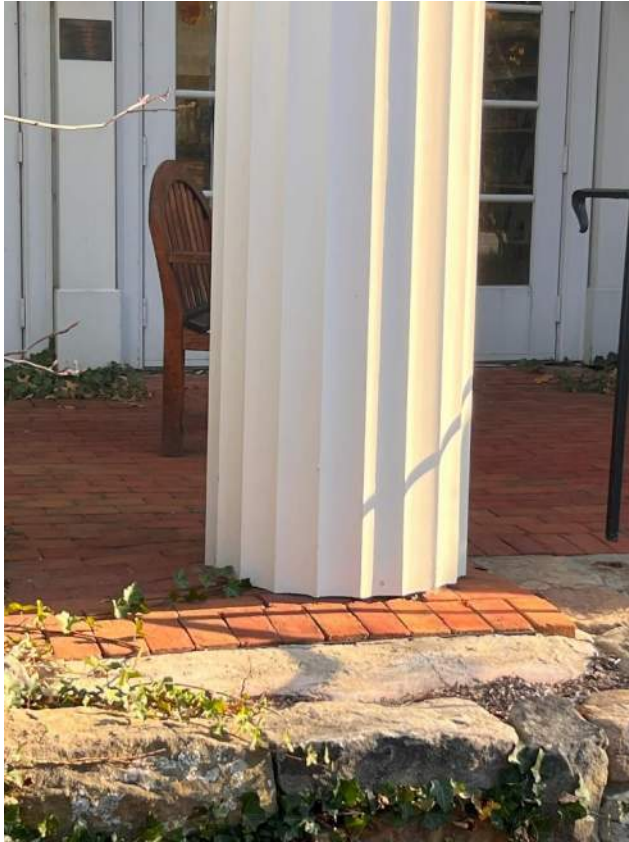
**Figure 5:** Column base at center patio location. The surrounding paver settlement indicates concrete support under column.

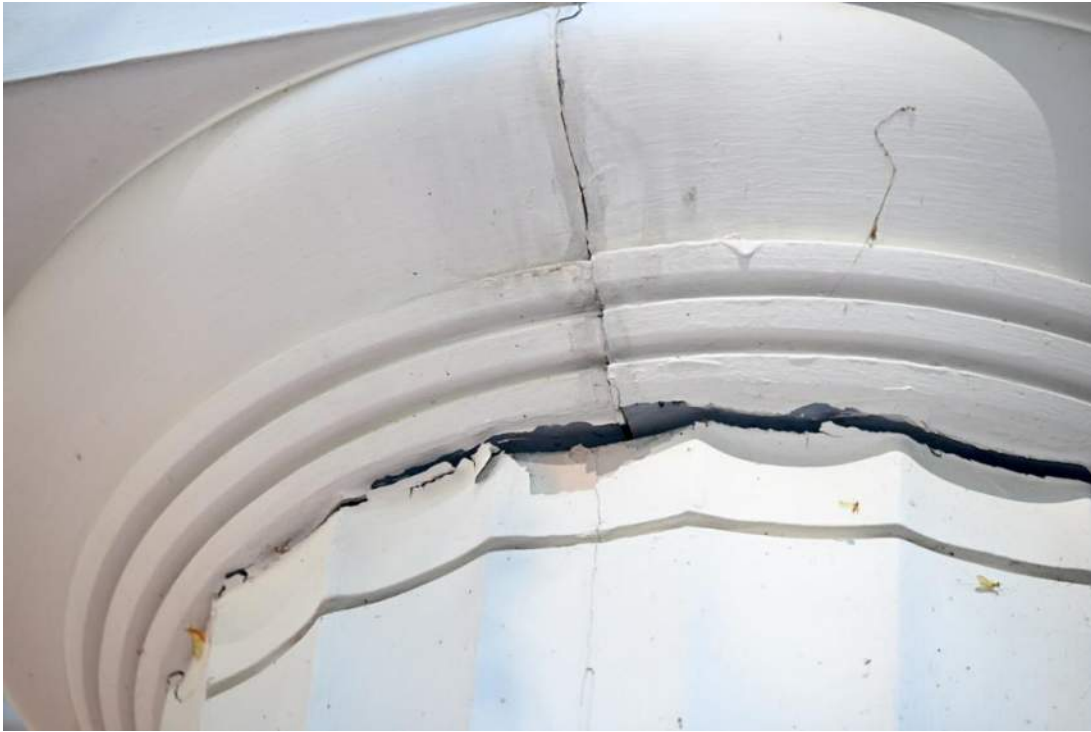
**Figure 10:** Crack in column capital.

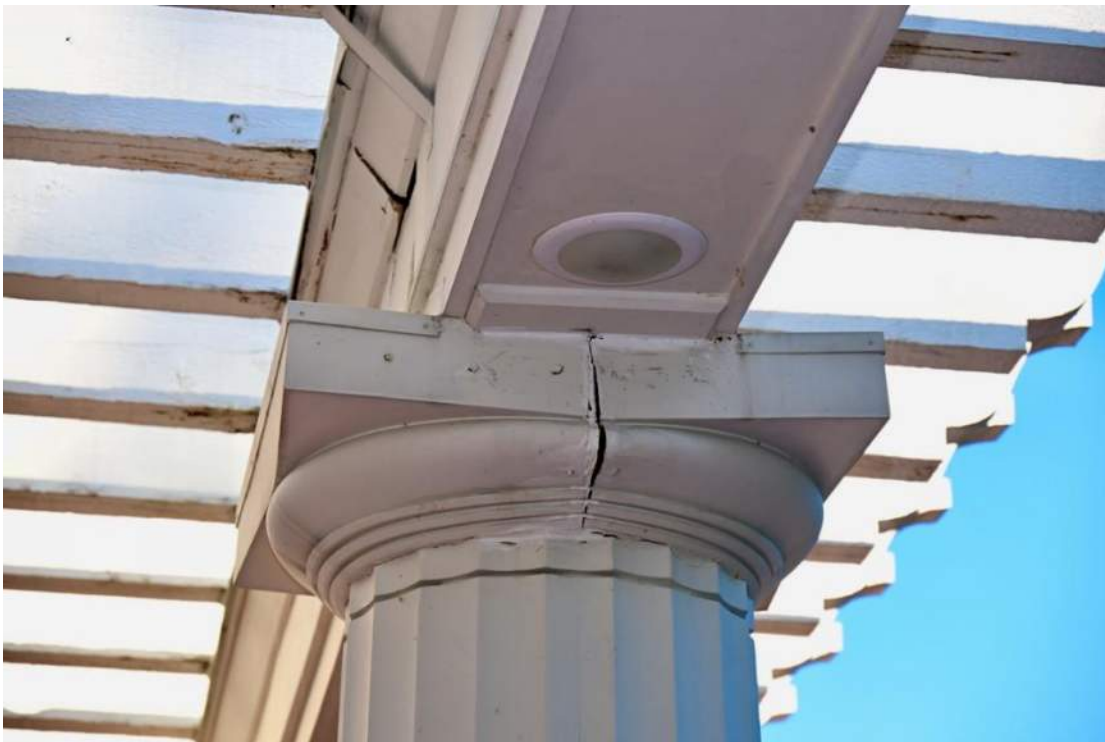
**Figure 11:** Major split at column capital near the parking lot.

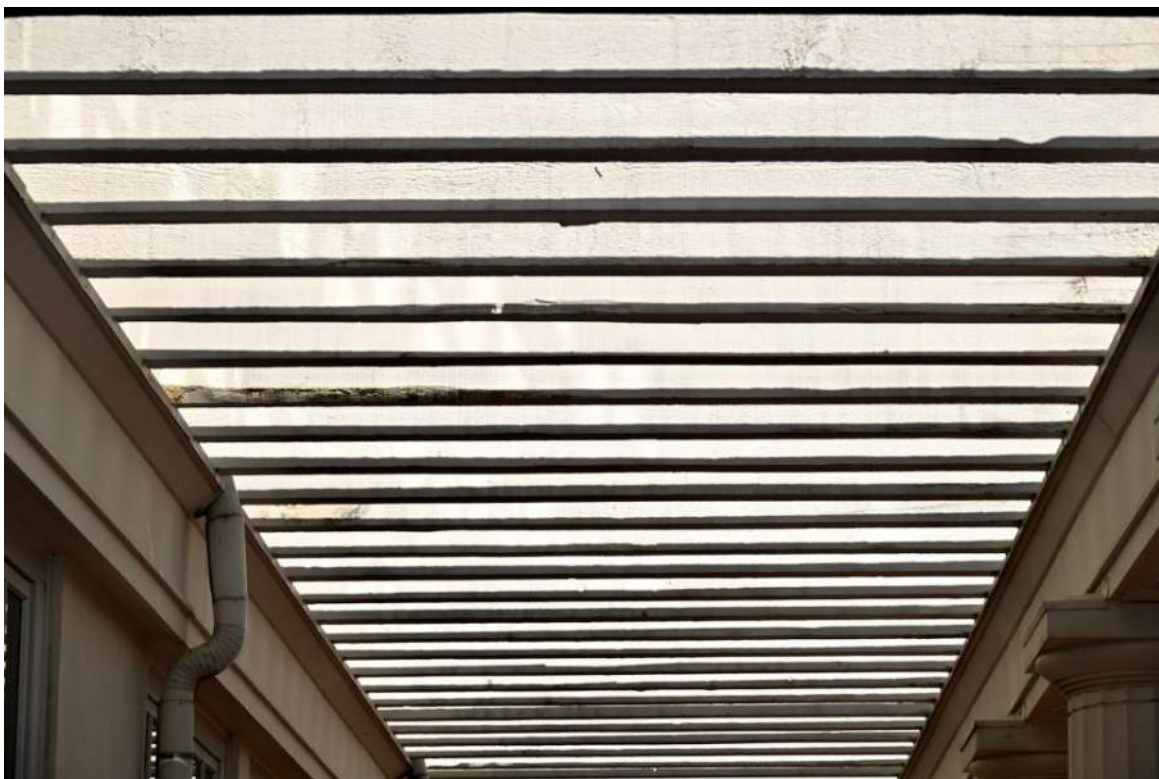
**Figure 13:** Joist deterioration at South Elevation.

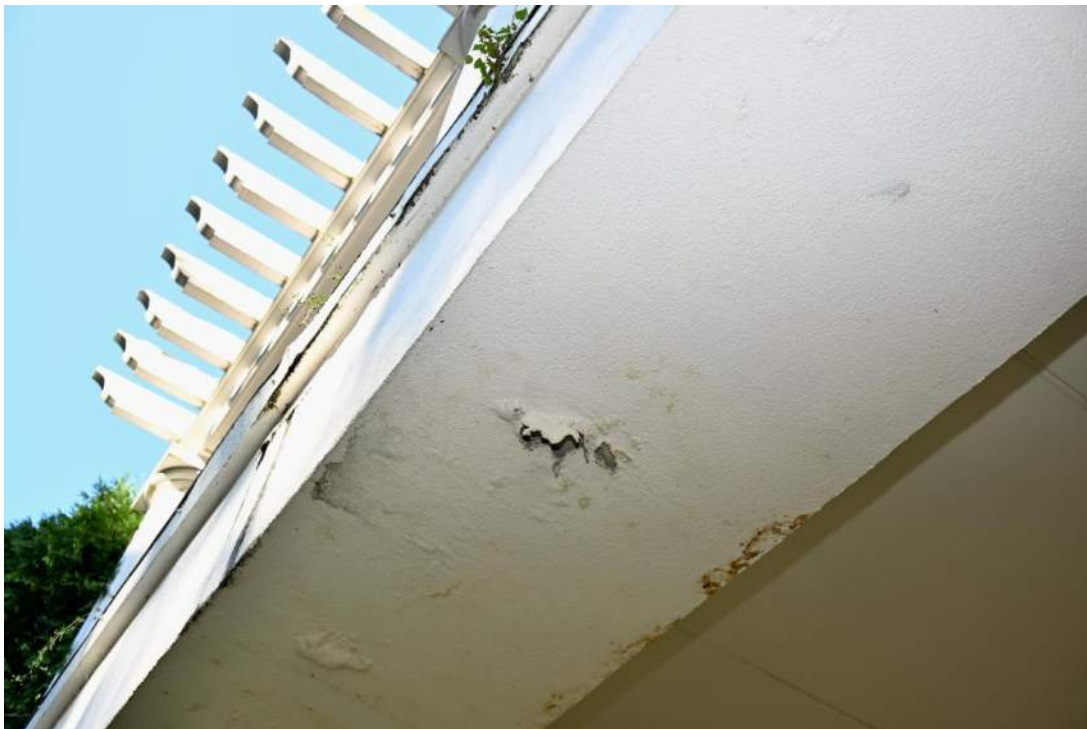
**Figure 4:** EFIS damage underneath the main-level balcony.

1. Carefully remove pavers for reuse. Demo the membrane, leaving the concrete planks accessible to install drains through the hollow openings.
2. Apply a new membrane and place the existing pavers back with compacted material. The wood trim and Pergolas will be replaced once the pavers are re-installed.
3. Replace all EIFS to the substrate to add a draining board.

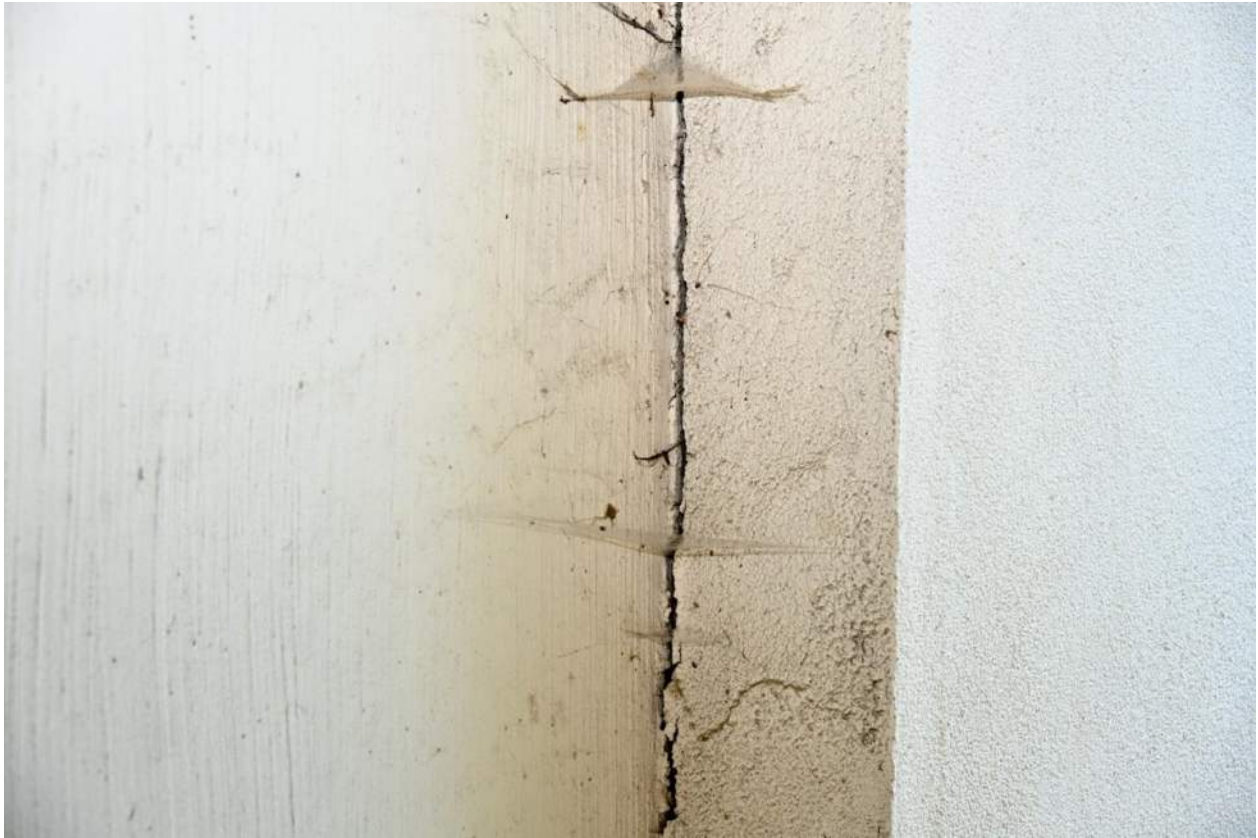
**Figure 5:** EFIS crack underneath main-level balcony.

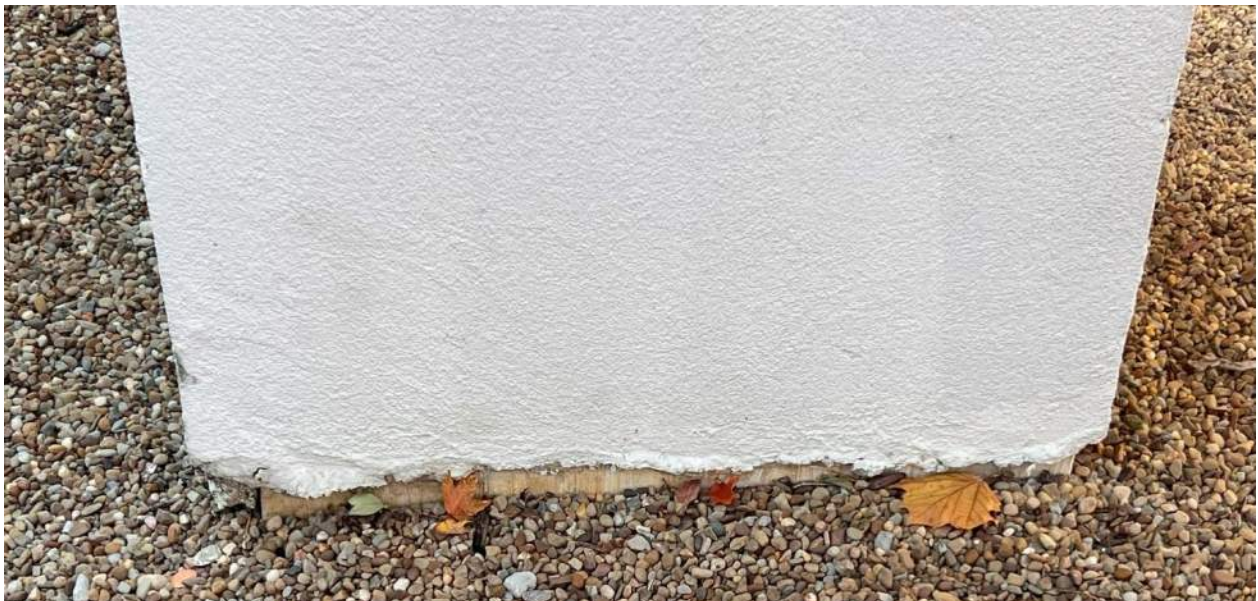
**Figure 6:** EFIS damage at base of concrete pillar.

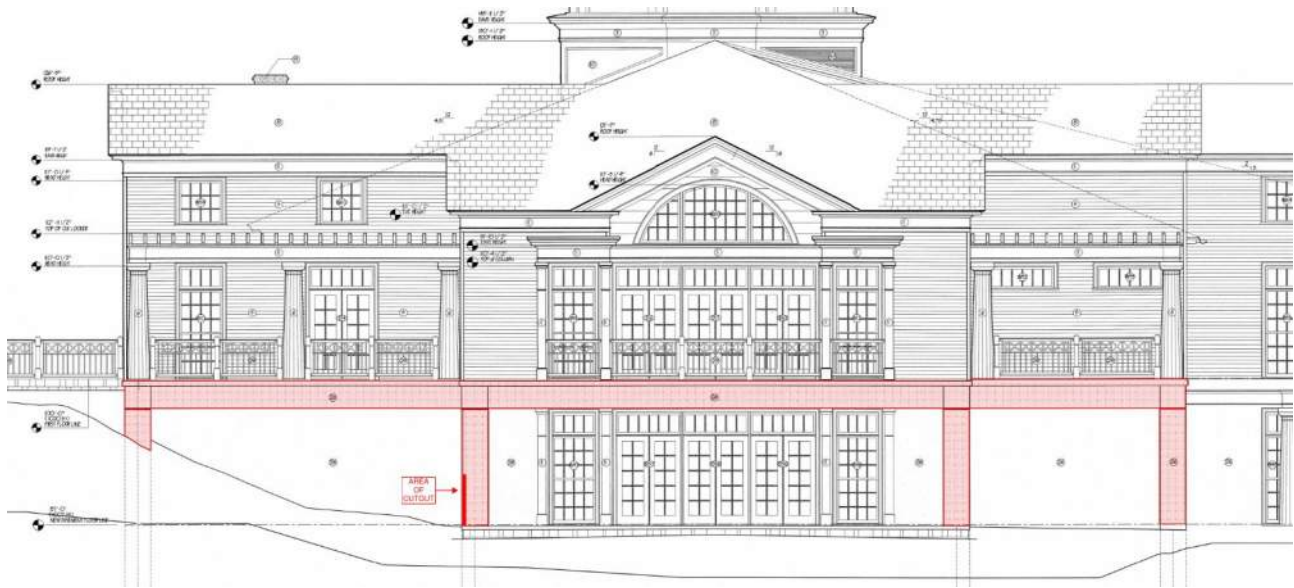
**Figure 7:** Location of EFIS damage areas (Northwest balcony) and EFIS cutout (dimensioned) highlighted with red hatching.

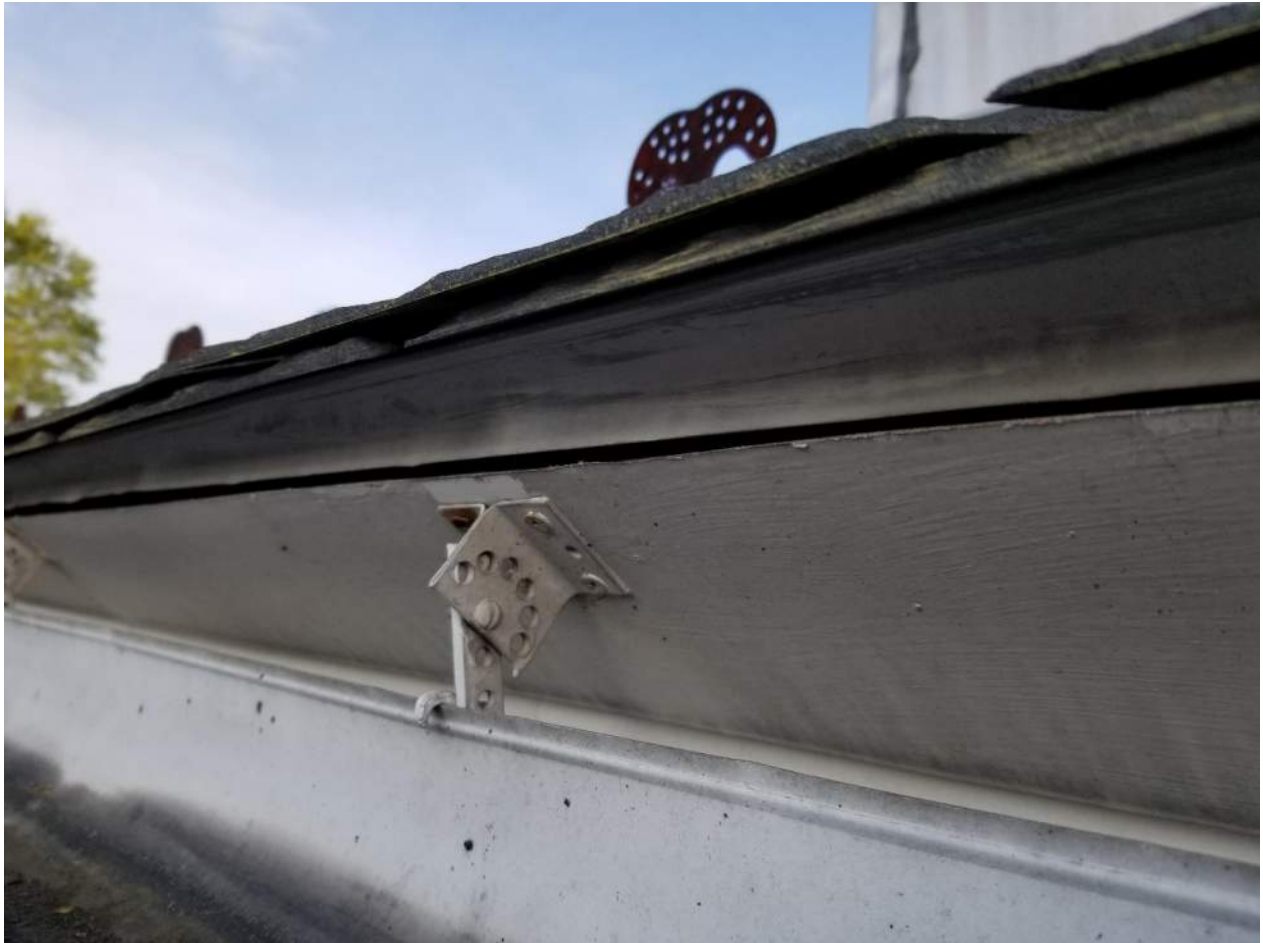
**Figure 1:** Closeup of gutter configuration.

Remove gutters and provide a larger size where existing gutters are placed.

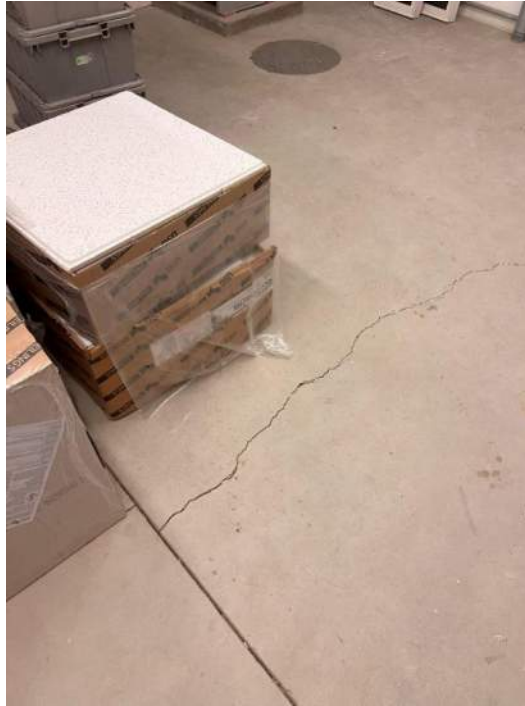
**Photograph 15:** Crack shown in floor slab.

Perform a subgrade inspection in the mechanical room to identify the cause of movement. If necessary, inject a stabilizing material beneath the slab or replace the slab with a properly compacted and reinforced foundation.
