# PLYMC – Poland Library

Poland Library Building Assessment

BSHM Architects, Inc.

1/23/24

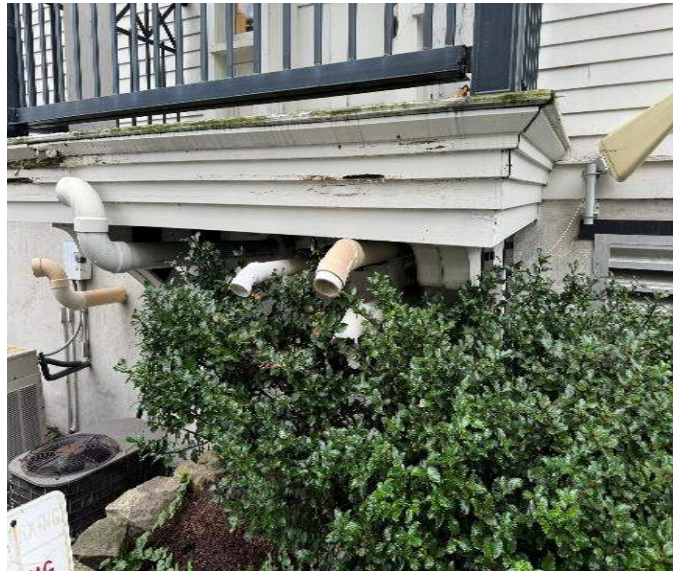
**Photograph 3:** *Damage from F/AC Vents.*

Replace the 2 furnace/AC units in the original house part of the facility. Rework the vents to eliminate the damage to the building structure.

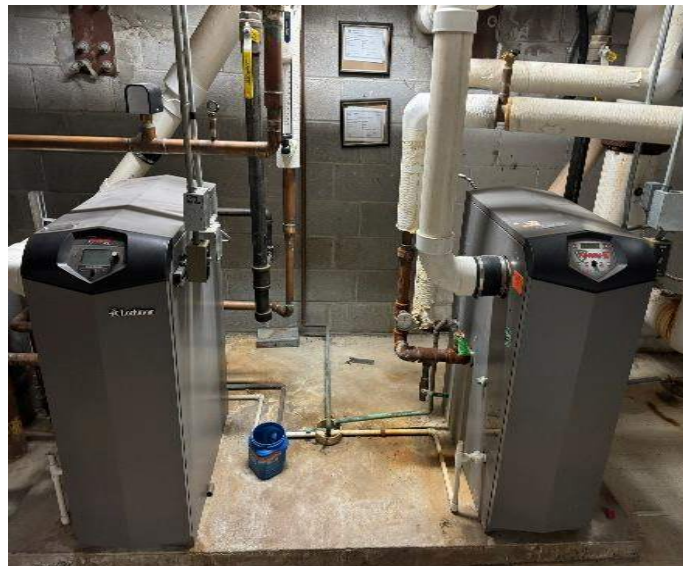
**Photograph 4:** Lochinvar Boilers (2006).

Consider replacing the 2 hot water boilers due to the age and expected life of the system. Rebalance pumps and distribution system to original values. Check and verify proper operation of all reheat coil control valve, thermostats and vav box controllers.

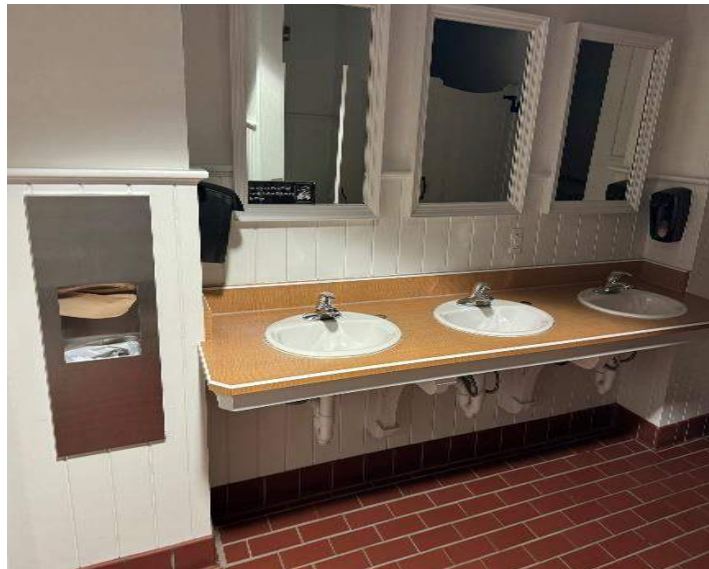
**Photograph 14:** Lavatories w/Manual Faucets.

- Replace water closet manual flush valves with automatic.
- Replace lavatory manual faucets with automatic.

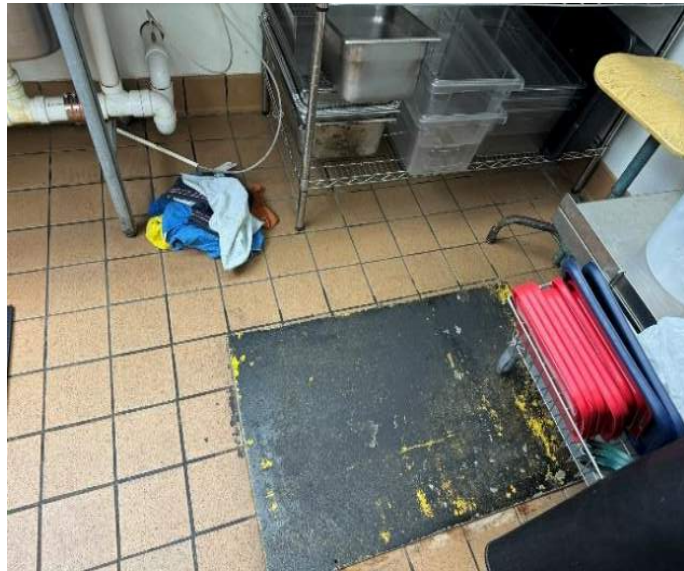
**Photograph 15:** Indoor Grease Trap.

Replace the indoor grease trap with a larger unit to prevent overflow of grease laden sanitary waste.

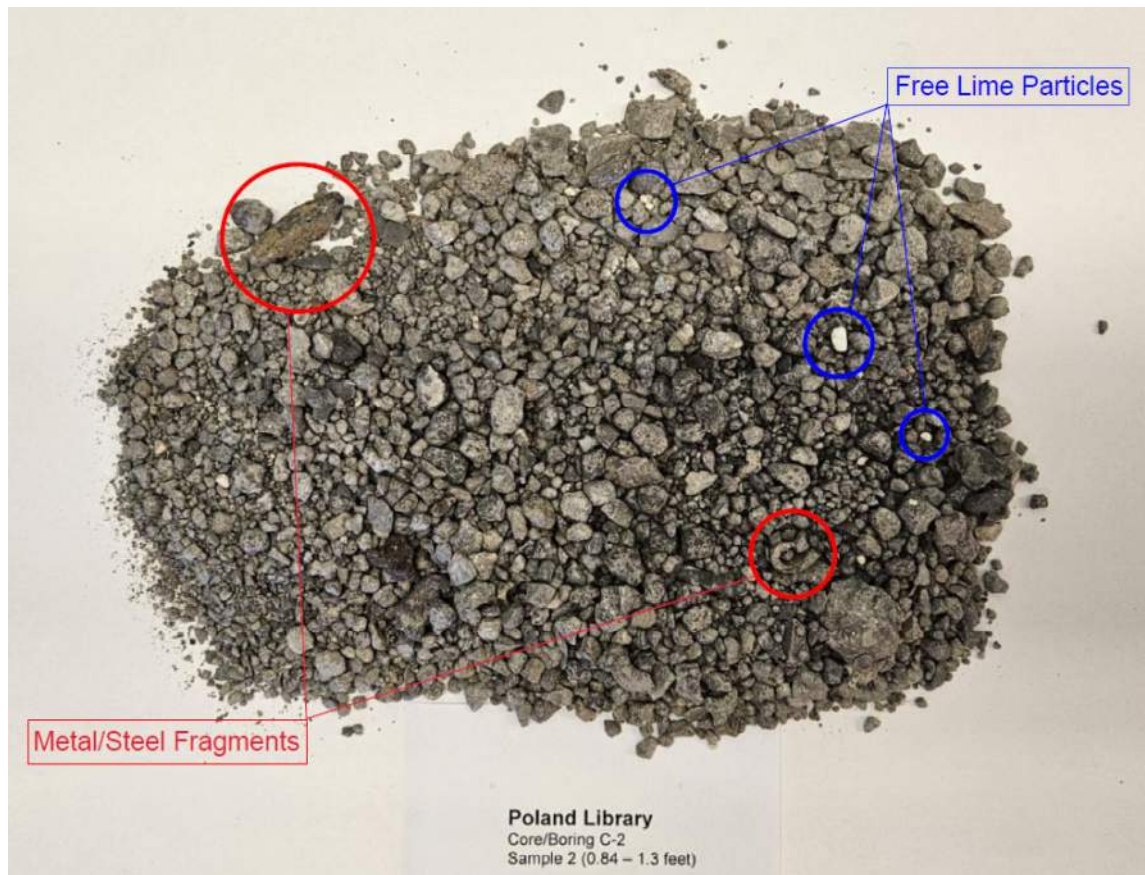
Below the floor slab section (concrete and underlying sub-base) at locations C-1 and C-2, we encountered dark gray slag-based fill. The slag-based fill consisted of mostly open-hearth slag and contained traces of gravel, sand, and metal fragments. In general, the slag profile had a gradation resembling a poorly graded sand with silt and gravel. The retrieved slag samples contained visible Calcium Oxide (CaO) at all depths. Calcium Oxide is un-hydrated free lime, which is added to the molten steel to facilitate the removal of ore impurities during the steel making process. The photograph below shows the typical slag-based fill gradation (after washing).

Typical slag-based fill at the project site

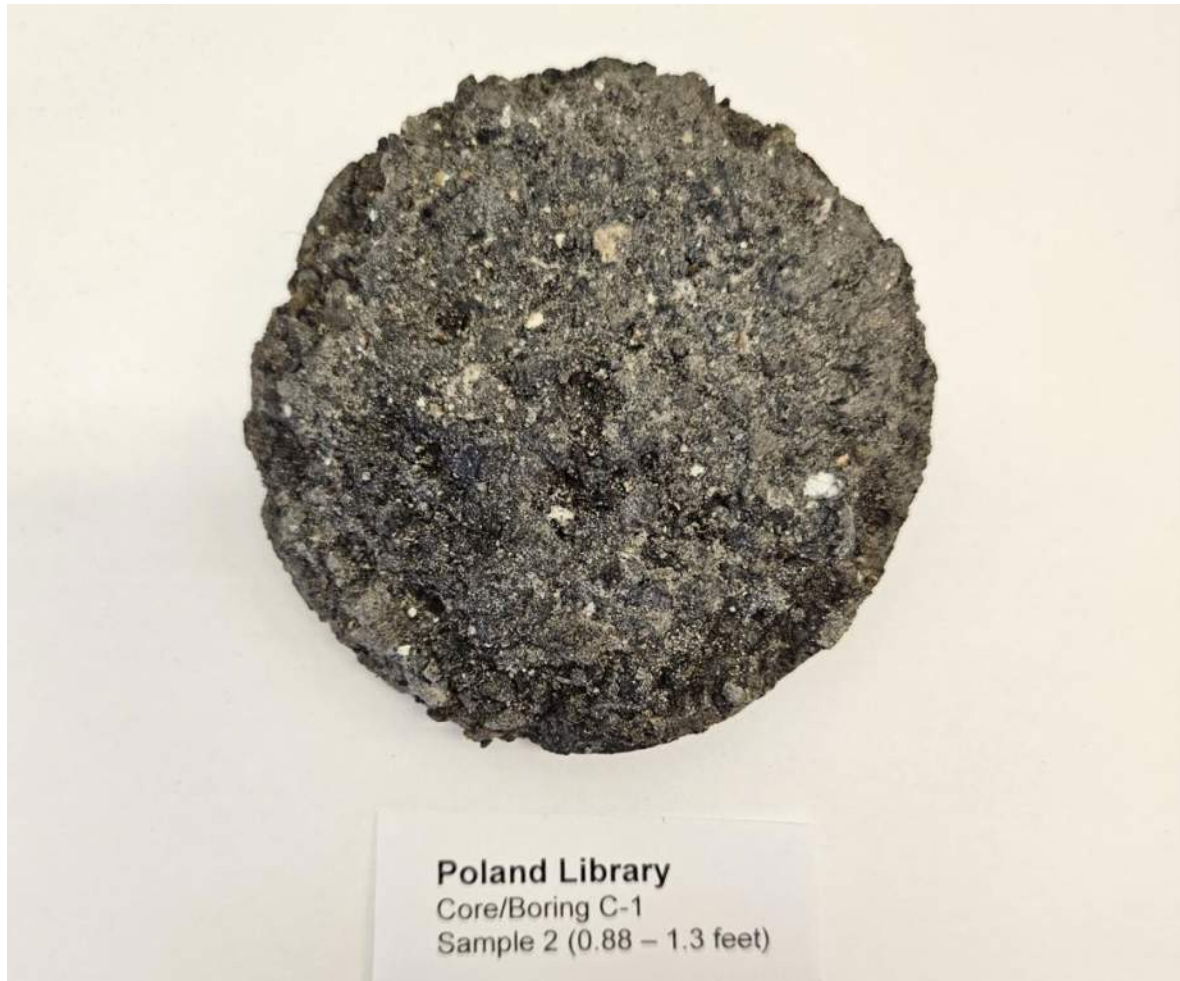
In portions of the slag profile in borings C-1 and C-2, the slag was found to be in a *fused* condition. Slag particles have the potential to fuse together (crystalize) when exposed to moisture as a result of the chemical compounds within the slag, typically Magnesium Oxide (MgO) and Iron Oxides ( $\text{Fe}_2\text{O}_3$ ). In our experience, fused slag typically has a comparable hardness similar to asphalt or occasionally as high as concrete. The photograph below shows a portion of the fused slag, obtained by coring methods from boring C-1.

Fused slag obtained (cored) from C-1 (nominal diameter 4 inches).  
Note the presence of free lime within the specimen (white inclusions).

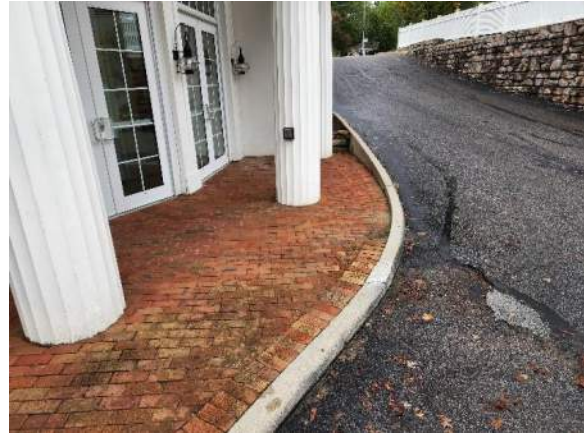
**Photograph 5: Absent frost slab at outswinging exterior door.**

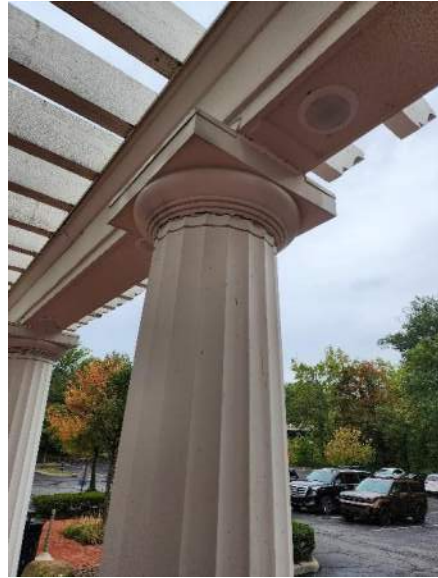
**Photograph 8: Column wrap failure.**

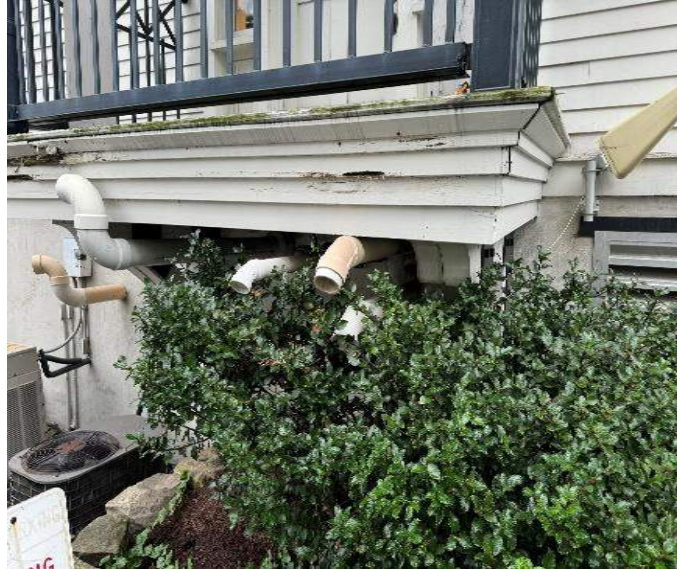
Damage from F/AC Vents
