# EXISTING FACILITY ASSESSMENT

## Poland Branch Library

DATE OF ASSESSMENT: January 13, 2025

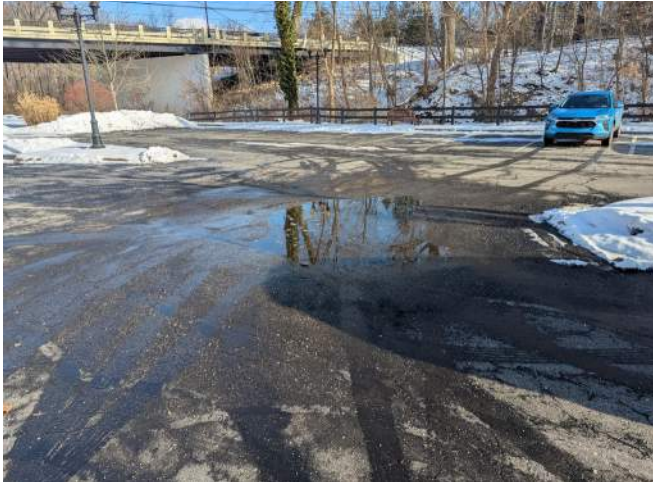
*Figure S-2: Ponding water in parking lot*

- S1.01 Repave and restripe parking lot.
- S1.02 Restripe accessible parking spaces to provide van accessible parking space.
- S1.03 Provide detectable warning strips at curb ramps.

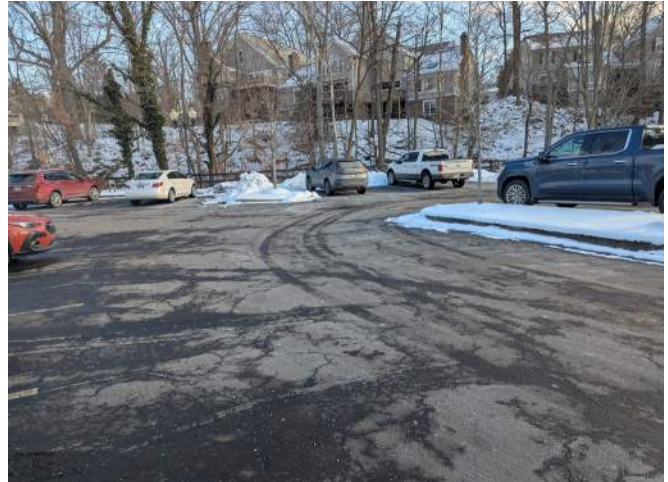
*Figure S-3: Parking lot conditions*

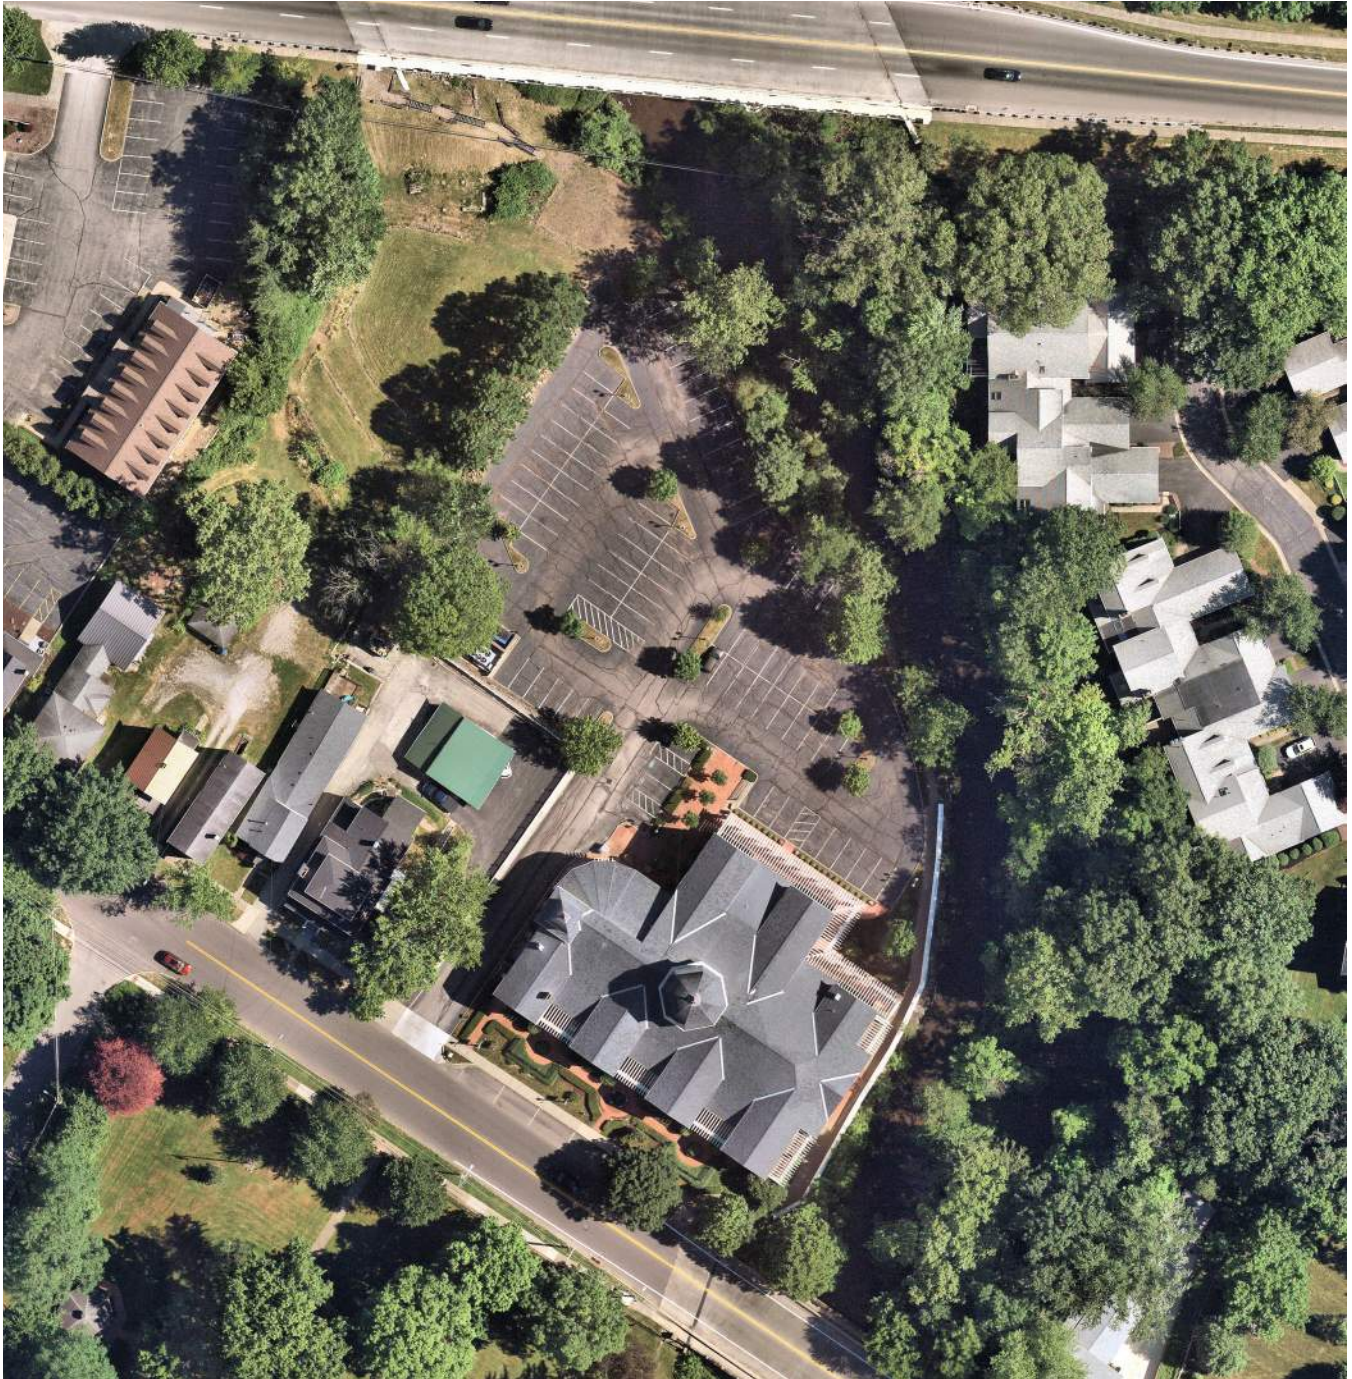
The hardscape on site is comprised primarily of concrete sidewalks on S Main St and internal site paver walkways. The public sidewalk was observed to be in good condition while the paver walkways on site had settled unevenly and were in poor condition.

Figure S-4: Site Hardscape Aerial

S2.01 Remove and reset pavers providing adequate subbase and soil compaction.

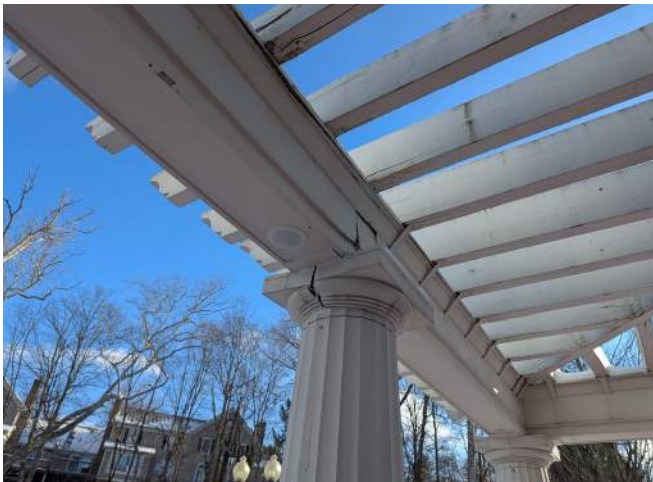
Figure A-1: Failing pergola column and beam

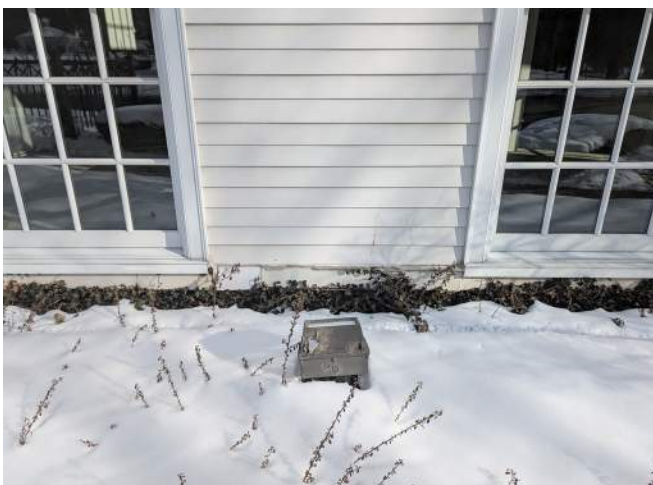
The envelope of the building is in poor condition. For more detailed information refer to the assessment performed by BSHM architects.

Figure A-3: Deteriorating siding

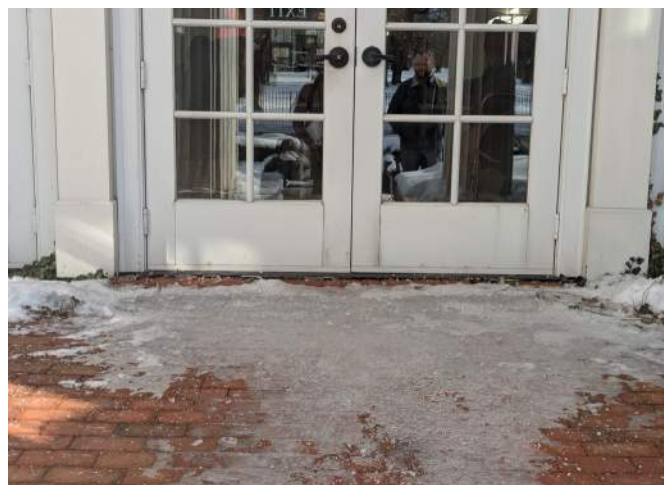
Figure A-4: Door sill threshold

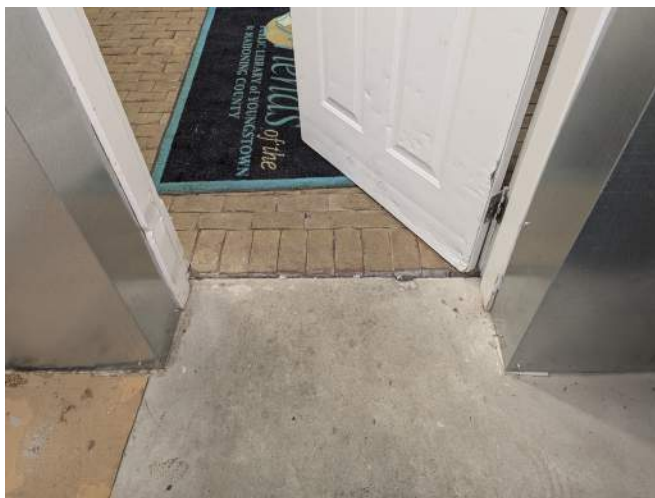
Interior doors appear to be in good condition, but the exterior doors are in poor condition due to ongoing problems with the envelope as well as poor site drainage. For more information refer to the assessment prepared by BSHM architects.

Figure A-6: Basement door threshold

A5.01 Replace damaged exterior doors and ensure grade slopes away from building.

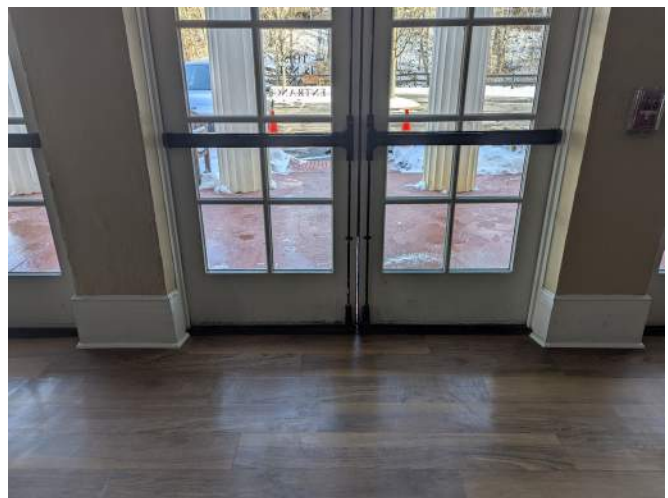
Figure A-7: Exterior door with gap

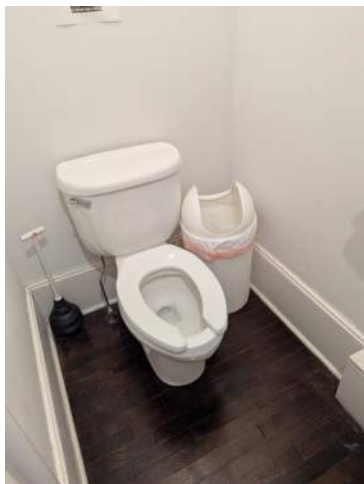
The toilet room adjacent to the children's programming room is too small to meet the necessary clearances for accessibility.

Figure A-10: Toilet room

- A6.01 Remodel basement restrooms to provide approachable door clearances.
- A6.02 Remodel first floor restrooms to provide approachable door clearances.
- A6.03 Demolish and rebuild family restroom to meet accessibility requirements.

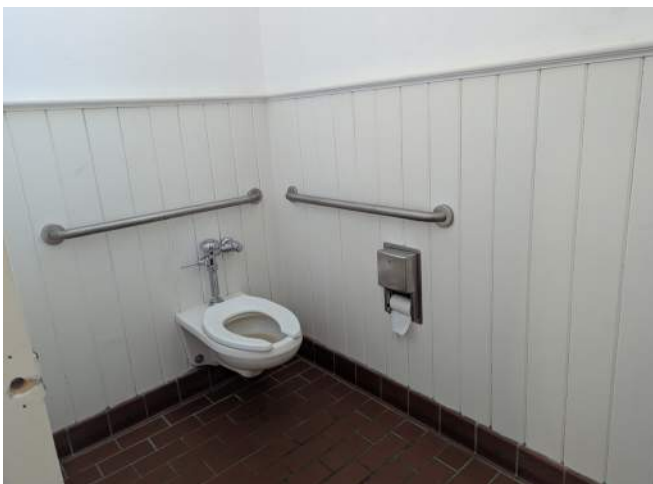
The public restrooms in the basement do not have appropriate door clearances for the accessible stalls and the public restrooms on the first floor do not have appropriate door clearances at the entry to the restrooms.

Figure A-18: Men's room accessible stall

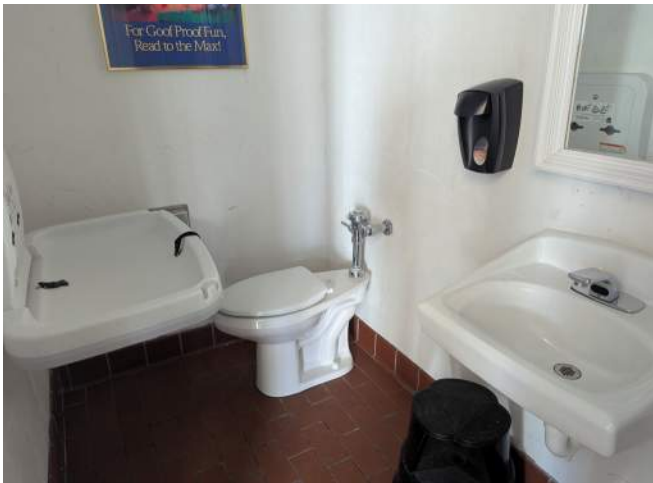
*Figure A-20: Family restroom*

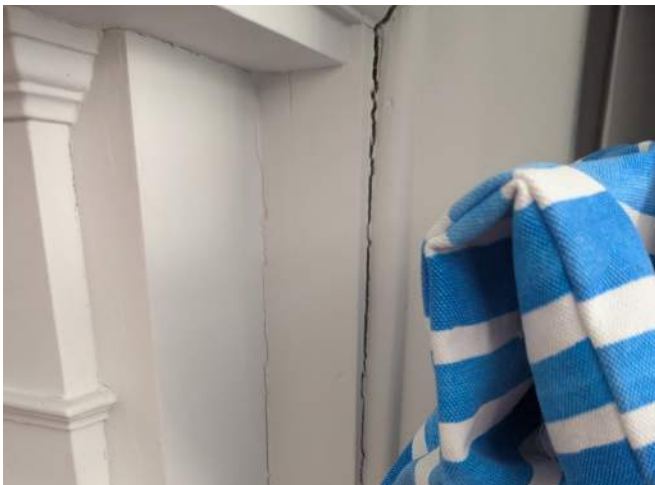
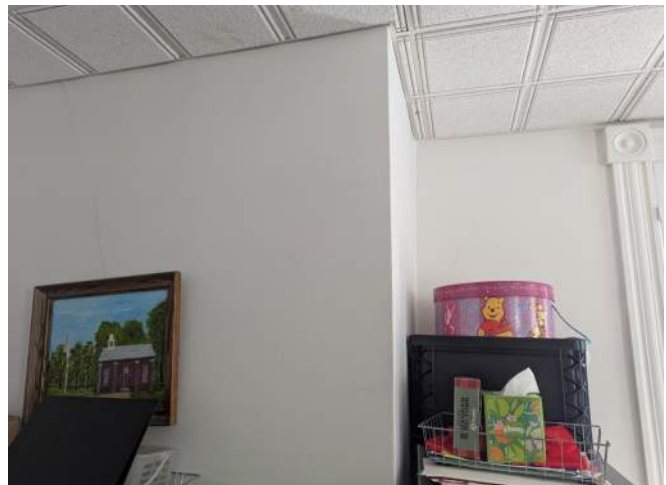
In general, the finishes are in fair condition. Cracks have formed throughout the building due to the settlement of the structure. The paver floor in the basement is especially uneven as it has settled over time.

Figure A-21: Fireplace crack in dormitory building

Figure A-22: Fireplace crack in dormitory building

A7.01 Patch and repair cracks. Monitor for future movement.

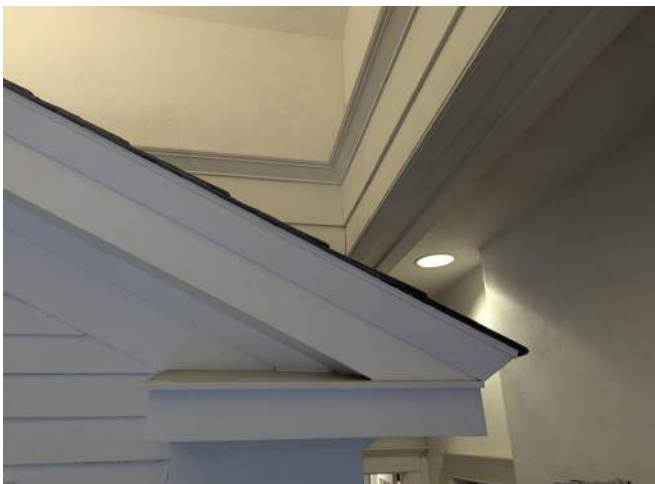
Figure A-23: Crack in corner of moldings

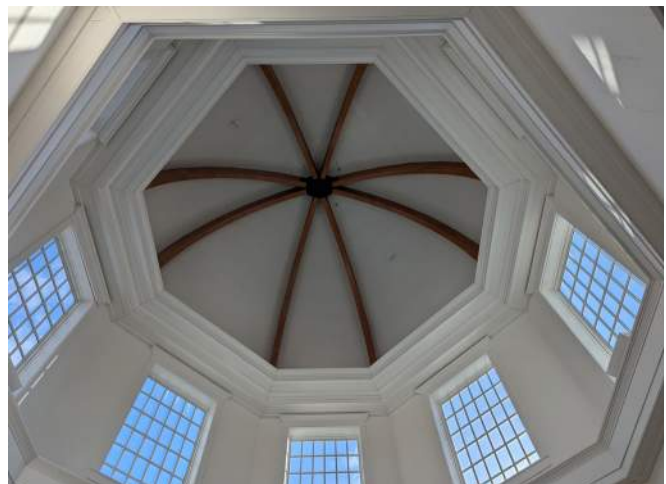
Figure A-24: Water stains on cupola ceiling

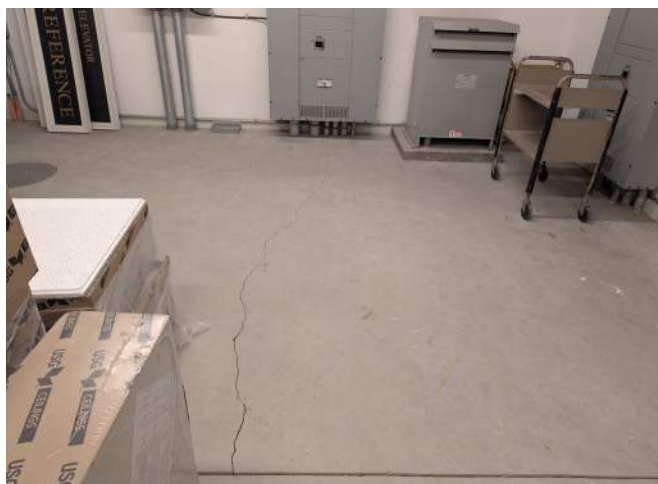
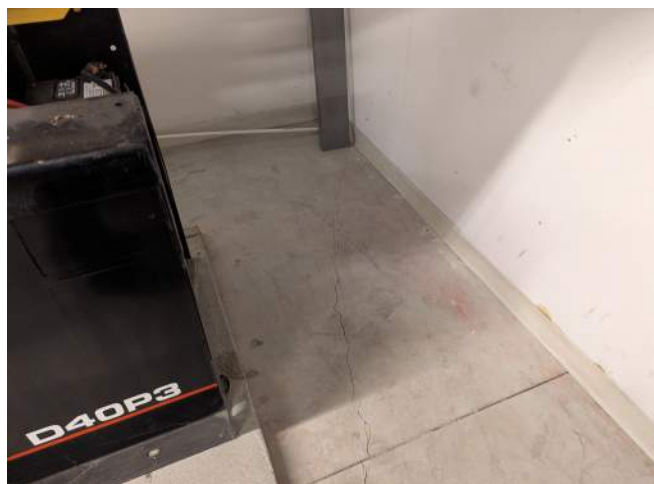
*Figure A-25: Cracked floor in electrical room*

*Figure A-26: Cracked floor in electrical room*

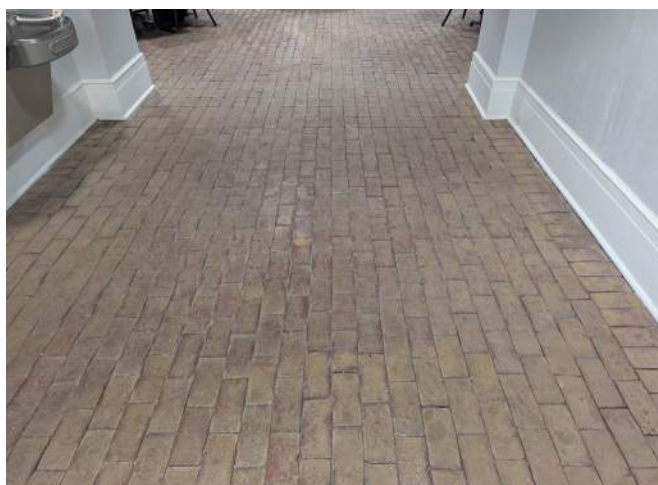
*Figure A-27: Basement pavers*

A7.02 Replace paver floor at basement level with a more suitable flooring material.

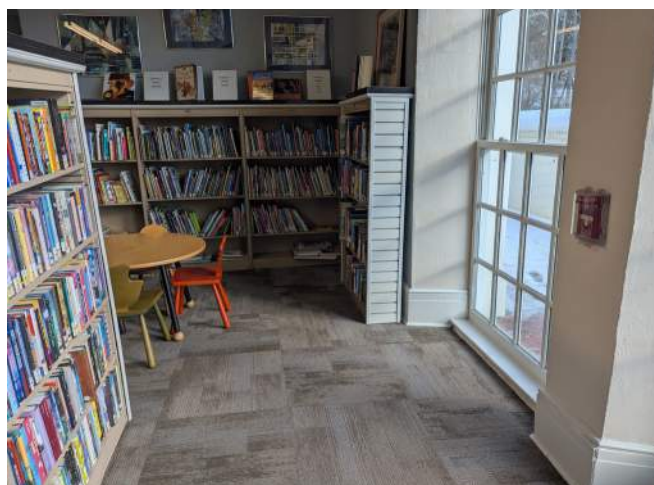
*Figure A-28: Bookstore floor settling*

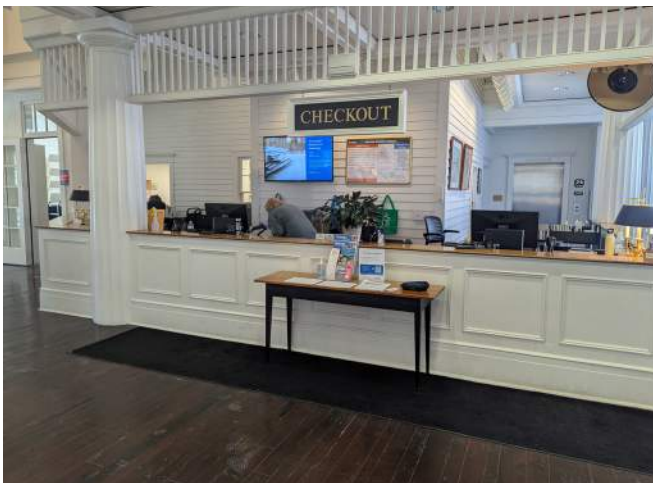
The main circulation desk does not have an ADA compliant transaction area.

Figure A-32: Checkout desk

A8.01 Rework circulation desk to meet ADA accessibility requirements.
