# PLYMC – Poland Library

Poland Library Building Assessment

BSHM Architects, Inc.

1/23/24

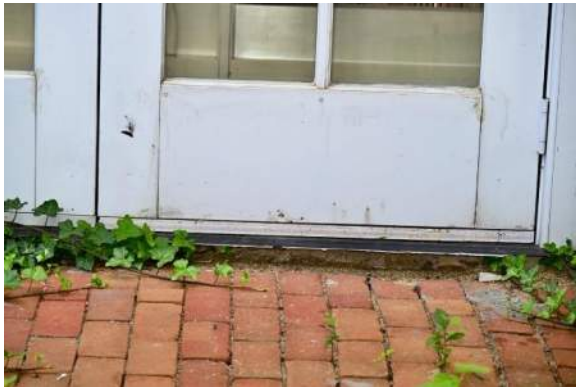
The patio areas at South Main Street have settled unevenly (**Figure 1**). The distance between the door sill and finish elevation of the pavers does not meet the requirements of The American with Disabilities Act and associated codes. These locations are included as means of egress to the public right-of-way. The railing leading up towards the center patio is broken at its base (**Figure 3**).

**Figure 1:** Pavers are recessed below the door at this patio location.

**For all areas with brick pavers** - Remove, salvage and clean the existing Brick pavers. Remove subbase material for installation of new concrete slab and crushed stone base. Before new pour, place underdrains to prevent water from migrating towards the building. Compact the existing subbase demolished on-site and allow for 4" min of compacted, crushed stone subbase. Install 4" reinforced concrete slab and provide control joints @ 10'-0" O.C. in slab that follows the Brick paver design. Provide accessible concrete ramp(s) from parking lot to paver elevation.

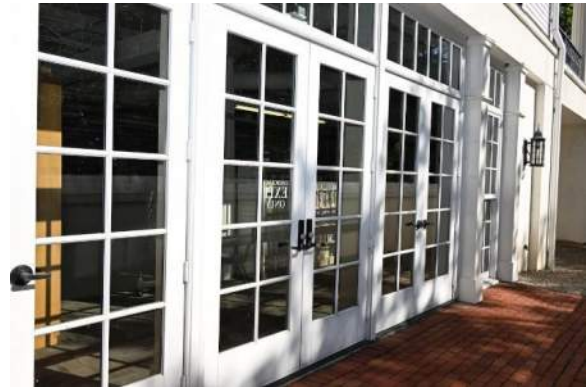
**Figure 2:** Pavers at lower-level exit, off the Bookstore.

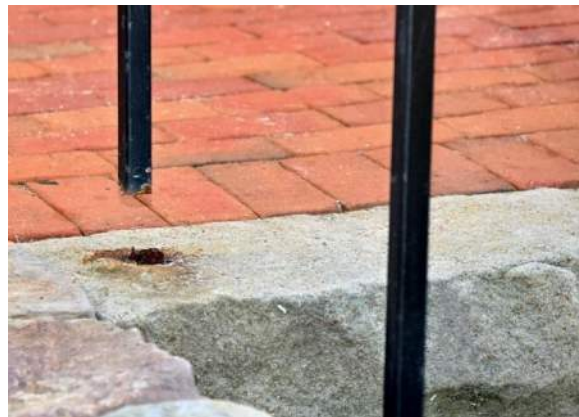
**Figure 3:** Railing at the center patio.

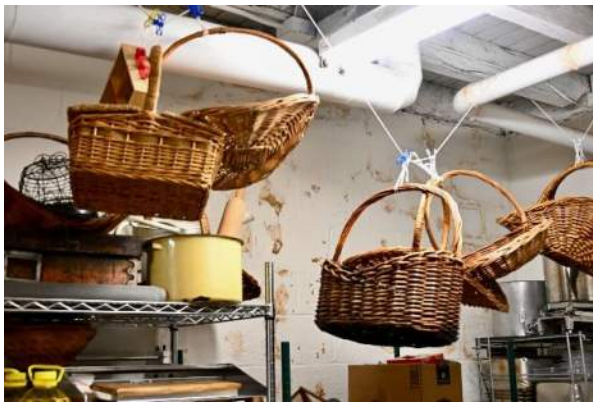
The existing dormitory building is on the North side of the building adjacent to the entrance drive. The West exterior basement wall is damp at various times and discolored. The first-floor slopes towards the center floor support beam. The space in the basement does not provide adequate space for a beam replacement addition. The second floor also slopes in the same direction. The original fireplace on the second floor is separated from the wall. Repair or replacement of the exterior flashing is needed for the existing fireplace chimney (West side of Dormitory), the other chimney with a metal cap (East side of Dormitory) and cupola.

**Figure 1:** Damp spots on the West wall.

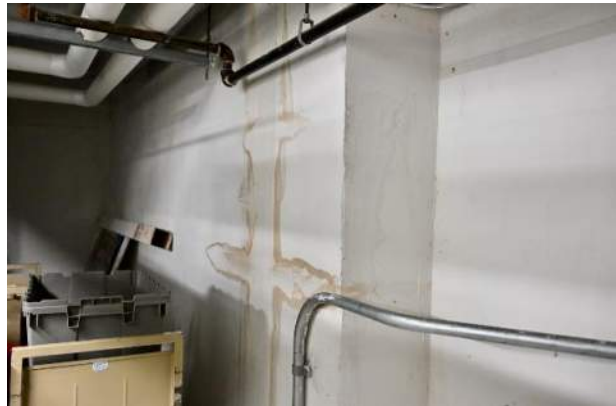
**Figure 2:** Discoloration of West basement wall.

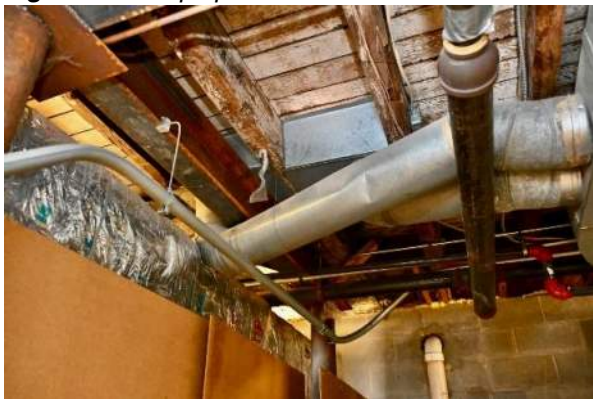
**Figure 3:** Lack of space beneath floor joists.

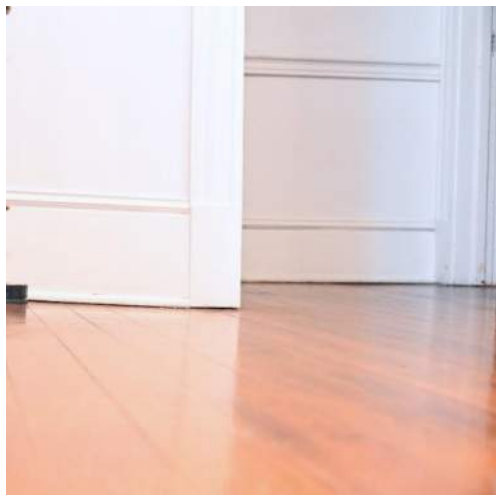
**Figure 5:** Uneven slope of the first floor.

**General demolition** includes removal of walls, floors, subfloors, ceilings on the first and second floor. Demolition also includes mechanical, electrical and plumbing on the ground level. The existing stairs from the lower level to the main floor shall remain. Renovation work includes new floor framing, structural beam replacement of subfloor and finish floor on the first and second floors. Provide new mechanical, electrical and plumbing for the Dormitory Building. The scope of renovation work includes three single use accessible restrooms. Repair interior mantle and block/brick backup. The recommended floor plan will remain like the original design. Materials/floor/ceiling shall be replaced in-kind.

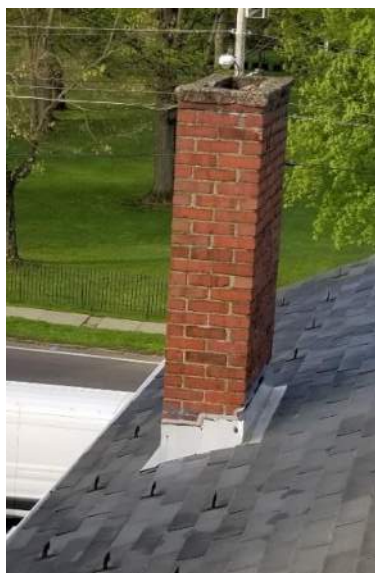
**Figure 7:** Existing Chimney Flashing.

The **Brick chimney** will require new stepped and counter flashing (**Figure 7**).

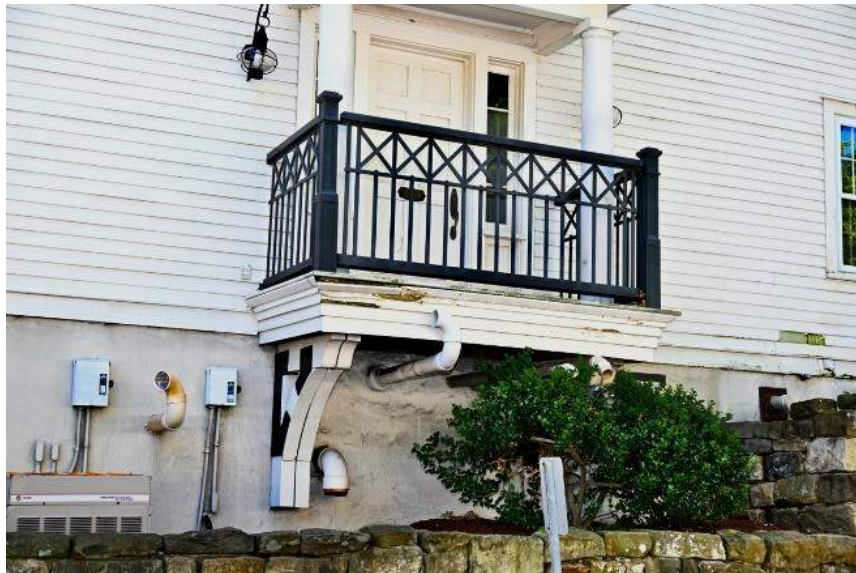
The exterior side porch shows signs of separation from the exterior wall. The Mechanical exhaust located below blows steam onto the wood area (see Mechanical section for more information and images). Railings located on the north elevation have rust at the joint connections, they are not secure.

**Figure 8:** Porch located on exterior wall. Note exhaust location.

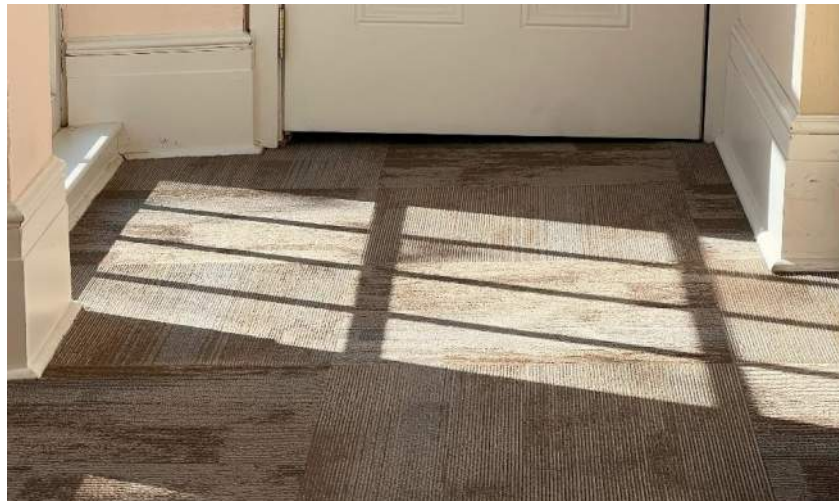
On the lower level, the Book Store (labeled as Future Space in plan drawings), is slab-on-grade at the Southern end of the building (**Figure 4**). The floor slab rests on open-hearth slag at the base (**Figure 1 and 2**). The slag may have impacted the unevenness in the floor due to differential settlement. It is possible that the floor slab condition extends into the storage area adjacent to the bookstore.

**Figure 2:** Book Store slab settlement issues.

Remove hearth slag and replace with new compacted gravel base and new concrete. Rebuild walls and casework per original documentation and design. Reinstall salvaged doors and carpet tile. Base profile to match existing.

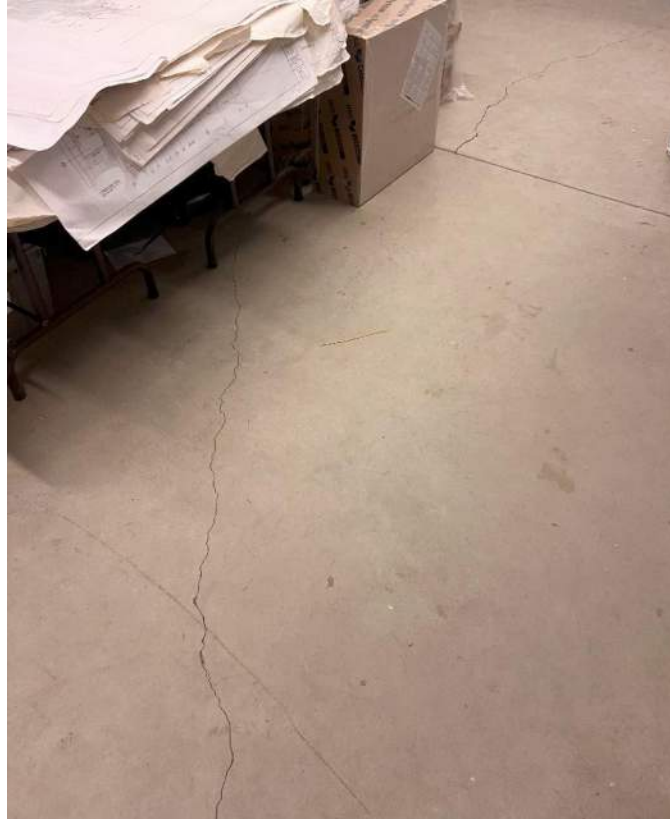
The same condition is in the Electrical Room (**Figure 3**). The concrete has visible cracks due to heaving in the center. The interior walls show no signs of cracking; therefore, it remains a slab issue.

**Figure 3:** Concrete Slab in Electrical Room.

Leave the slab in the Electrical Room as-is. Library staff should monitor the cracking to see if the current condition worsens. The existing utilities in the Electrical Room pose adversities in the demo and removal of the floor slab.

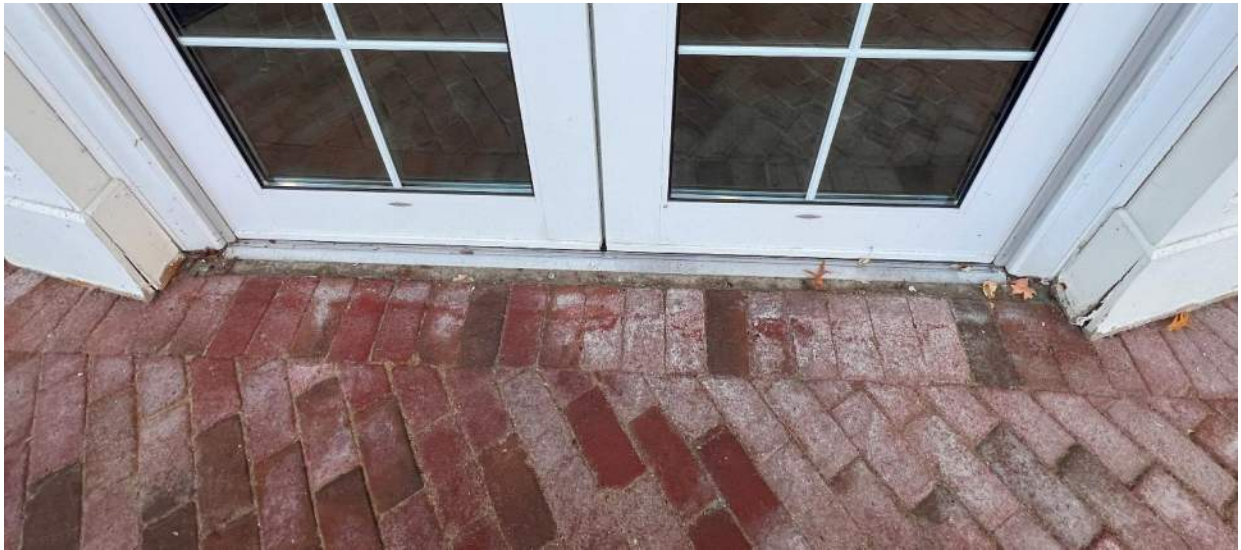
**Figure 8:** Door sill at East entrance. Note both pilaster bases.

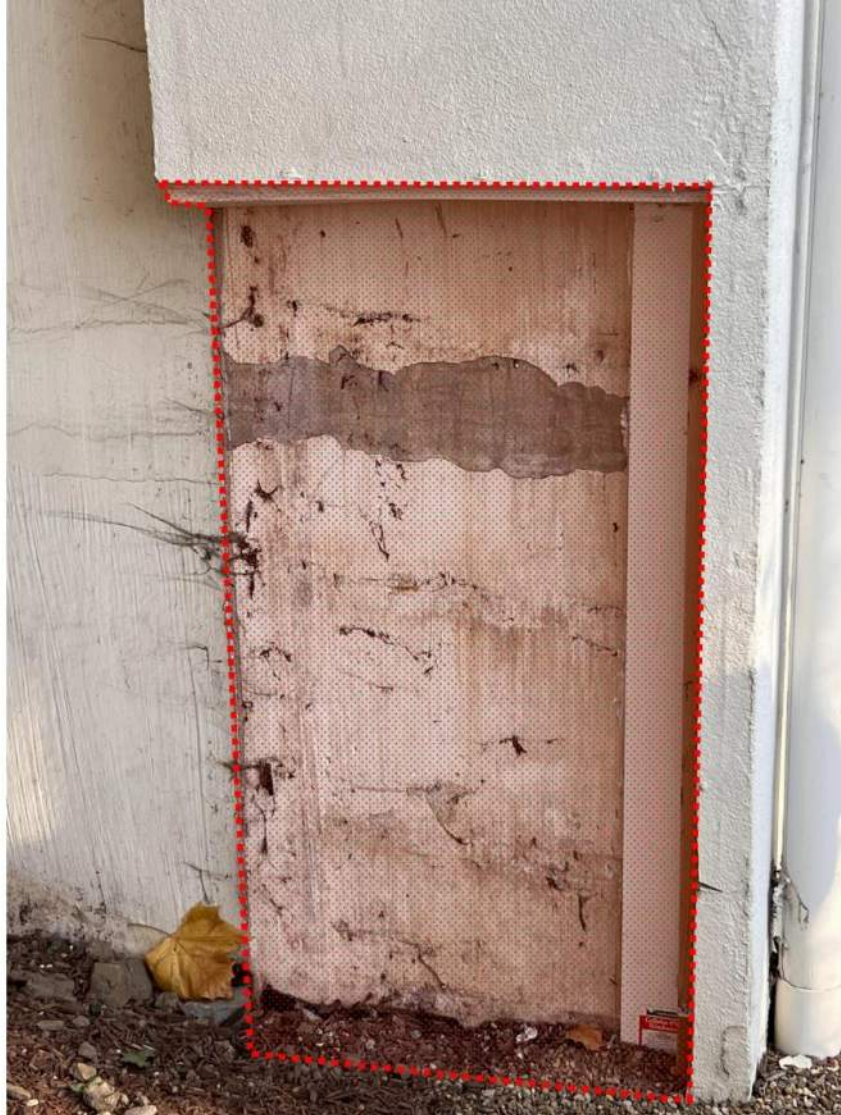
**Figure 12:** Concrete exposure on West Elevation. Red hatch shows desired infill.

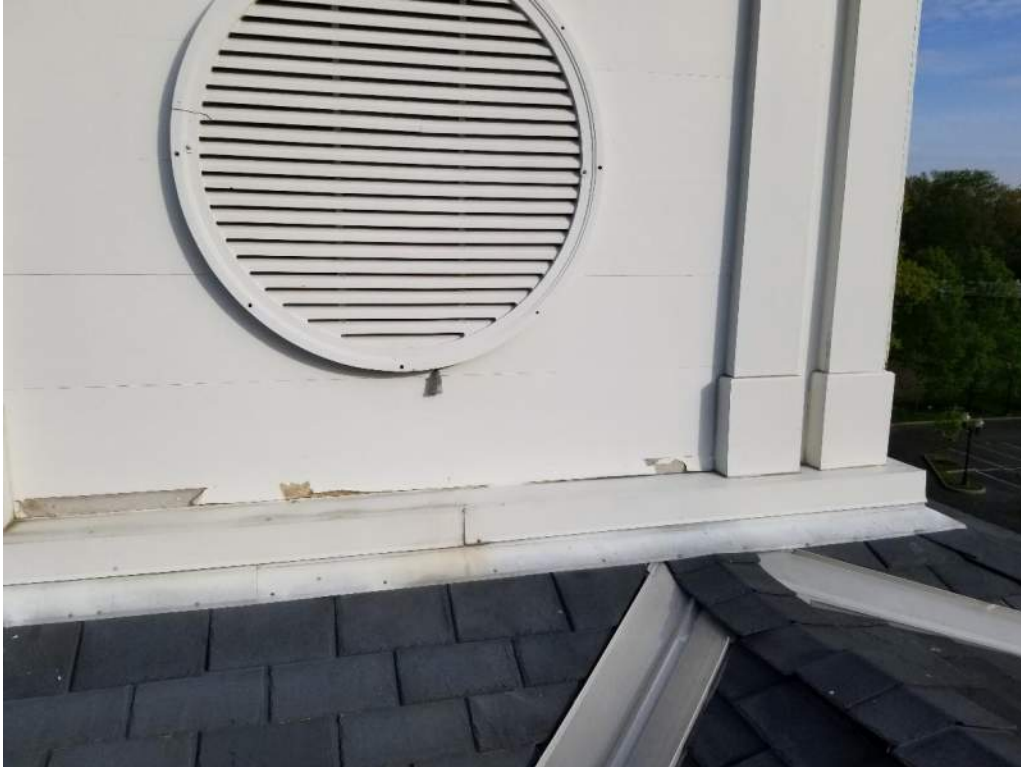
**Figure 13:** View of cupola occupied near the Dormitory Bldg.

Replace Horizontal siding base repair around the entire perimeter of the building where it has not been restored. The locations of replacement are shown on plans and the pictures below: **Figures 1,2,3,13,14,16,18,19,20.**

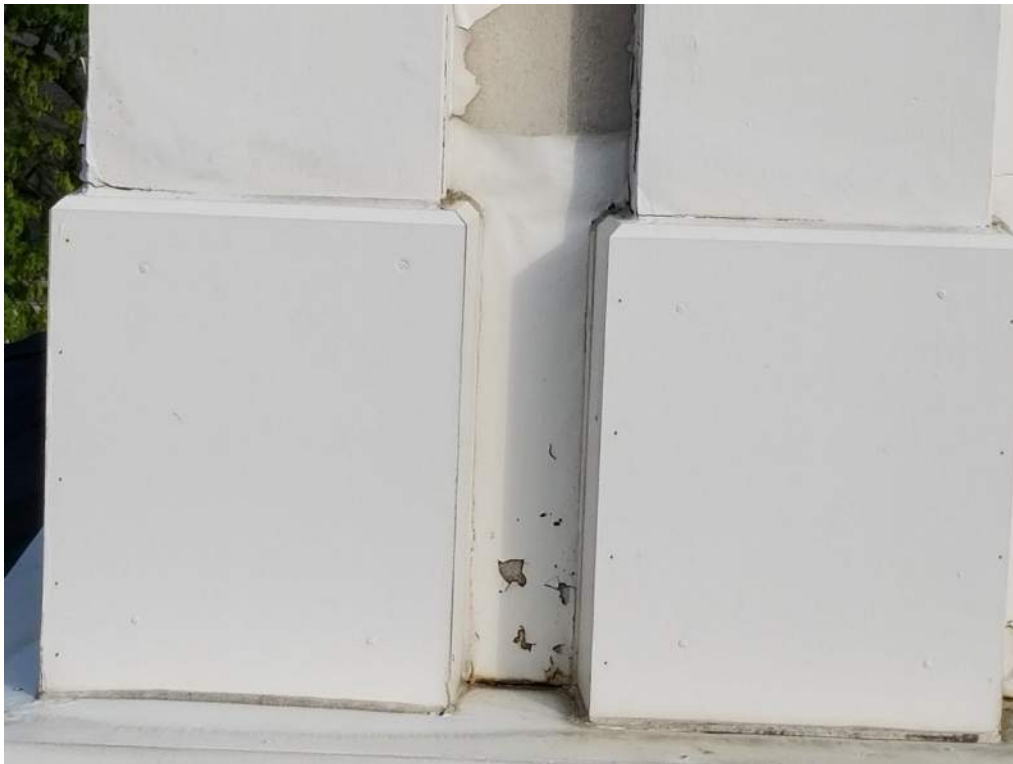
**Figure 14:** Cupola pilaster bases.

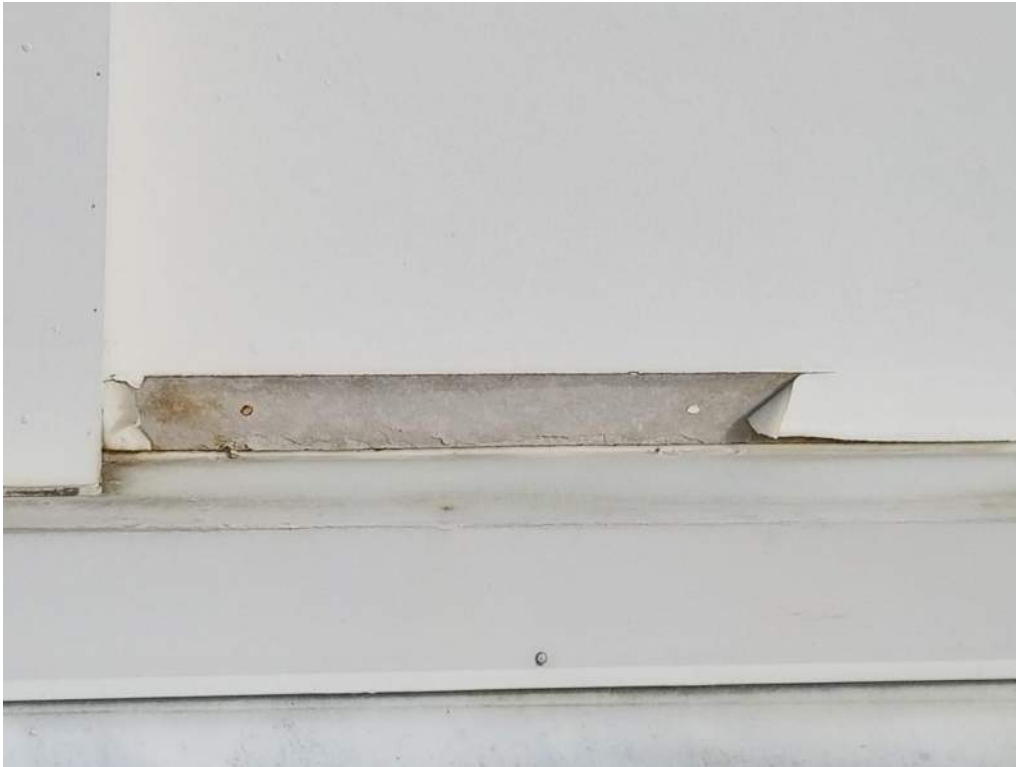
**Figure 15:** Cupola trim peeling at base.

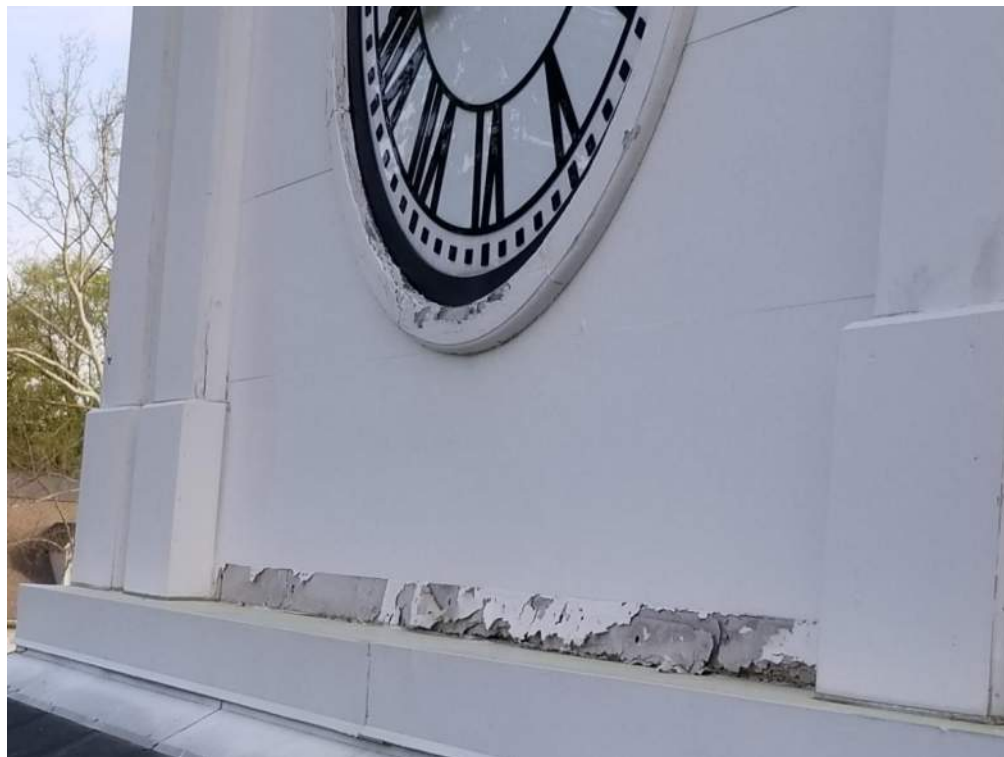
**Figure 16:** Cupola base trim issues.

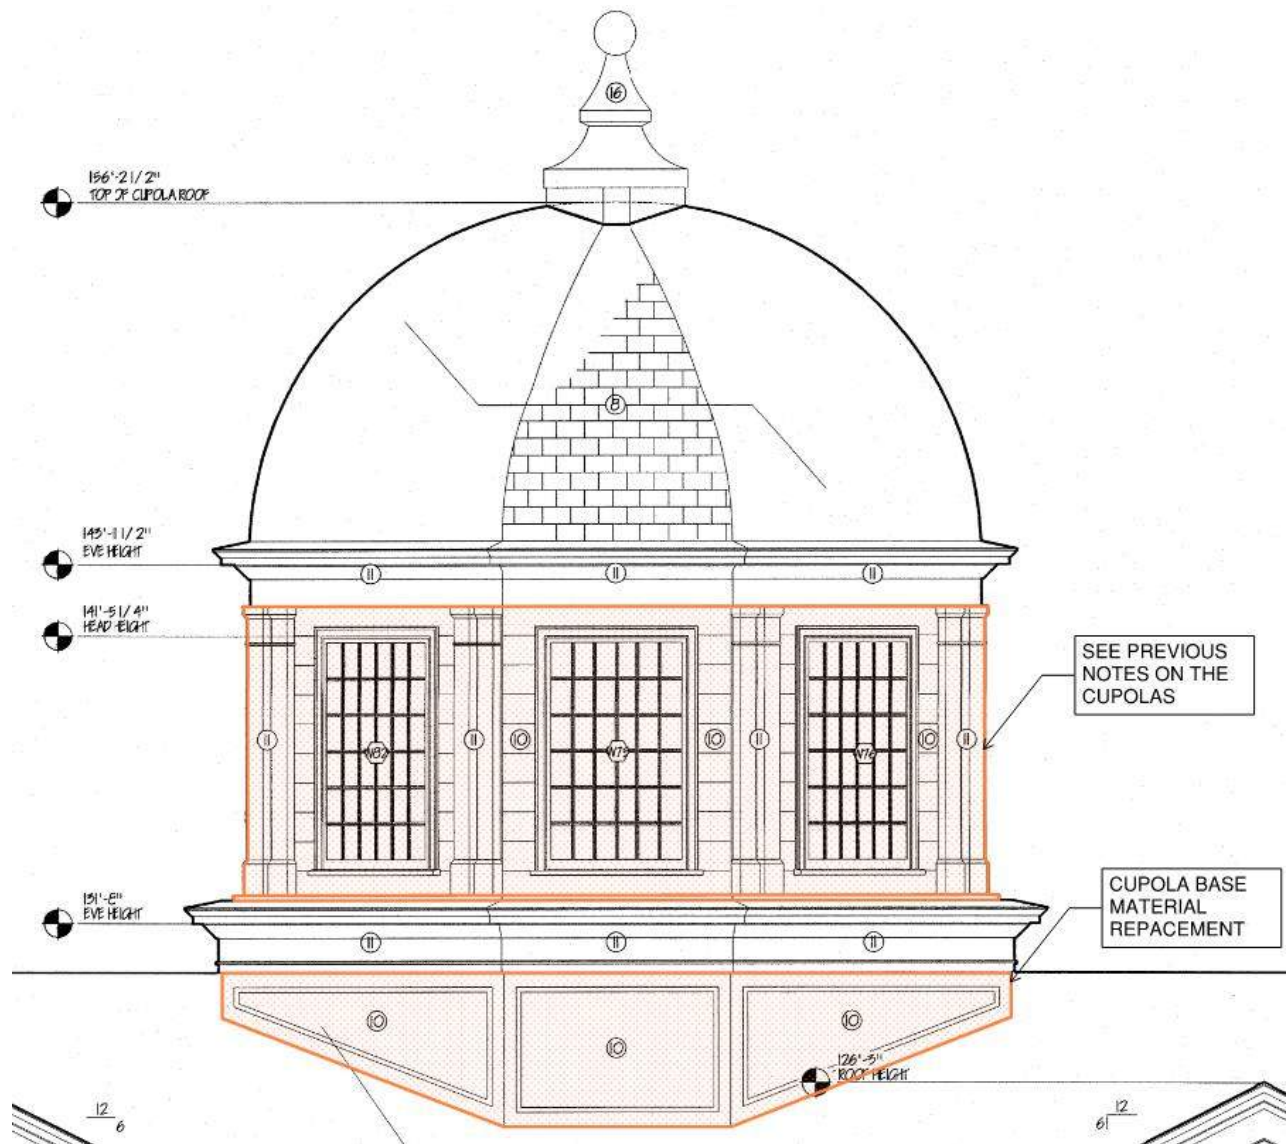
**Figure 20:** North Elevation of centralized cupola. Orange hatch highlights areas of material replacement.

Provide new weather barrier and transition membrane at flashing and open locations. Verify the condition of existing flashing. Profiles and design to be per existing documentation and existing built cupola **(Figure 19 & 20)**.

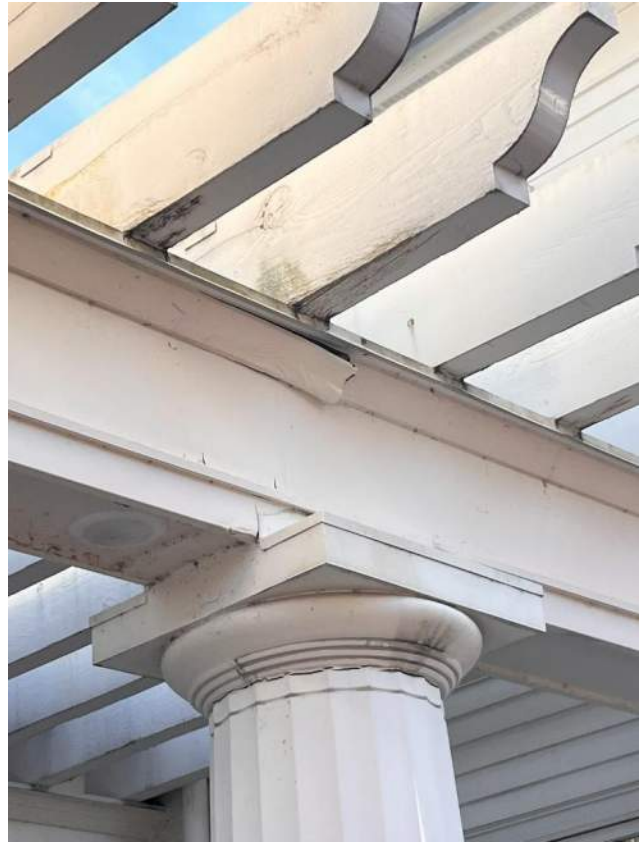
**Figure 6:** Compromise of beam at the corner patio location.

Replace all joists and beam structures with 4x12 cedar material (spec. type of material will be addressed later). Replace entire columns where needed due to extensive material repair or to add structural column inside the doric shell. Where there is excessive wear at the column base, cut and replace with column wraps in-kind. The column profile used throughout the building is the Doric column.

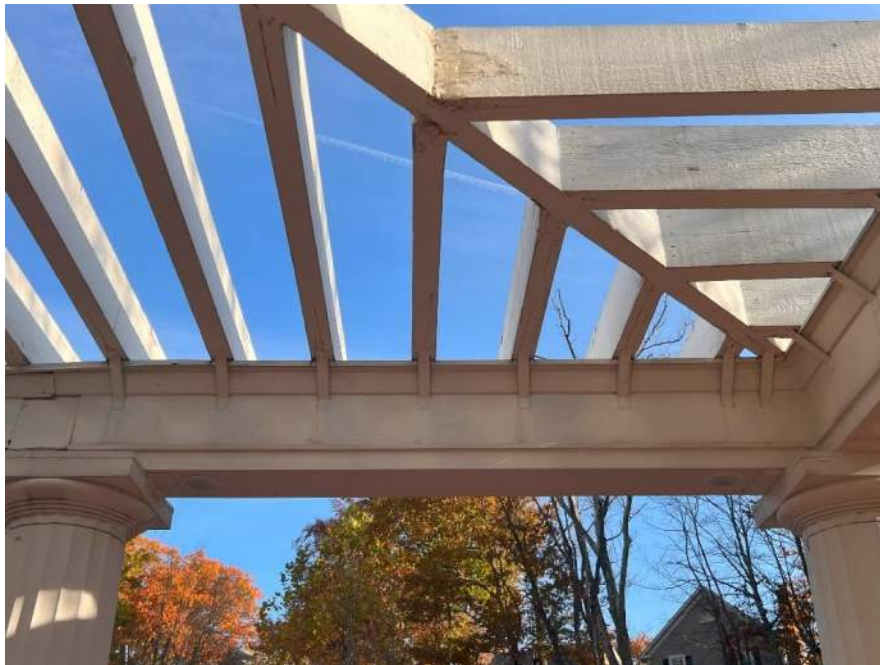
**South Elevation** – The 2 closet columns in the Southwest corner have severe cracking down the center of each capital onto the beam. Starting at the same corner, the first five columns have additional joint-beam metal strap connections from the architrave to the bottom off the joists. This continues at every joist as the pergola wraps around to the Southern end (**Figures 7,9,10,11,12,13**).

**Figure 7:** Metal-strap connections on pergola assembly near parking lot.

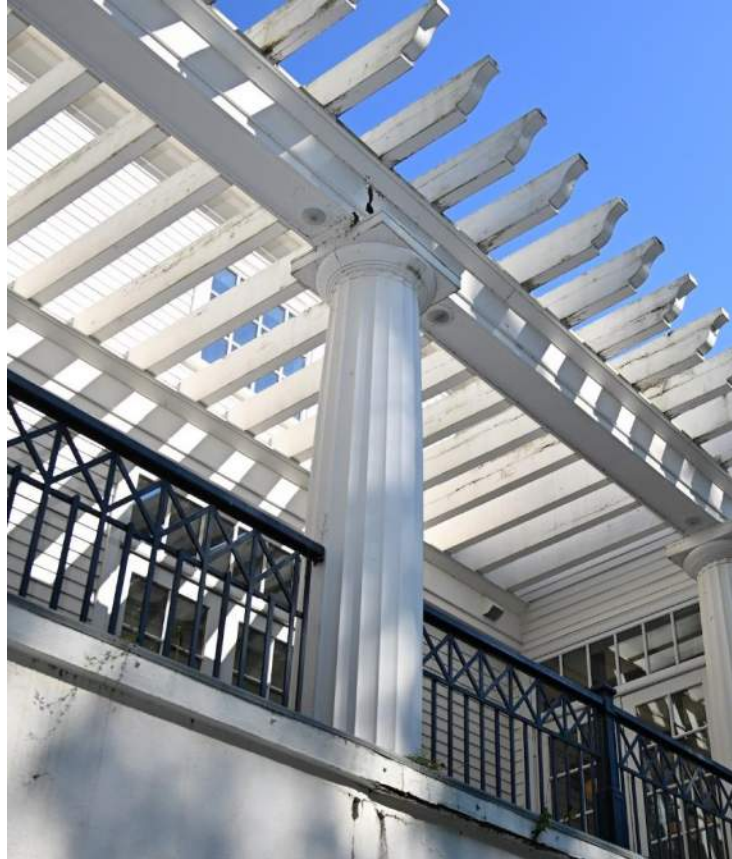
**West Elevation (Main Level Balconies)** – From the view of the Southern Balcony, there is more evidence of wood rot of the joists on the lower-level pergola. The balconies themselves have the same condition, as well as beam deterioration and the beginning of the column capital splitting (**Figure 8**).

**Figure 8:** Pergola on balcony looking out to S Main St.

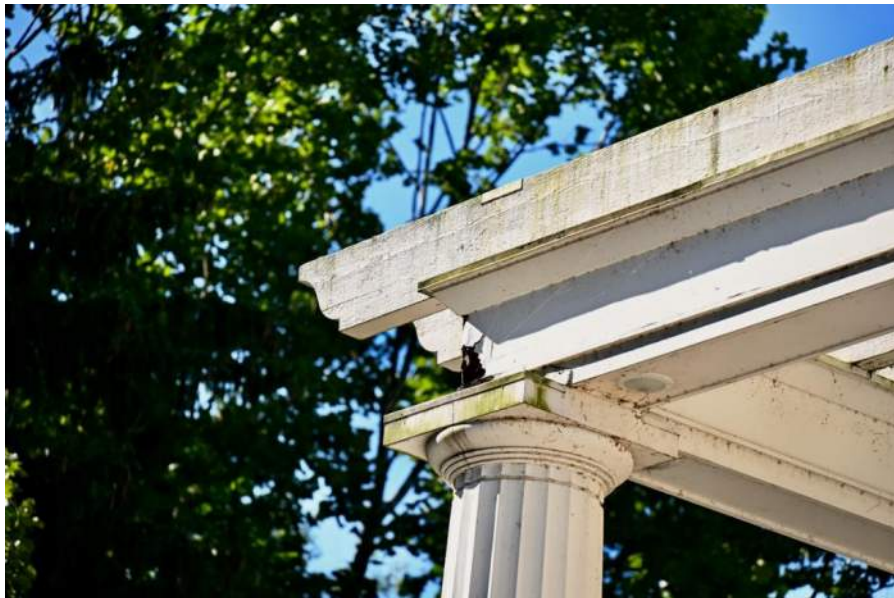
**Figure 9:** Pergola corner condition near parking lot.

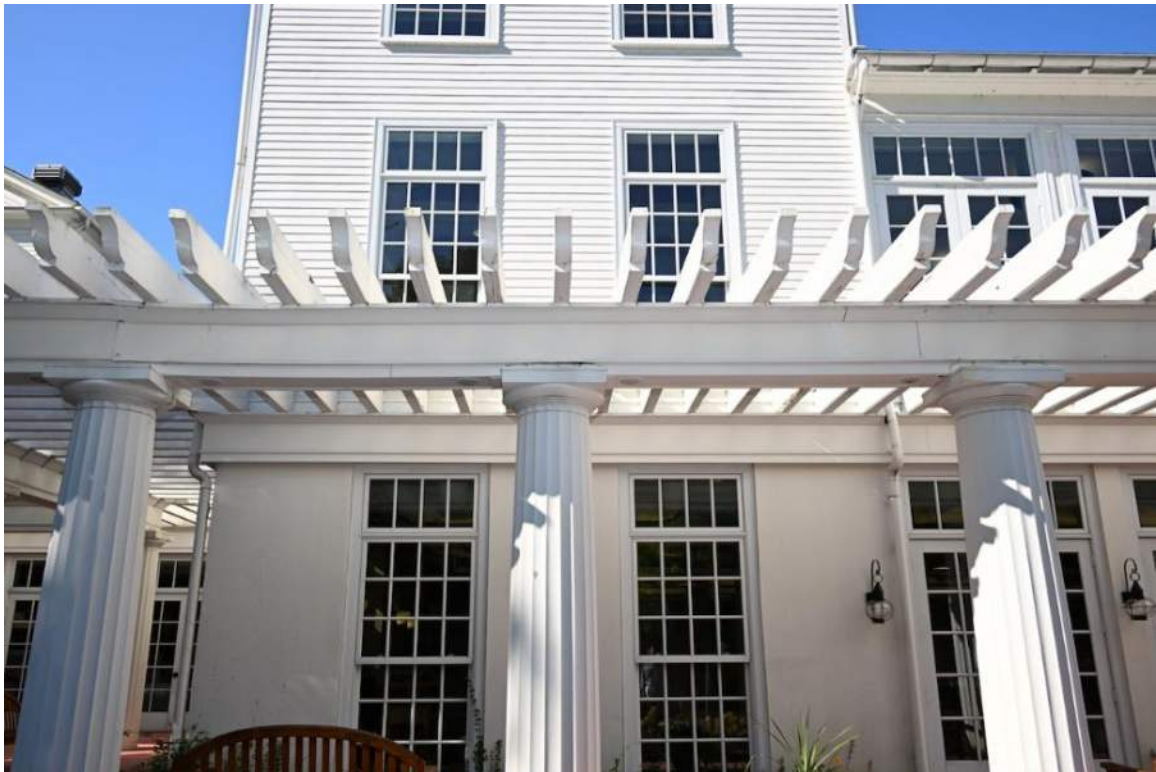
**Figure 12:** South Elevation pergola.

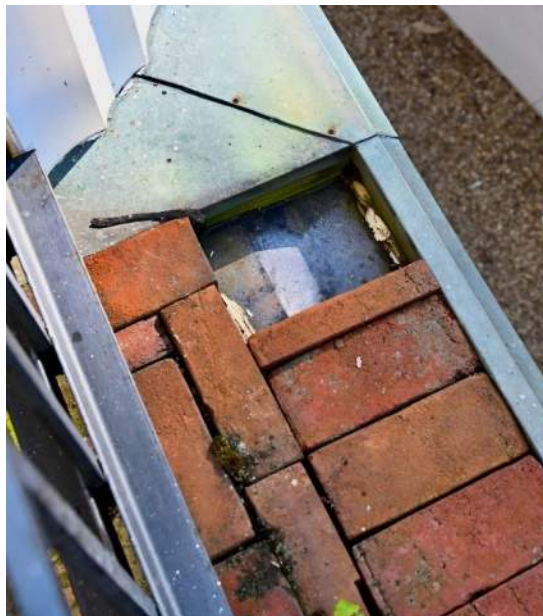
**Figure 2:** Exposed membrane at the balcony facing the parking lot.

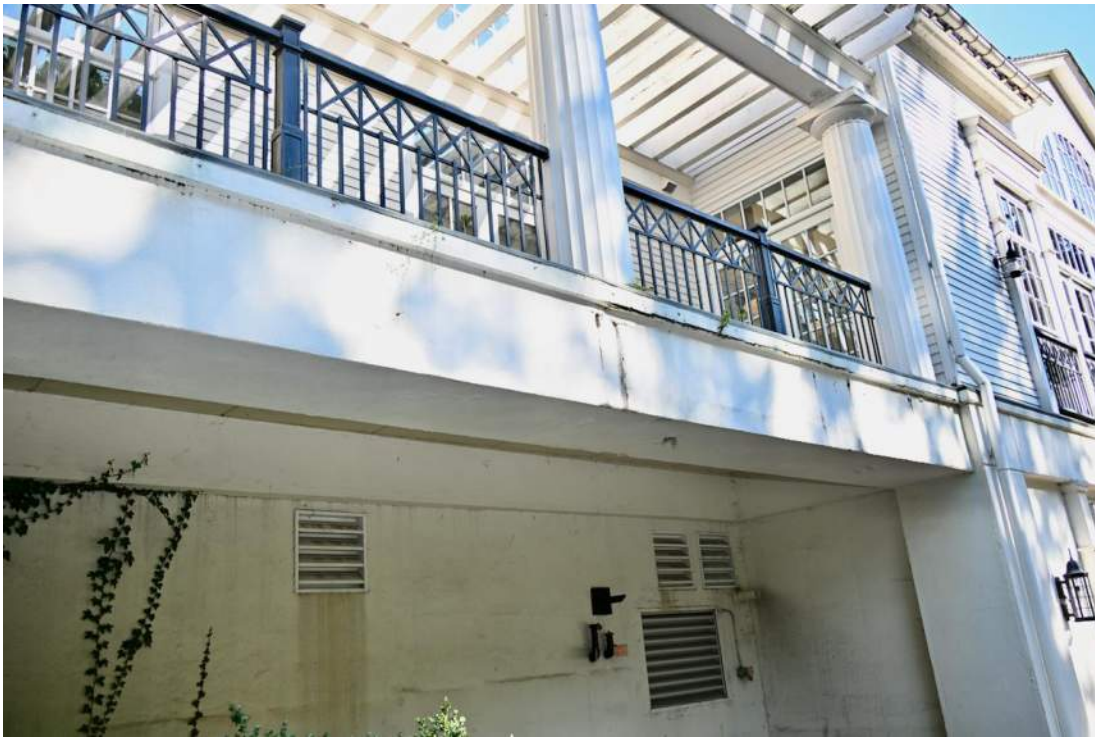
**Figure 3:** View underneath the main-level balcony.

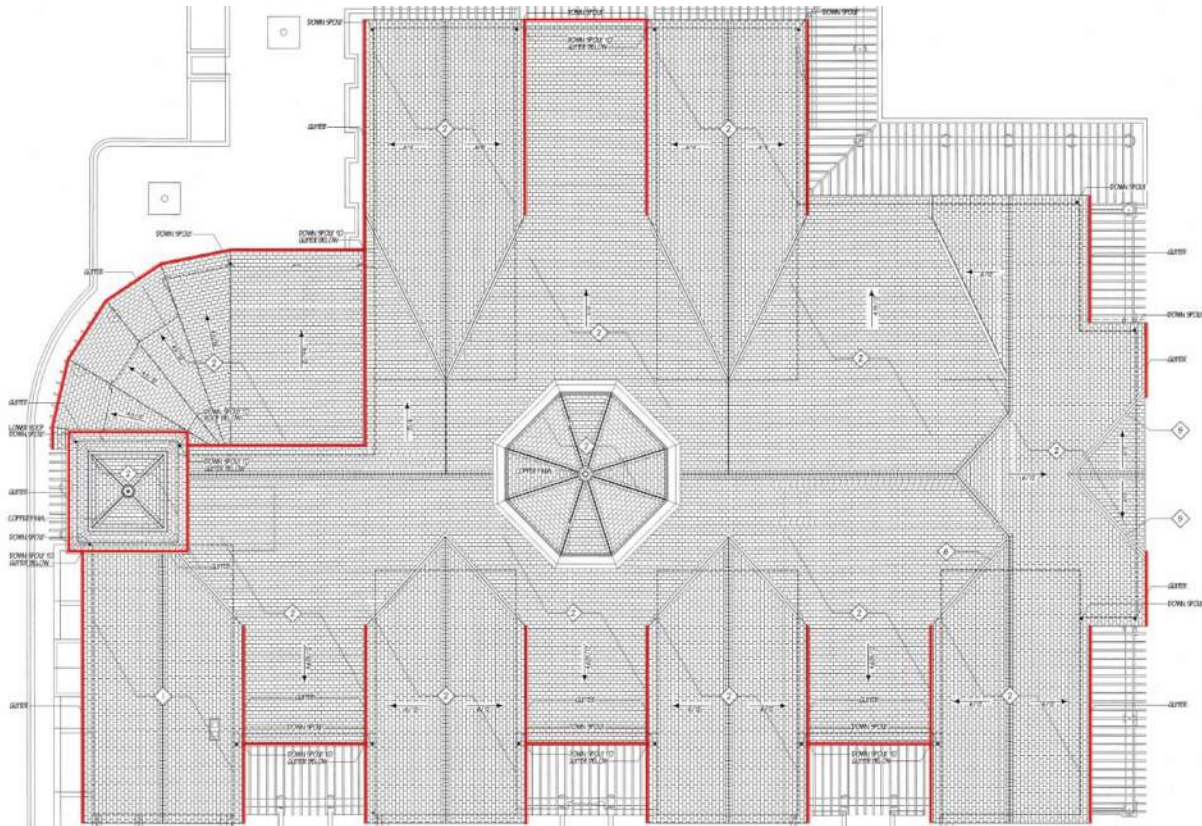
**Figure 2:** Red Segments highlight Gutter placements.

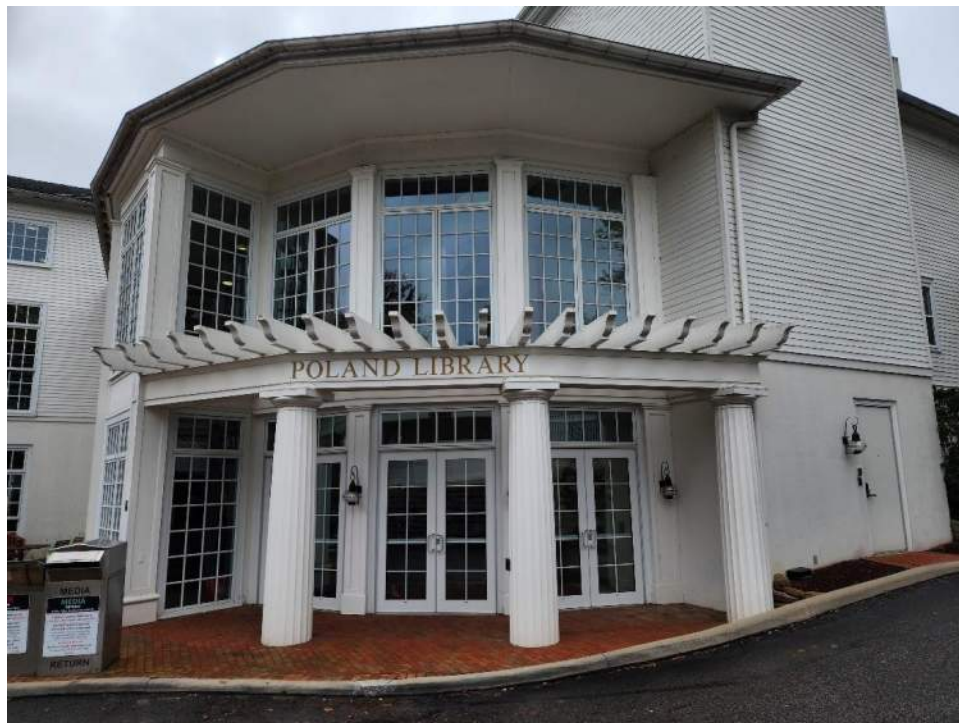
***Photograph 1: Main Entrance to the Poland Library looking south.***

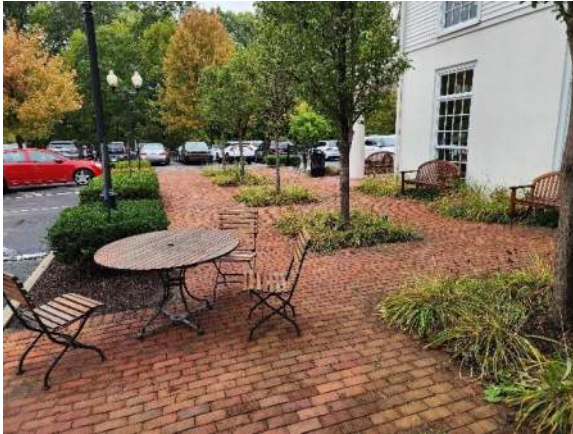
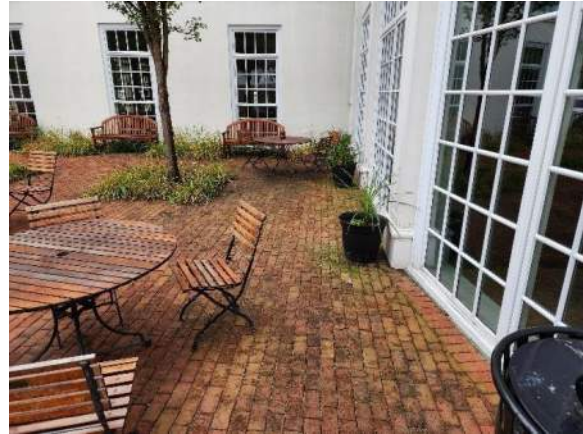
The brick pavers at the east entrance exhibit unevenness due to settlement of the underlying soils. This movement is likely a result of insufficient compaction of base material or natural soil consolidation over time, affecting the surface stability and levelness of the entrance pavers.

**Photograph 2:** Standard photography of the pavers looking east.

**Photograph 3:** Standard photography of the pavers looking south.

Settlement of underlying soils and/or inadequate base material has caused unevenness in the brick pavers, affecting the east entrance's surface integrity.

Remove and replace uneven pavers. Conduct a geotechnical assessment to determine the need for additional base preparation, including proper compaction or stabilization of underlying soils, to prevent future settlement.

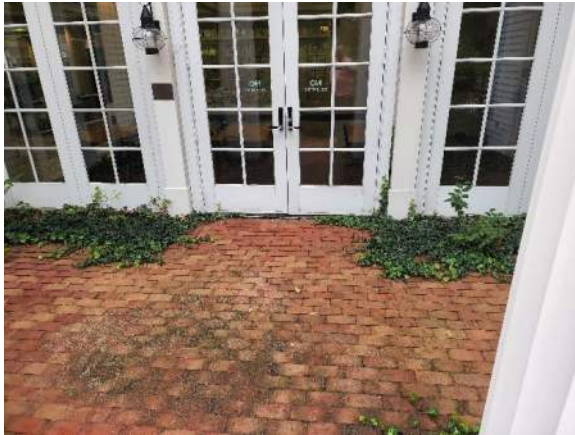
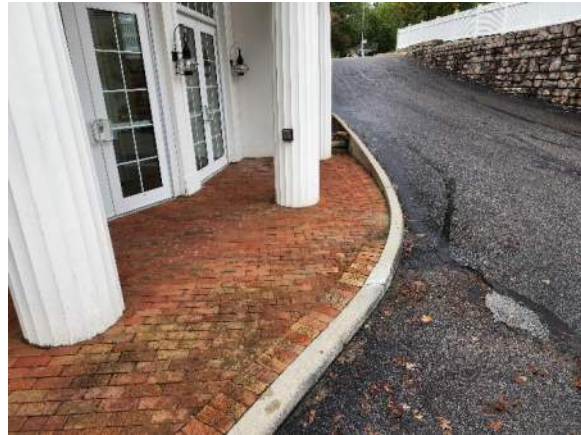
At all exit doors throughout the building, frost slabs appear to be absent, which are required by building codes to prevent frost heave. Without these frost slabs, the exit thresholds are vulnerable to movement and heaving, which can pose a safety hazard, particularly during colder months.

The absence of code-required frost slabs at exit doors exposes the exit pathways to potential heave and movement from freeze-thaw cycles, which can compromise safety.

**Photograph 4:** Absent frost slab at outswinging exterior door.

**Photograph 5:** Absent frost slab at outswinging exterior door.

Install frost slabs at all egress door locations in compliance with building codes. These frost slabs will mitigate movement from freeze-thaw cycles, ensuring stable thresholds at each exit.

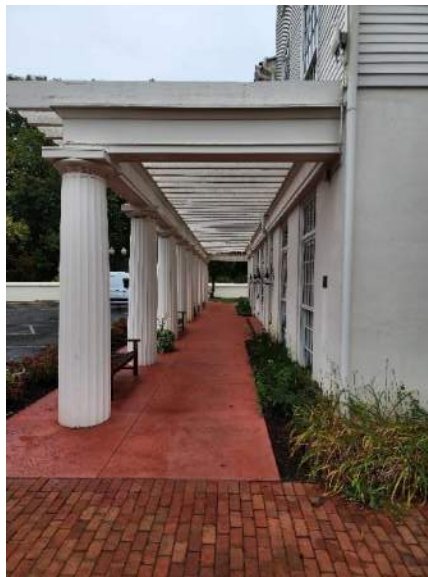
The sidewalk on the east side of the building under the pergola slopes toward the building. This negative slope condition allows water to pool and flow towards the building rather than away from it, creating potential moisture intrusion issues that may impact the foundation and structural elements over time.

**Photograph 6:** East sidewalk slopes toward building.

The sidewalk slope towards the building under the pergola creates drainage issues that may lead to foundation damage due to moisture intrusion.

Re-grade or replace the sidewalk adjacent to the building to achieve a positive slope away from the structure. Consider installing a drainage system along the building's edge under the pergola to redirect water away from the foundation.

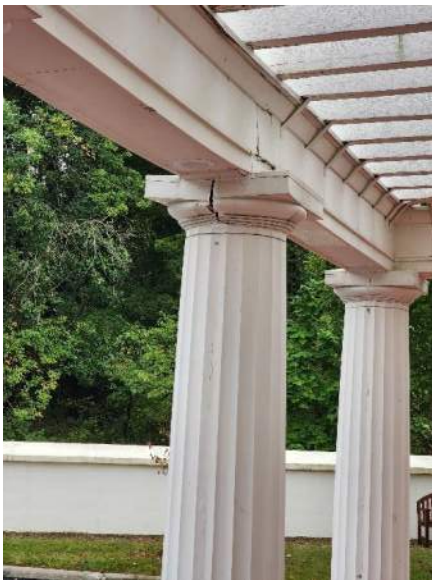
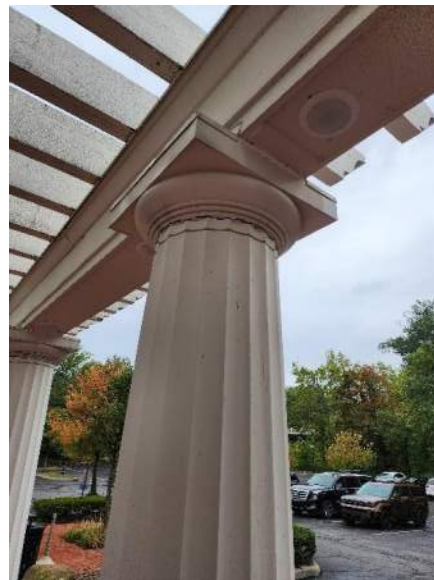
Several column wraps, primarily at the exterior pergolas, are in various stages of failure. This appears to be due to structural issues within the columns themselves, as the wraps have experienced displacement or separation, potentially compromising the load-carrying capacity of the columns.

**Photograph 7:** Column wrap failure.

**Photograph 8:** Column wrap failure.

Failures in several column wraps indicate potential structural deficiencies in the columns that may compromise their load-bearing capacity.

Conduct a structural assessment of all columns with failed wraps to determine the extent of damage. Replace or repair columns as needed, ensuring that new wraps are adequately secured to the columns.

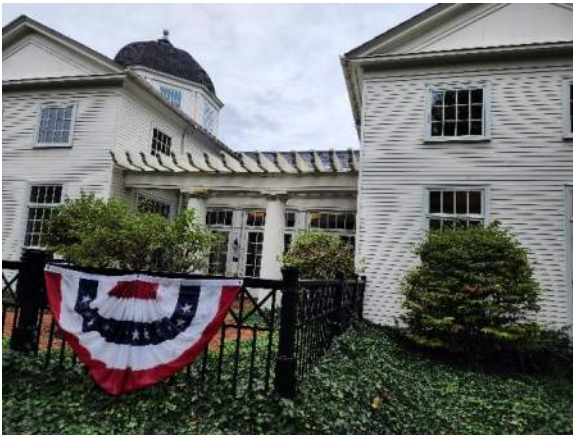
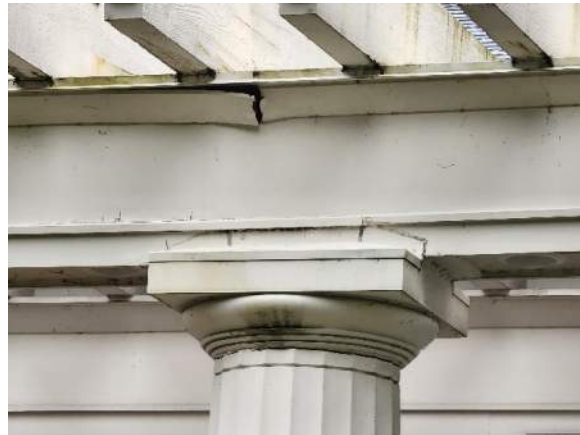
The pergola at the southern end of the west side has shifted, suggesting foundation movement in this area. This movement may stem from soil instability, insufficient foundation support, or differential settlement, which is affecting the stability of the pergola.

*Photograph 9: Standard photography of the west side southern pergola.*

*Photograph 10: Close up of the west side southern pergola.*

Movement of the pergola on the west side of the building suggests foundation instability or settlement, likely due to underlying soil conditions.

Perform a foundation investigation for the pergola area to assess soil conditions and foundation stability. Reinforce or rebuild the foundation as necessary to address any settlement or soil instability.

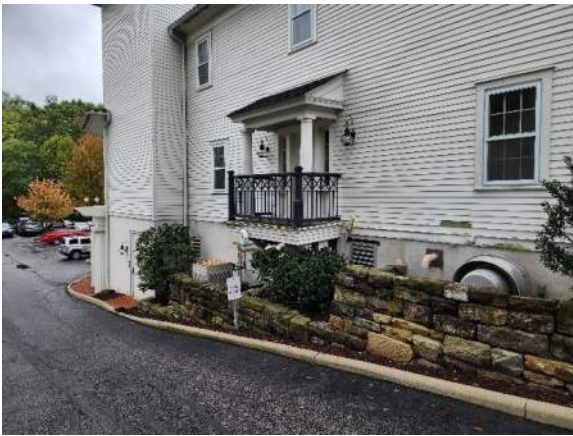
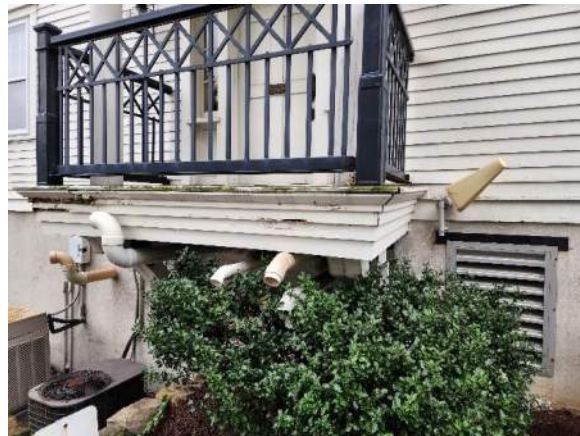
The balcony located at the north end of the building exhibits significant structural distress and displacement. The extent of this movement suggests a structural deficiency that has compromised the balcony's stability and serviceability, posing safety risks to occupants.

The north balcony is experiencing structural failure and displacement, suggesting inadequate structural support or material degradation over time.

**Photograph 11:** *Standard photography of the north side balcony.*

**Photograph 12:** *Close up of the north side balcony.*

Engage a structural engineer to design reinforcement or replacement of the balcony structure to restore its integrity and prevent further displacement.

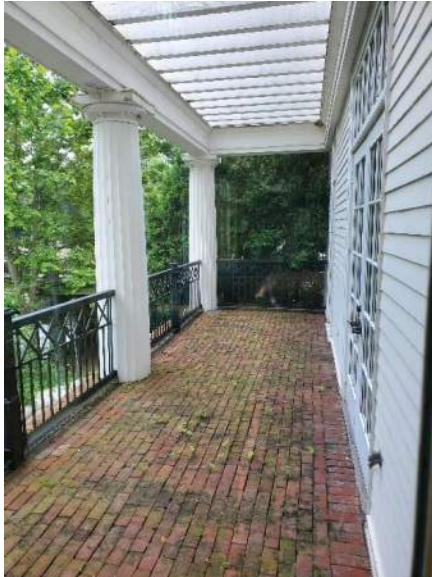
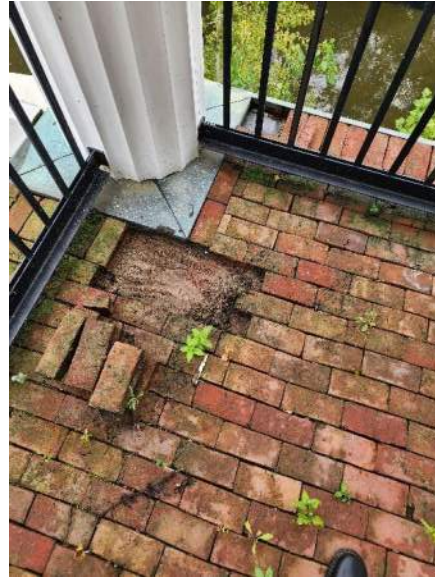
The second-floor balconies on the south side of the building appeared to be constructed with a concrete slab and finished with brick pavers. There are wrapped columns supporting pergolas at each balcony. As at the ground level pergolas, several of the column wraps are in various stages of failure, again indicating structural issues within the columns themselves. Although vegetation was growing on and between the brick pavers, structural distress was not observed in the slab itself.

**Photograph 13:** Standard photograph of the south balcony looking west.

**Photograph 14:** Close up of the brick pavers.

Conduct a structural assessment of all columns with failed wraps to determine the extent of damage. Replace or repair columns as needed, ensuring that new wraps are adequately secured to the columns. Remove pavers and conduct a thorough assessment of the structure. Waterproof and refinish the balconies.

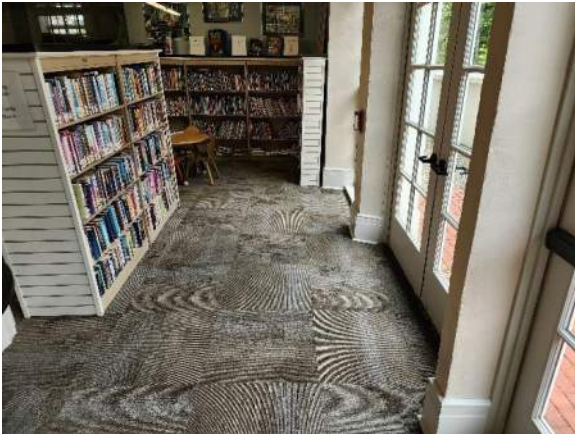
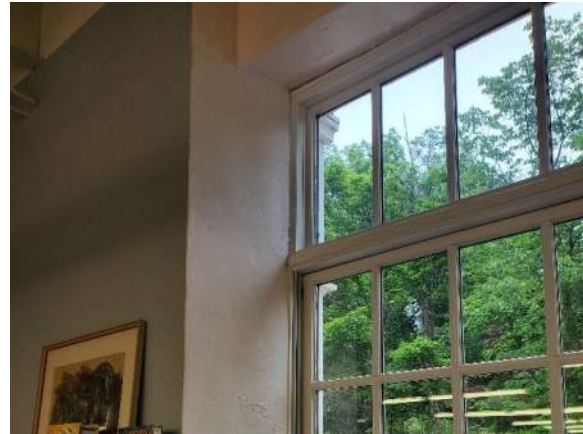
**Photograph 16:** Floor slab sloping in the Bookstore Area.

**Photograph 17:** Gap above east exterior window in the Bookstore Area.

Remove the existing slab near the bookstore and excavate to remove the open-hearth slag. Replace with compacted, engineer-approved fill material and install a new slab-on-grade with appropriate reinforcement.
