# PLYMC – Poland Library

Poland Library Building Assessment

BSHM Architects, Inc.

1/23/24

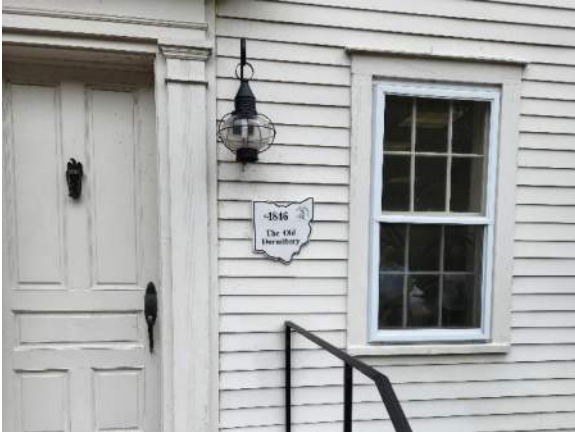
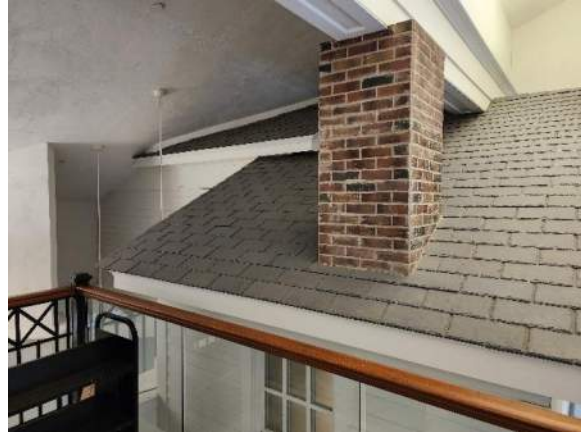
**Photograph 18:** Standard photography of the Dormitory.

The two-story dormitory area at the north end of the building exhibits structural distress that warrants significant attention to ensure safe usage. Extensive utility presence complicates access for repairs, requiring a carefully coordinated approach to both reinforce structural elements and preserve essential utility functions. By following the outlined recommendations, the library can address these structural issues while minimizing disruption to library operations. Regular inspections and monitoring of this area are advised to prevent reoccurrence and maintain structural integrity. To address the structural and access issues in the dormitory portion, the following actions are recommended:

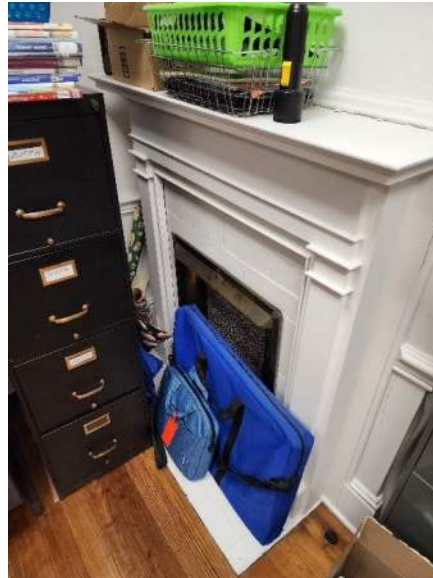
*Photograph 22: Cracking around fireplace.*

Investigate the structural condition around the fireplace and repair cracks using flexible sealants or epoxy injection techniques where appropriate. Consider reinforcing adjacent walls and supports to improve load distribution.

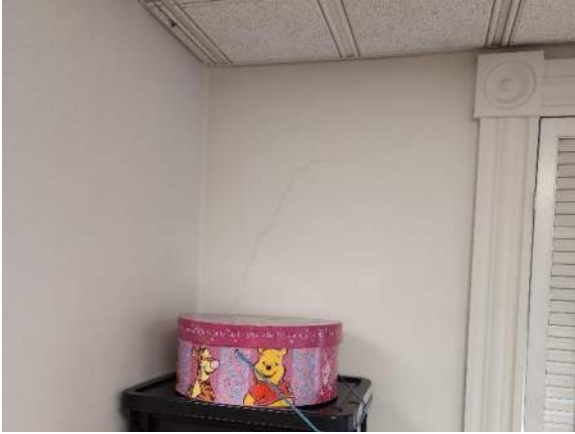
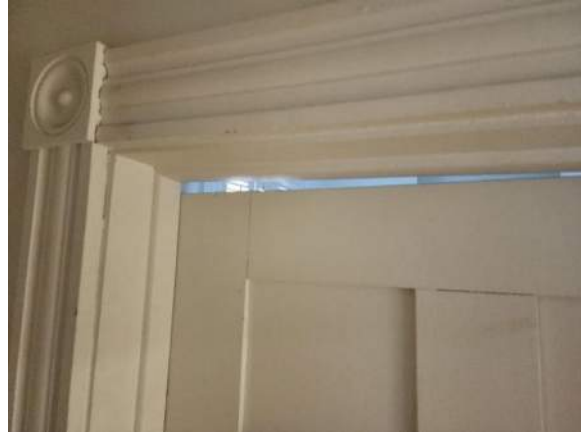
**Photograph 23:** *Cracking in wall.*

**Photograph 24:** *Gap at door.*

Use minimally invasive repair techniques, such as fiber-reinforced polymer (FRP) wraps or post-installed anchors, to reinforce load-bearing walls and framing. These methods reduce the need for extensive demolition and facilitate repairs in hard-to-access areas.

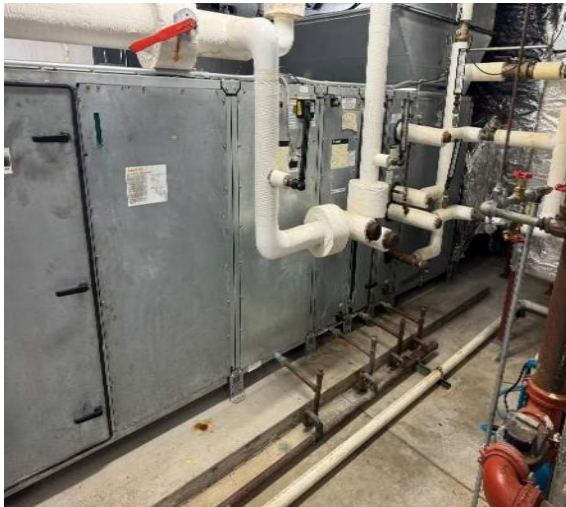
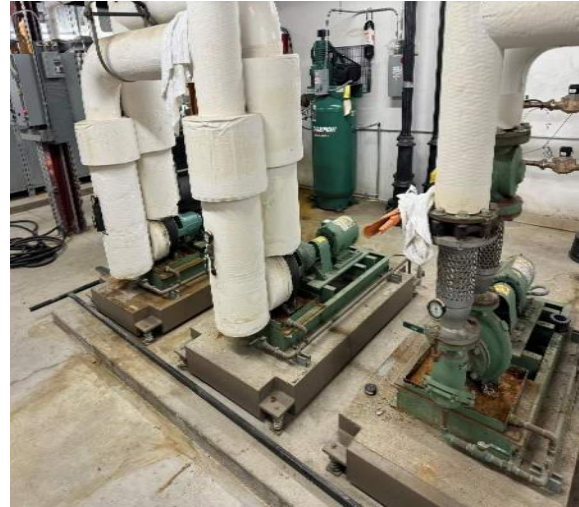
**Photograph 9:** AHU with Chilled Water Coil.

**Photograph 10:** Chilled Water Pumps Coil.

Rebalance air handling units along with cleaning all coils, verifying proper operations of all economizer dampers and verify that all sequences of operation are controlling to the desired parameters.

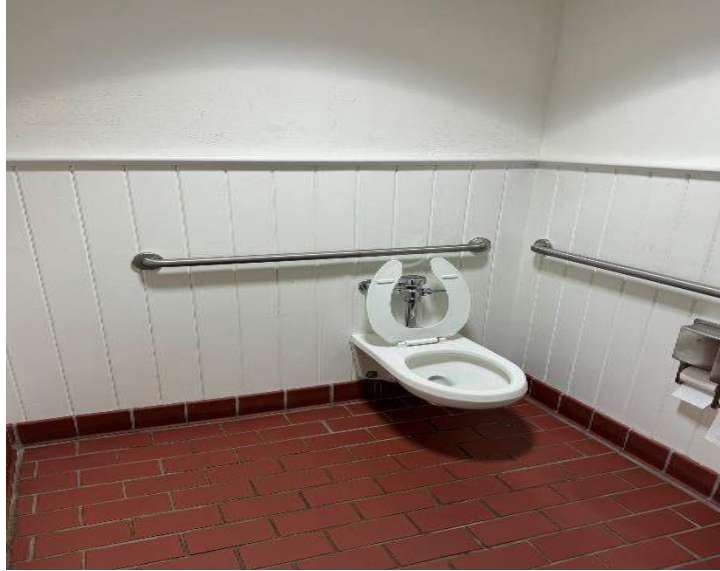
**Photograph 13:** Water Closet w/MFV.

- Replace water closet manual flush valves with automatic.
- Replace lavatory manual faucets with automatic.

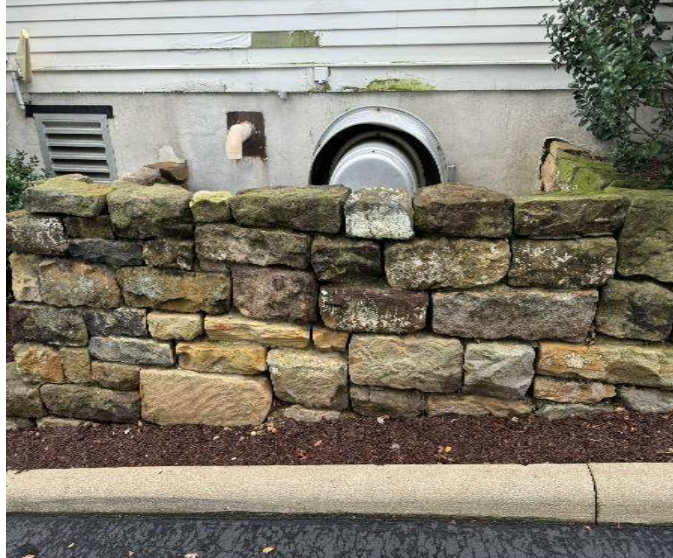
**Photograph 18:** Kitchen EF Discharge.

Relocate the kitchen hood exhaust fan to meet code.

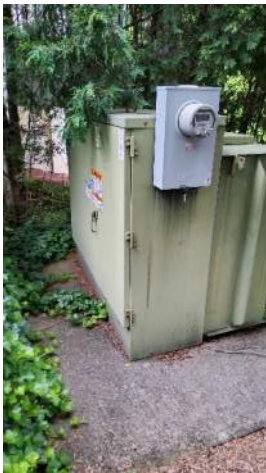
**Photograph 20:**  
*Utility Transformer.*

The electrical service is adequate for the current use. The distribution throughout the building is in good condition and is sufficient for the use of the building. GFCI protection should be added for the kitchen outlets and receptacles replaced with tamper resistant models.

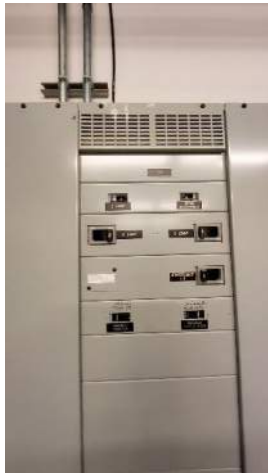
**Photograph 21:**  
*Main Distribution Panel.*

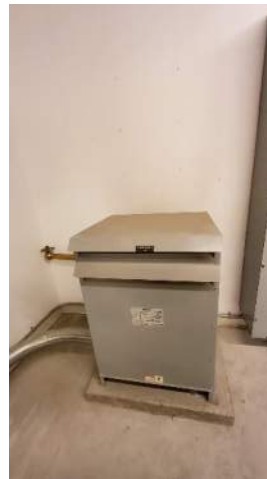
**Photograph 22:**  
*Step-Down Transformer.*

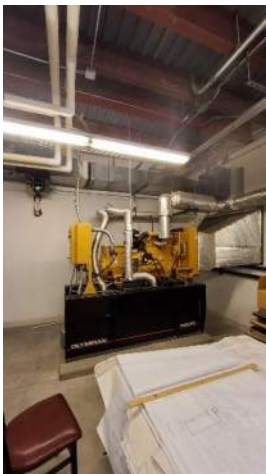
**Photograph 23:**  
*Standby Generator.*

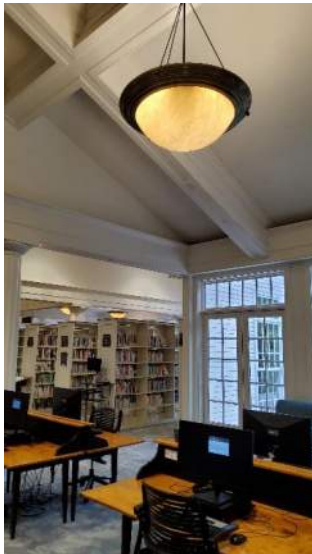
**8.3** - Lighting throughout the building is provided by downlights with compact fluorescent lamps, suspended strip lights with T-8 fluorescent lamps, chandeliers that have been retrofitted with LED lamps, and lay-in fluorescent fixtures. Light levels in the meeting room were measured at 10 foot-candles (FC), 18 FC in the reading area, and 30 FC in the office. Recommended light levels for a library are 20 to 50 FC.

**Photograph 24:**  
*Reading Area Lighting.*

The lighting is marginal for a library and steps should be taken to increase lighting levels. It is also recommended that the lighting controls be replaced with a control system that will meet the requirements of the current energy code. Exterior lighting should be replaced with more energy efficient fixtures.

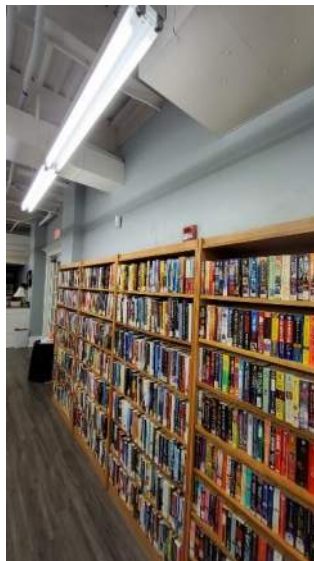
**Photograph 25:**  
*Stack Area Lighting.*

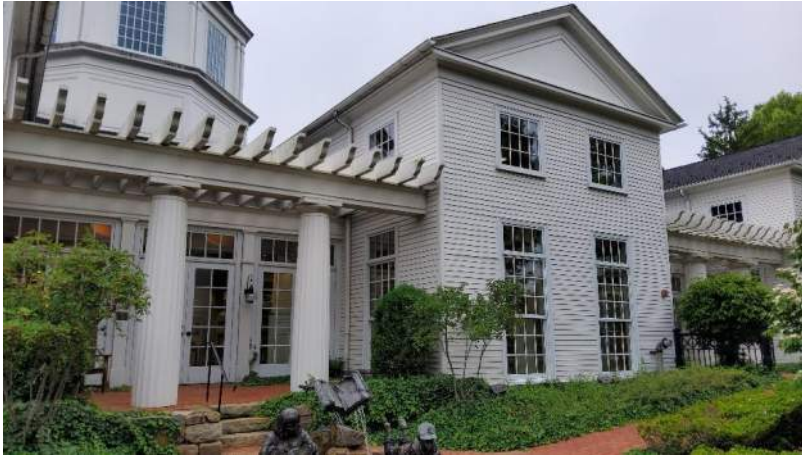
**8.5** - Exterior lighting is by post top metal-halide fixtures, wall mounted fixtures with compact fluorescent or LED bulbs, and metal halide building façade lighting.

**Photograph 26:** Exterior Wall Lights and Façade Lighting.

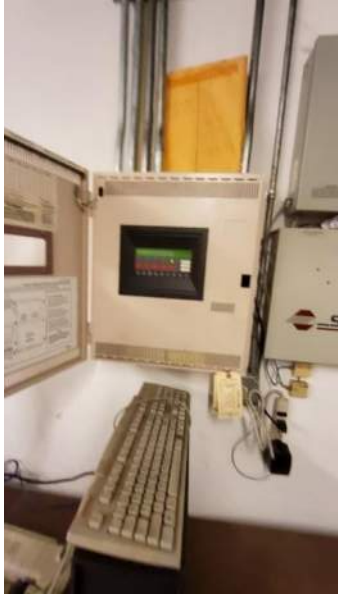
There is a fire alarm system throughout the building utilizing a Simplex 4010 fire alarm control panel. This is an addressable, modular panel that provides audible and visible indications during trouble, supervisor, or alarm conditions. The system utilizes horn/strobe devices for annunciation and manual pull stations, flow switches, and tamper switches for monitoring. This model panel was discontinued in 2001.

**Photograph 27:**  
*Fire Alarm Control Panel.*

The fire alarm system is approaching the end of its life and should be replaced.

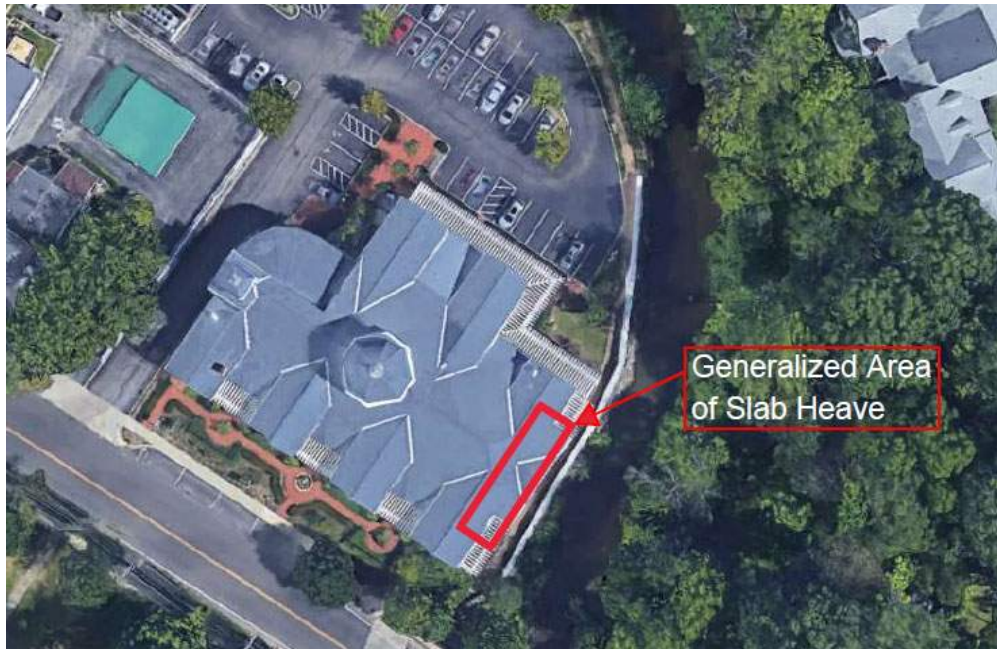
Based on walk-over site observations, it appears that the slab heave (up to  $\pm 3$ -inches, locally) is occurring along a *generalized* line on the southeast side of the building. Presently, the heaving appears to only be impacting the floor slab. General observations of the building structure do not reveal any overt signs of foundation heave or structural framing distress. GCI understands that a structural engineer has been retained to evaluate if any impact to the structural components of the building has occurred. The aerial image on the next page shows the approximate location of the floor slab heave within the building footprint.

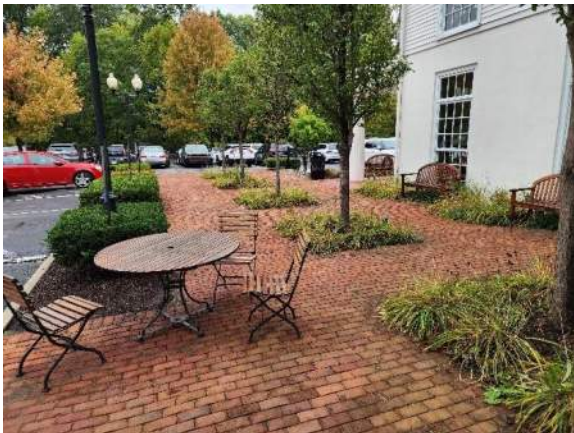
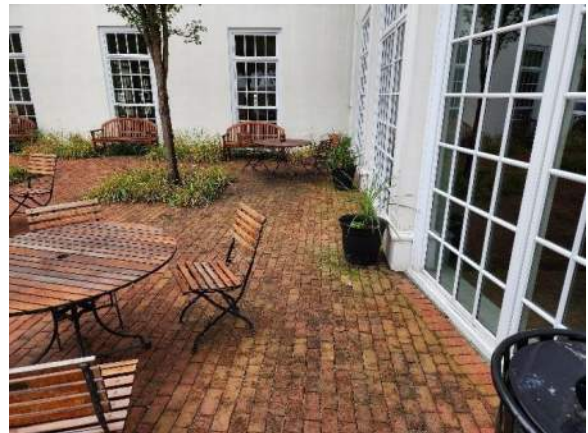
The brick pavers at the east entrance exhibit unevenness due to settlement of the underlying soils. This movement is likely a result of insufficient compaction of base material or natural soil consolidation over time, affecting the surface stability and levelness of the entrance pavers.

**Photograph 2: Standard photography of the pavers looking east.**

**Photograph 3: Standard photography of the pavers looking south.**

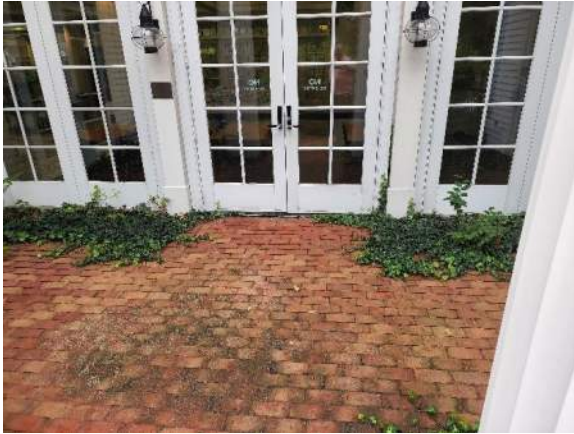
At all exit doors throughout the building, frost slabs appear to be absent, which are required by building codes to prevent frost heave. Without these frost slabs, the exit thresholds are vulnerable to movement and heaving, which can pose a safety hazard, particularly during colder months.

**Photograph 4: Absent frost slab at outswinging exterior door.**

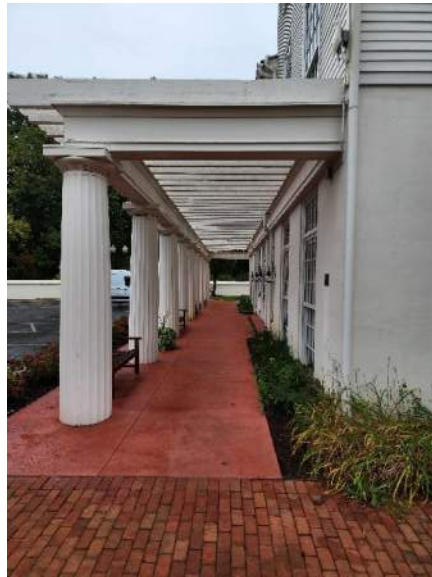
The sidewalk on the east side of the building under the pergola slopes toward the building. This negative slope condition allows water to pool and flow towards the building rather than away from it, creating potential moisture intrusion issues that may impact the foundation and structural elements over time.

**Photograph 6: East sidewalk slopes toward building.**

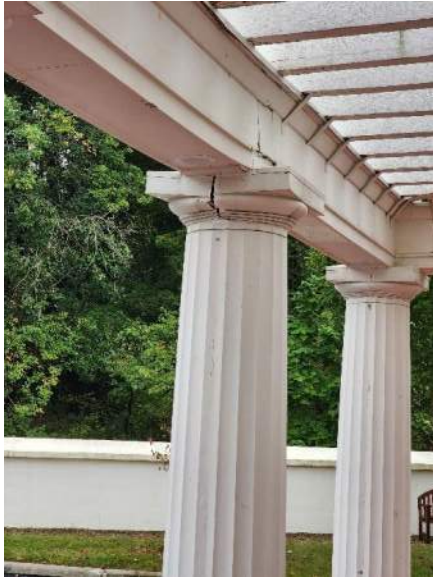
Several column wraps, primarily at the exterior pergolas, are in various stages of failure. This appears to be due to structural issues within the columns themselves, as the wraps have experienced displacement or separation, potentially compromising the load-carrying capacity of the columns.

**Photograph 7: Column wrap failure.**

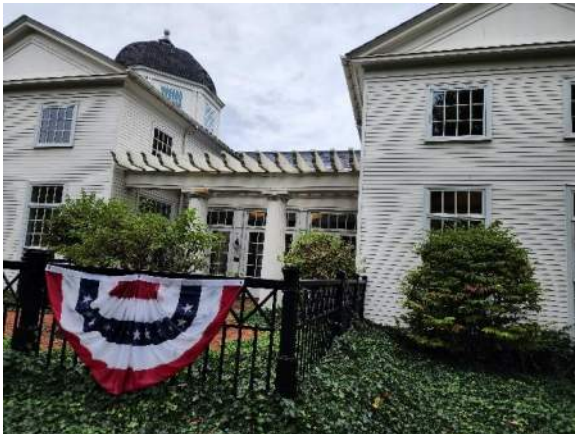
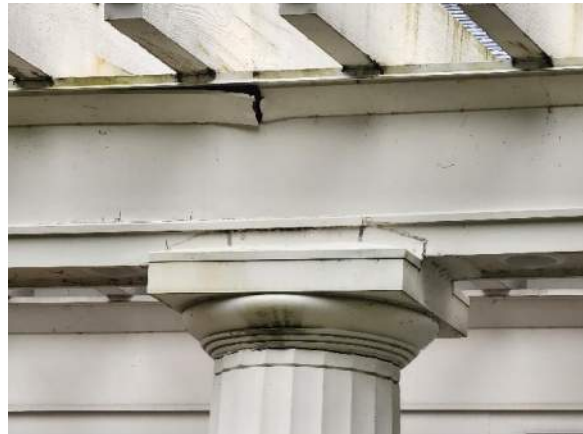
The pergola at the southern end of the west side has shifted, suggesting foundation movement in this area. This movement may stem from soil instability, insufficient foundation support, or differential settlement, which is affecting the stability of the pergola.

**Photograph 9: Standard photography of the west side southern pergola.**

**Photograph 10: Close up of the west side southern pergola.**

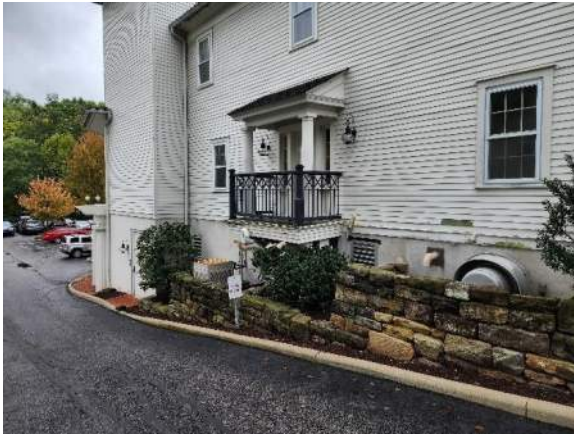
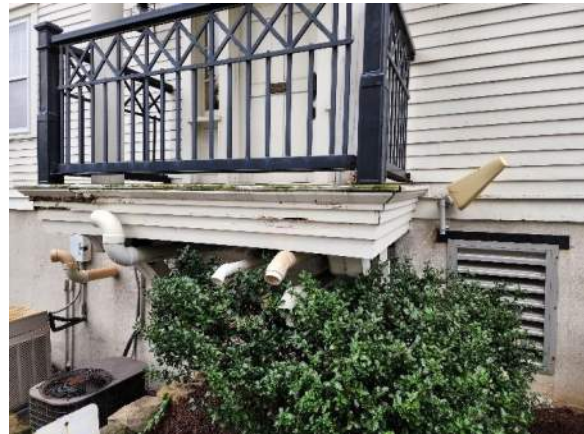
The balcony located at the north end of the building exhibits significant structural distress and displacement. The extent of this movement suggests a structural deficiency that has compromised the balcony's stability and serviceability, posing safety risks to occupants.

**Photograph 11: Standard photograph of the north side balcony.**

**Photograph 12: Close up of the north side balcony.**

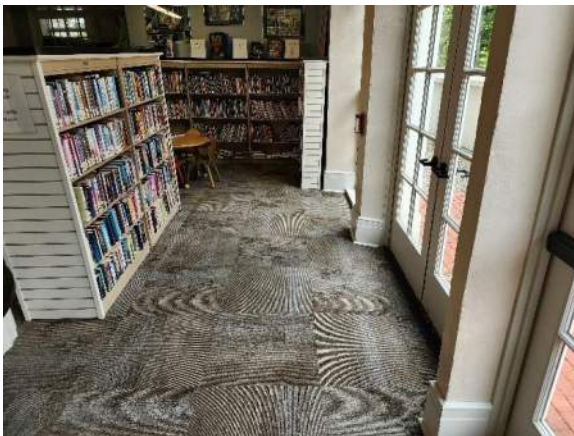
There is noticeable slope in the floor slab in the Bookstore Area at the southern end of the building. The slab-on-grade was installed over an unsuitable base material, identified as open-hearth slag. The presence of slag may lead to differential settlement and unevenness in the slab, causing structural issues over time.

**Photograph 13: Floor slab sloping in the Bookstore Area.**

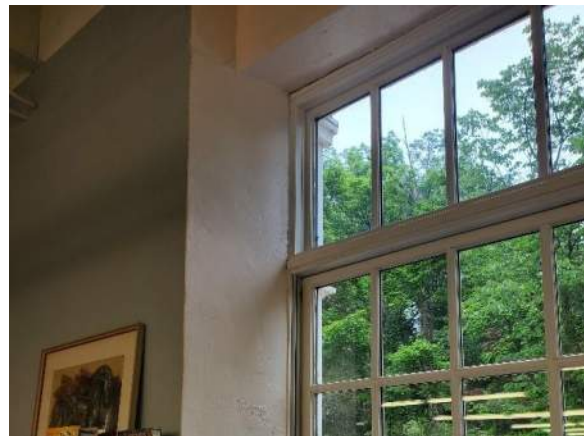
**Photograph 14: Gap above east exterior window in the Bookstore Area.**

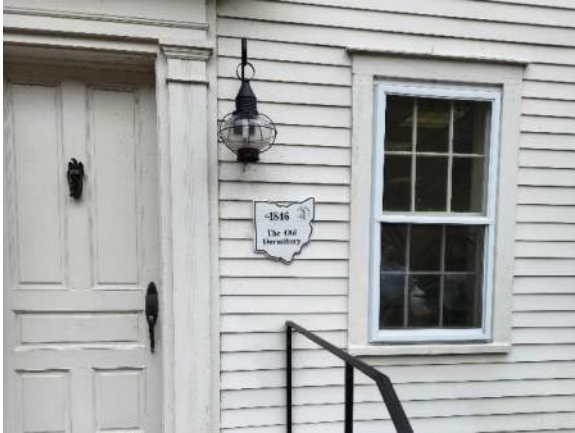
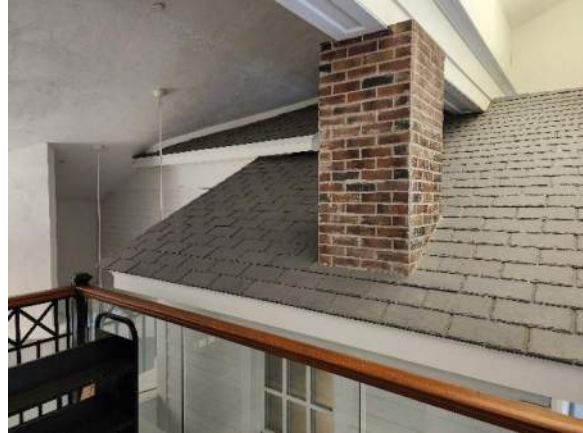
The two-story dormitory portion of the library, located at the north end of the building, presents additional structural concerns. This area is unique in its configuration, as it includes a basement with extensive utilities. Due to the nature of the construction and current structural conditions,

**Photograph 15: Standard photography of the Dormitory.**

**Photograph 16: Standard photography of the Dormitory.**

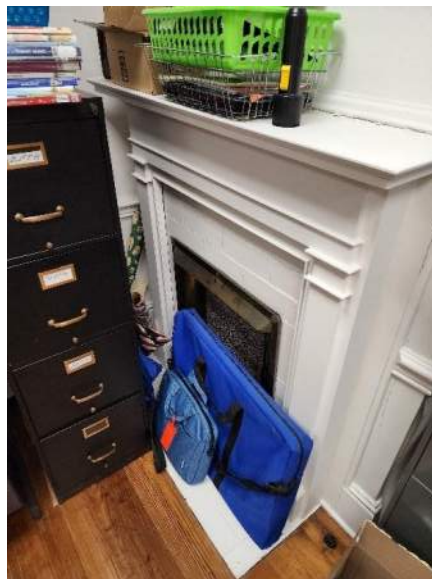
**2.9.2 Cracking Around Fireplace:** The area surrounding the fireplace displays cracking, indicating stress and potential movement of structural elements in this location. The presence of cracks near the fireplace is concerning, as it suggests movement or settlement in the adjacent wall or floor supports.

**Photograph 17: Cracking around fireplace.**

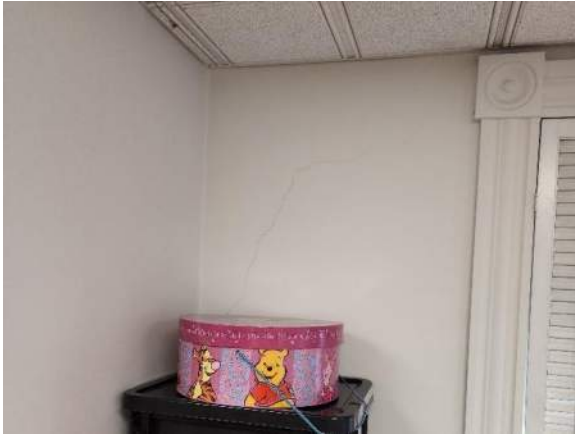
**2.9.3 Additional Structural Distress:** Other signs of structural distress are visible throughout the dormitory area, with cracking in walls and around openings. These symptoms may stem from differential settlement, material degradation, or load-induced stress.

**Photograph 18: Cracking in wall.**

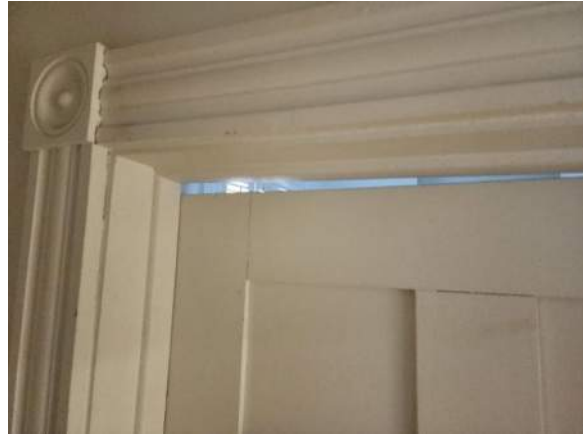
**Photograph 19: Gap at door.**

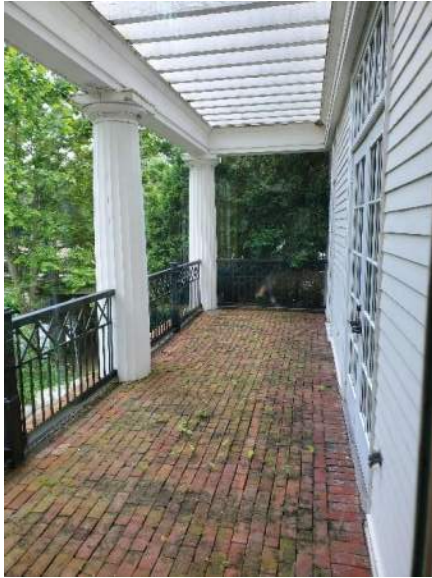
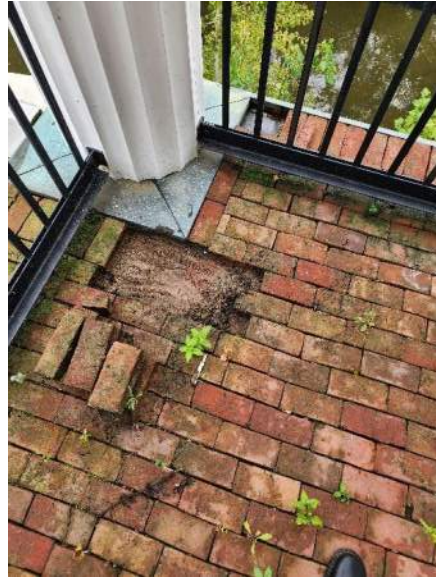
The second-floor balconies on the south side of the building appeared to be constructed with a concrete slab and finished with brick pavers. There are wrapped columns supporting pergolas at each balcony. As at the ground level pergolas, several of the column wraps are in various stages of failure, again indicating structural issues within the columns themselves. Although vegetation was growing on and between the brick pavers, structural distress was not observed in the slab itself.

**Photograph 20: Standard photography of the south balcony looking west.**

**Photograph 21: Close up of the brick pavers.**

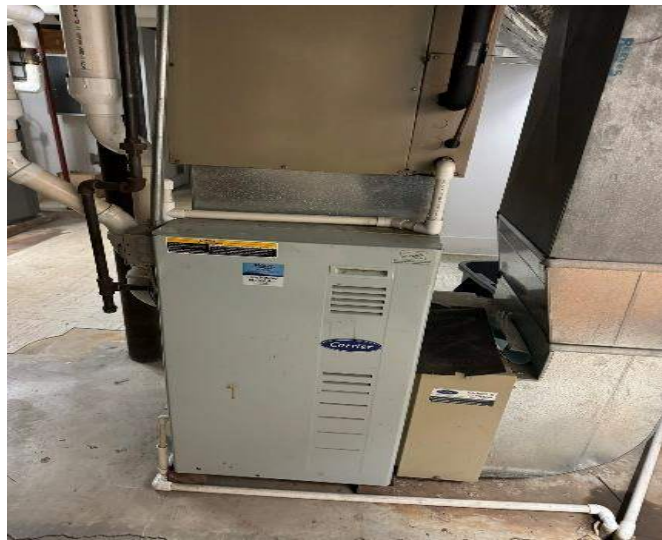
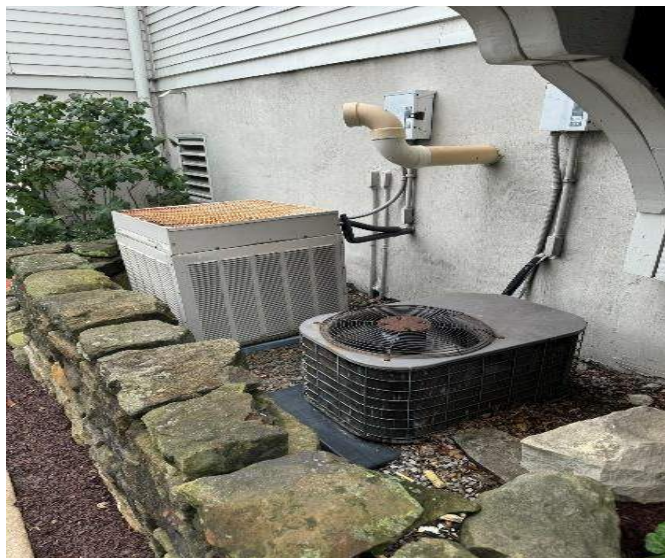
F/AC Unit

The original house portion of the facility houses the offices and cafe for the newer library facility built in 1999. The heating and air conditioning, of this original portion, occurs from 2- condensing furnace/AC units located in the basement level. These units were installed over 20+ years ago and are in poor shape. The vents from these units are causing considerable damage to the porch and siding of the original building. These vents need to be relocated to prevent further damage and unsafe conditions for the public.

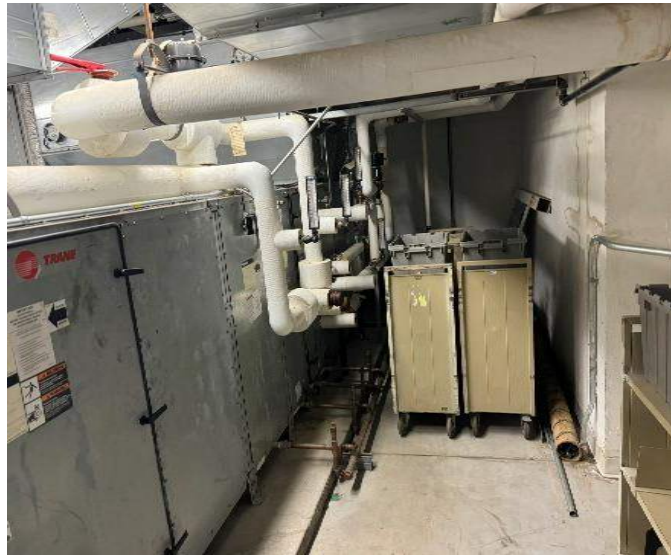
Indoor Air Handling Unit

This heating hot water is supplied to 2 large, indoor Air Handling Units serving the newer library facility, along with VAV Boxes and reheat coils in each of the different spaces. The units and all reheat coils are original from the 1999 construction. These 2 air handling units had the linkages and actuators upgraded to electronic DDC control last year. The remaining VAV Boxes and reheat coils are pneumatic and original to the new construction.

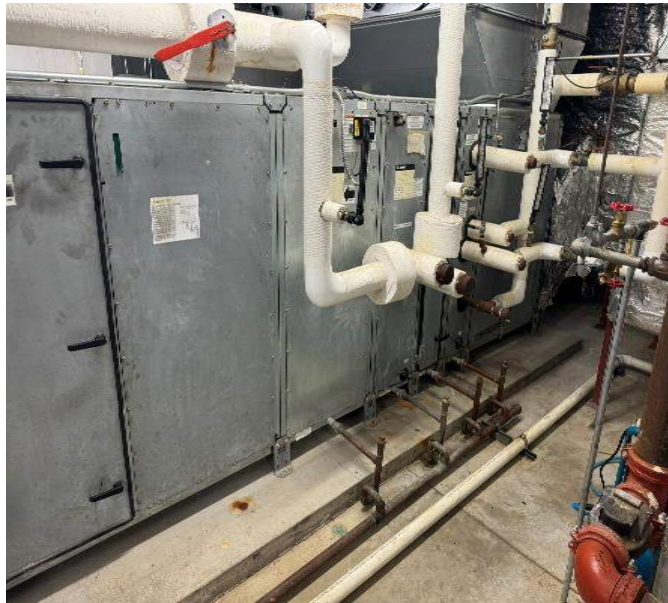
The entire 1999 facility is cooled from a central outdoor air cooler chiller. This unit is original and is nearing the end of its useful life. This unit utilizes R-22 as its refrigerant, which is no longer commercially available, and very expensive to purchase when needed for this chiller. The maintenance personnel have added that this unit is very loud when operating. Compressor blankets, sound enclosures and other sound attenuating considerations should be evaluated if this unit is to remain. These same considerations should occur if the unit is replaced. In addition, there is an ongoing, underground leak in the chilled water piping from the outdoor chiller to the building that will need to be replaced.

AHU with Chilled Water Coil

- Replace the outdoor air-cooled chiller with a unit that is quieter, has better performance characteristics and safer, allowable refrigerants that are more readily accessible.
- Rebalance air handling units along with cleaning all coils, verifying proper operations of all economizer dampers and verify that all sequences of operation are controlling to the desired parameters.
- Determine where the underground leak is occurring and replace that portion of the chilled water piping.

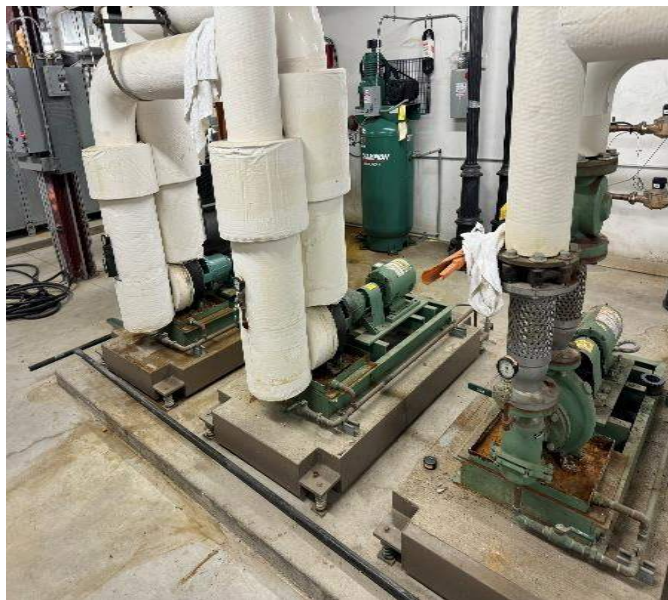
The chilled water distribution pumps are original and were rebuilt last year. The piping is original and does not appear to have any leaking or ongoing problems with the operating characteristics.

Chilled Water Pumps Coil

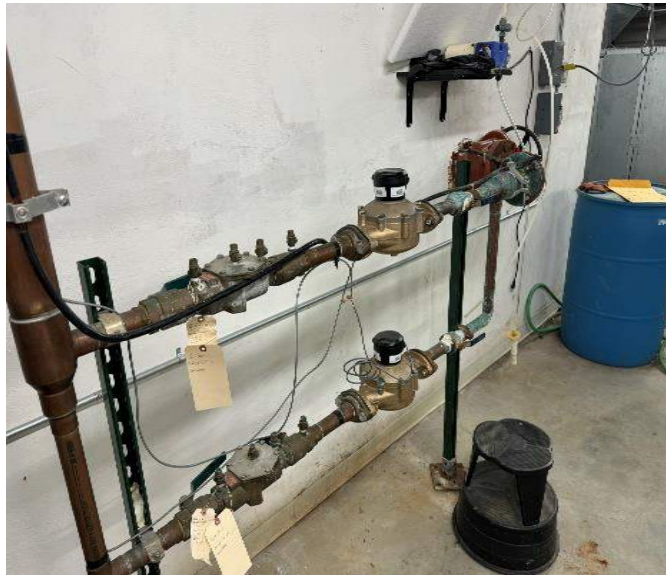
Water Service Backflow  
Preventer

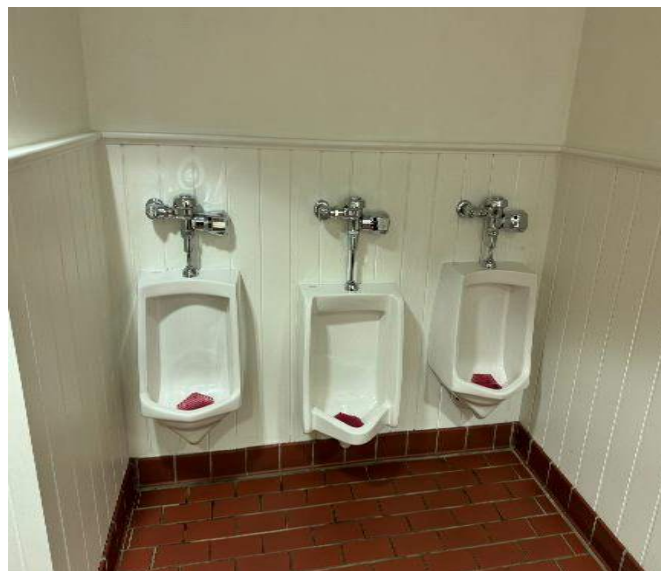
Urinals w/AFV

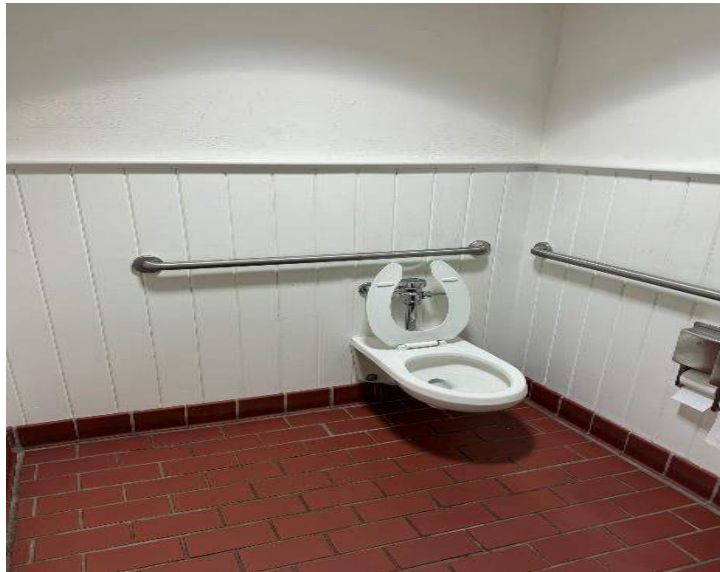
Water Closet w/MFV

- Replace water closet manual flush valves with automatic.
- Replace lavatory manual faucets with automatic.
- Replace the indoor grease trap with a larger unit to prevent overflow of grease laden sanitary waste.

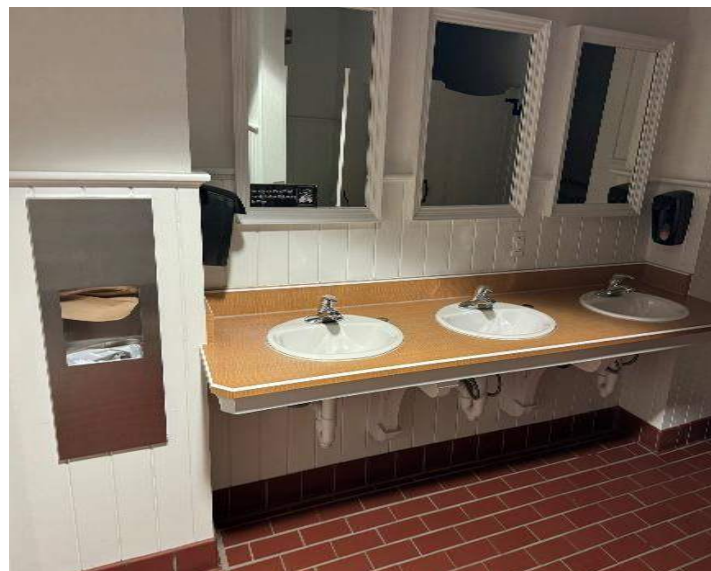
Lavatories w/Manual Faucets

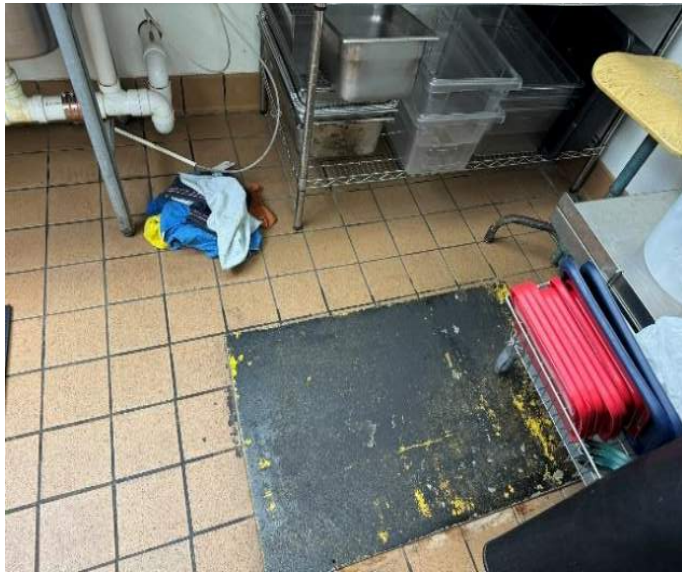
Indoor Grease Trap

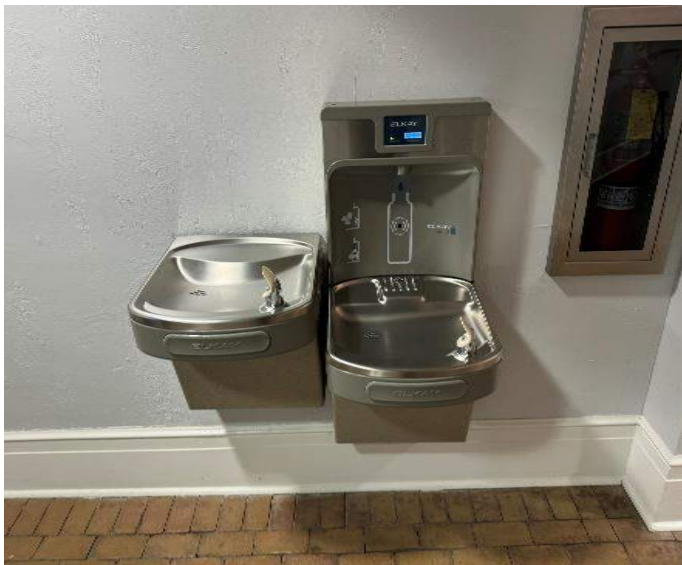
EWC w/Bottle Filler

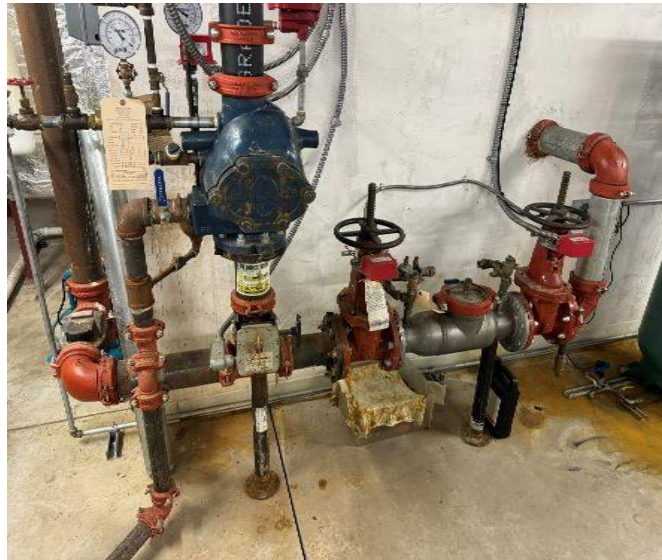
The entire facility has a fire protection system that is adequate and meets all codes. The system utilizes an incoming 4" water service and has the required backflow preventer.

Fire Service and Riser

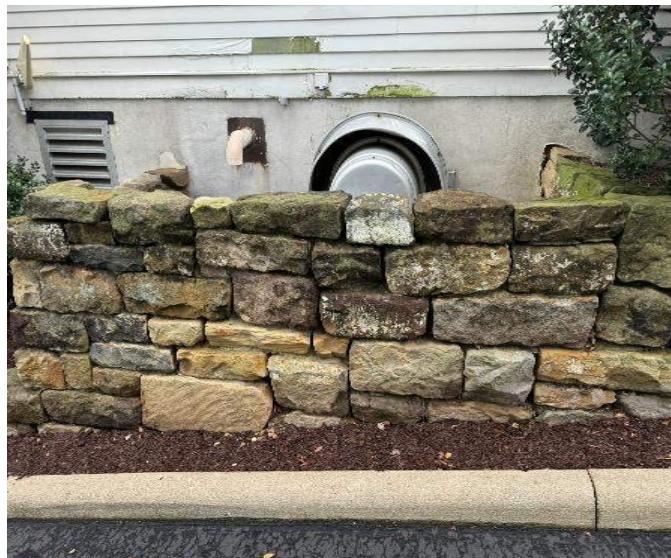
The kitchen utilizes a Type I Hood that appears to be installed correctly and has all of the required components, interlocks and control for a Type I system. The exhaust fan for this hood is a sidewall fan and does not meet present code for installation height above grade. The location of this kitchen exhaust fan poses both a safety risk with the grease vapor discharge and a maintenance issue of grease buildup at or near ground level.

Kitchen EF Discharge

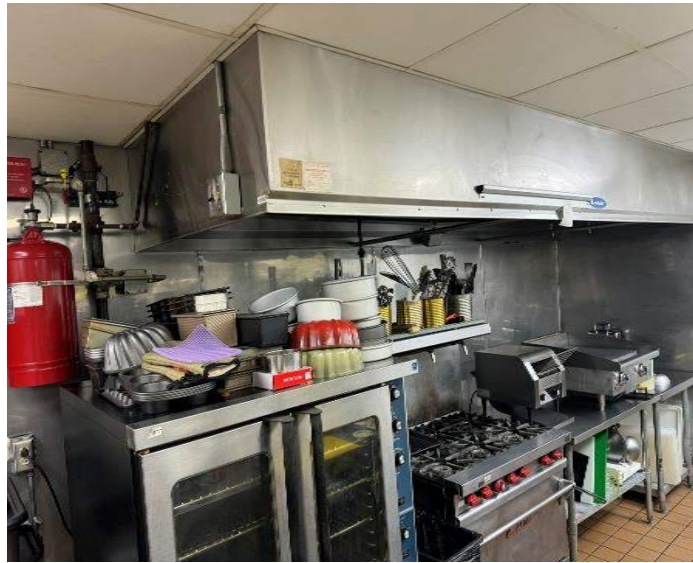
Type 1 Kitchen Hood
