# EXISTING FACILITY ASSESSMENT

## Poland Branch Library

DATE OF ASSESSMENT: January 13, 2025

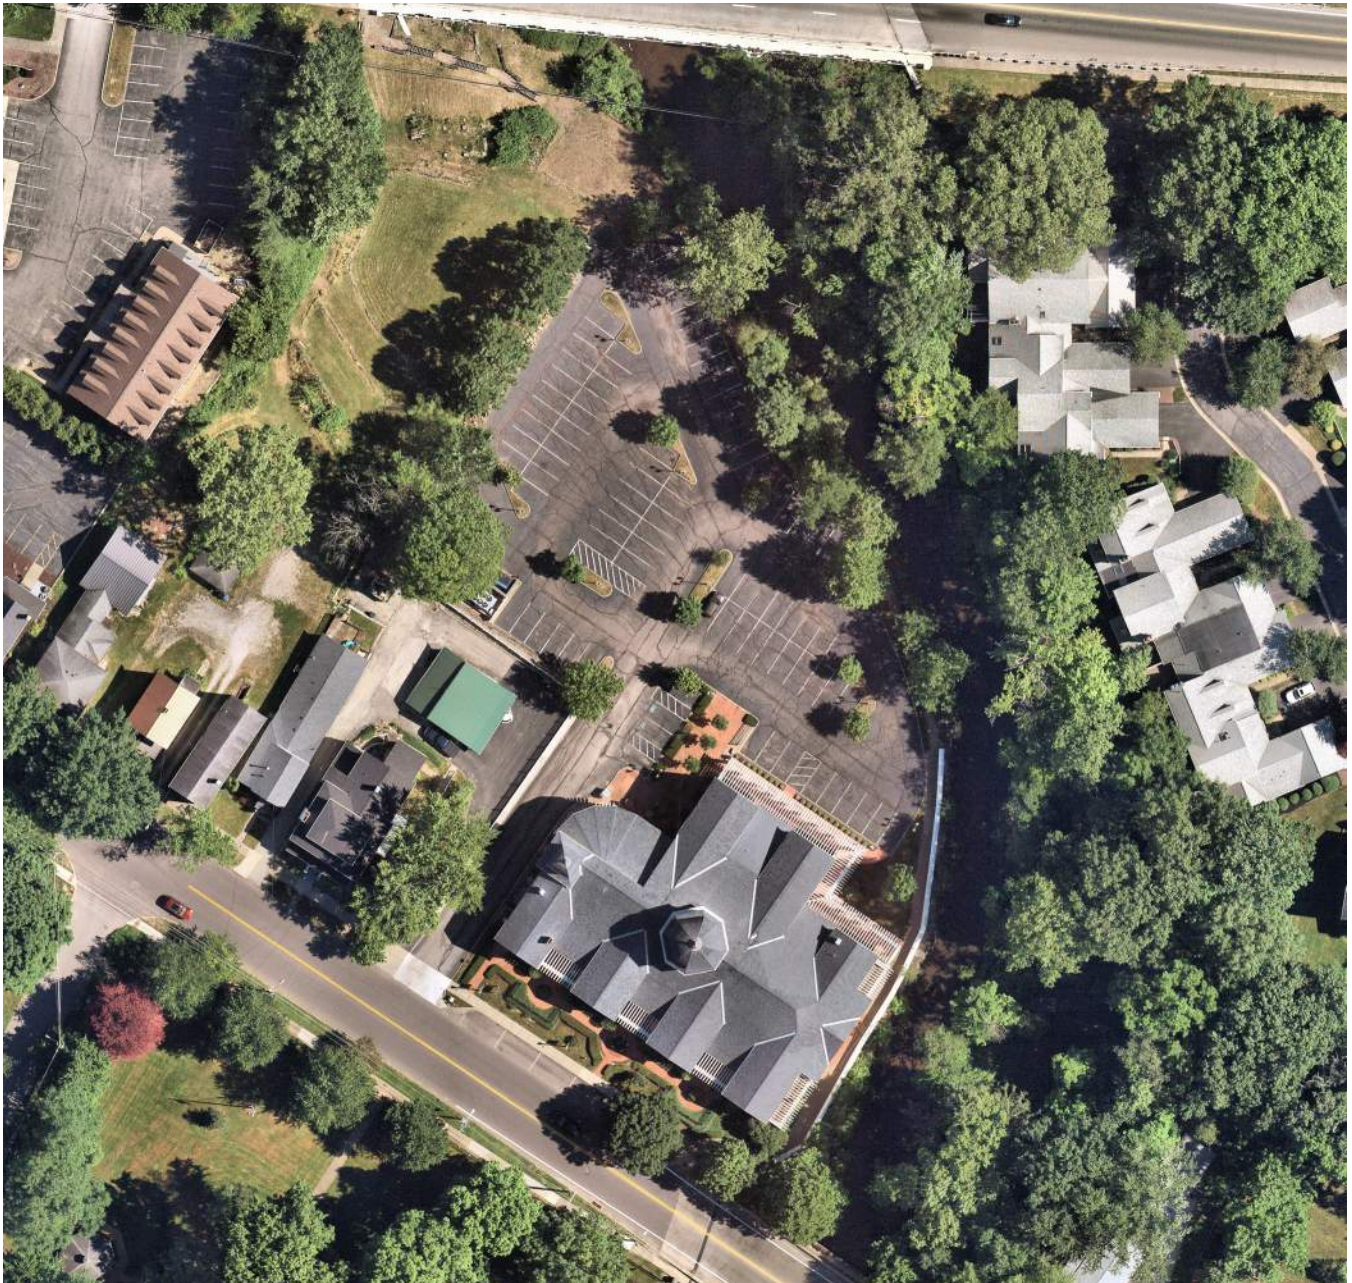
*Figure S-1: Surface Parking Aerial*

The building has an on-site asphalt parking lot north of the building which is accessed via a steep driveway from S Main St. The parking lot is located at grade with the Library's basement level. The lot has 85 standard parking stalls and 4 handicap stalls near the rear building entry, none of which are van accessible. The curb ramps do not have detectable warning strips. The asphalt and curb surrounds are in fair condition with some areas of ponding water. There are three catch basins located in the parking lot.

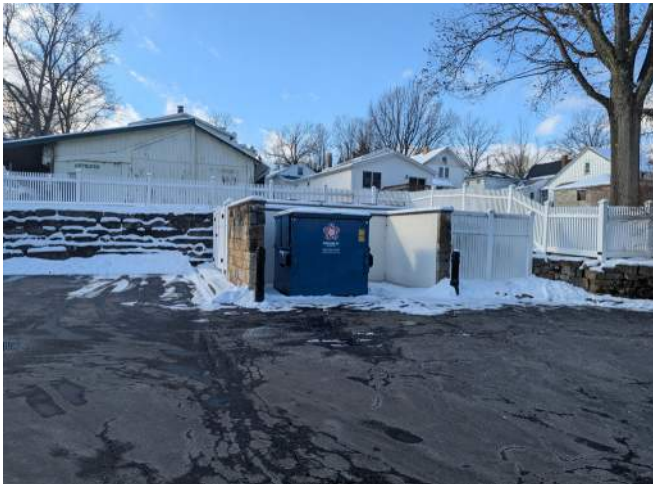
No bike parking was observed on site. The dumpster sits in an enclosure adjoined with the chiller enclosure. There is site signage and there are banners along S Main St and on the building facing S Main St.

*Figure S-5: Trash enclosure*

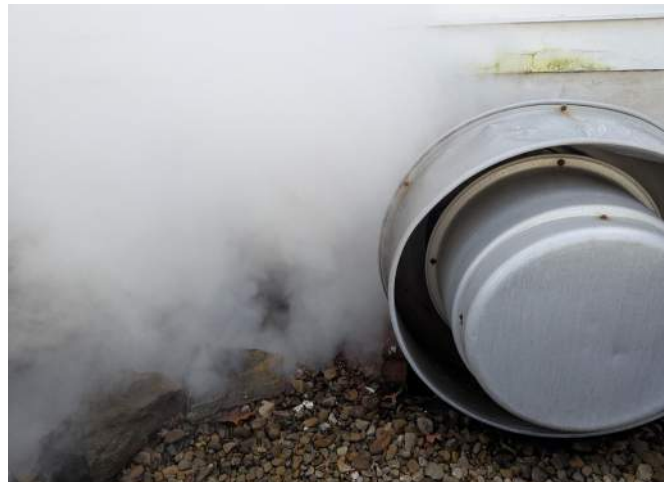
Figure A-2: Cafe exhaust

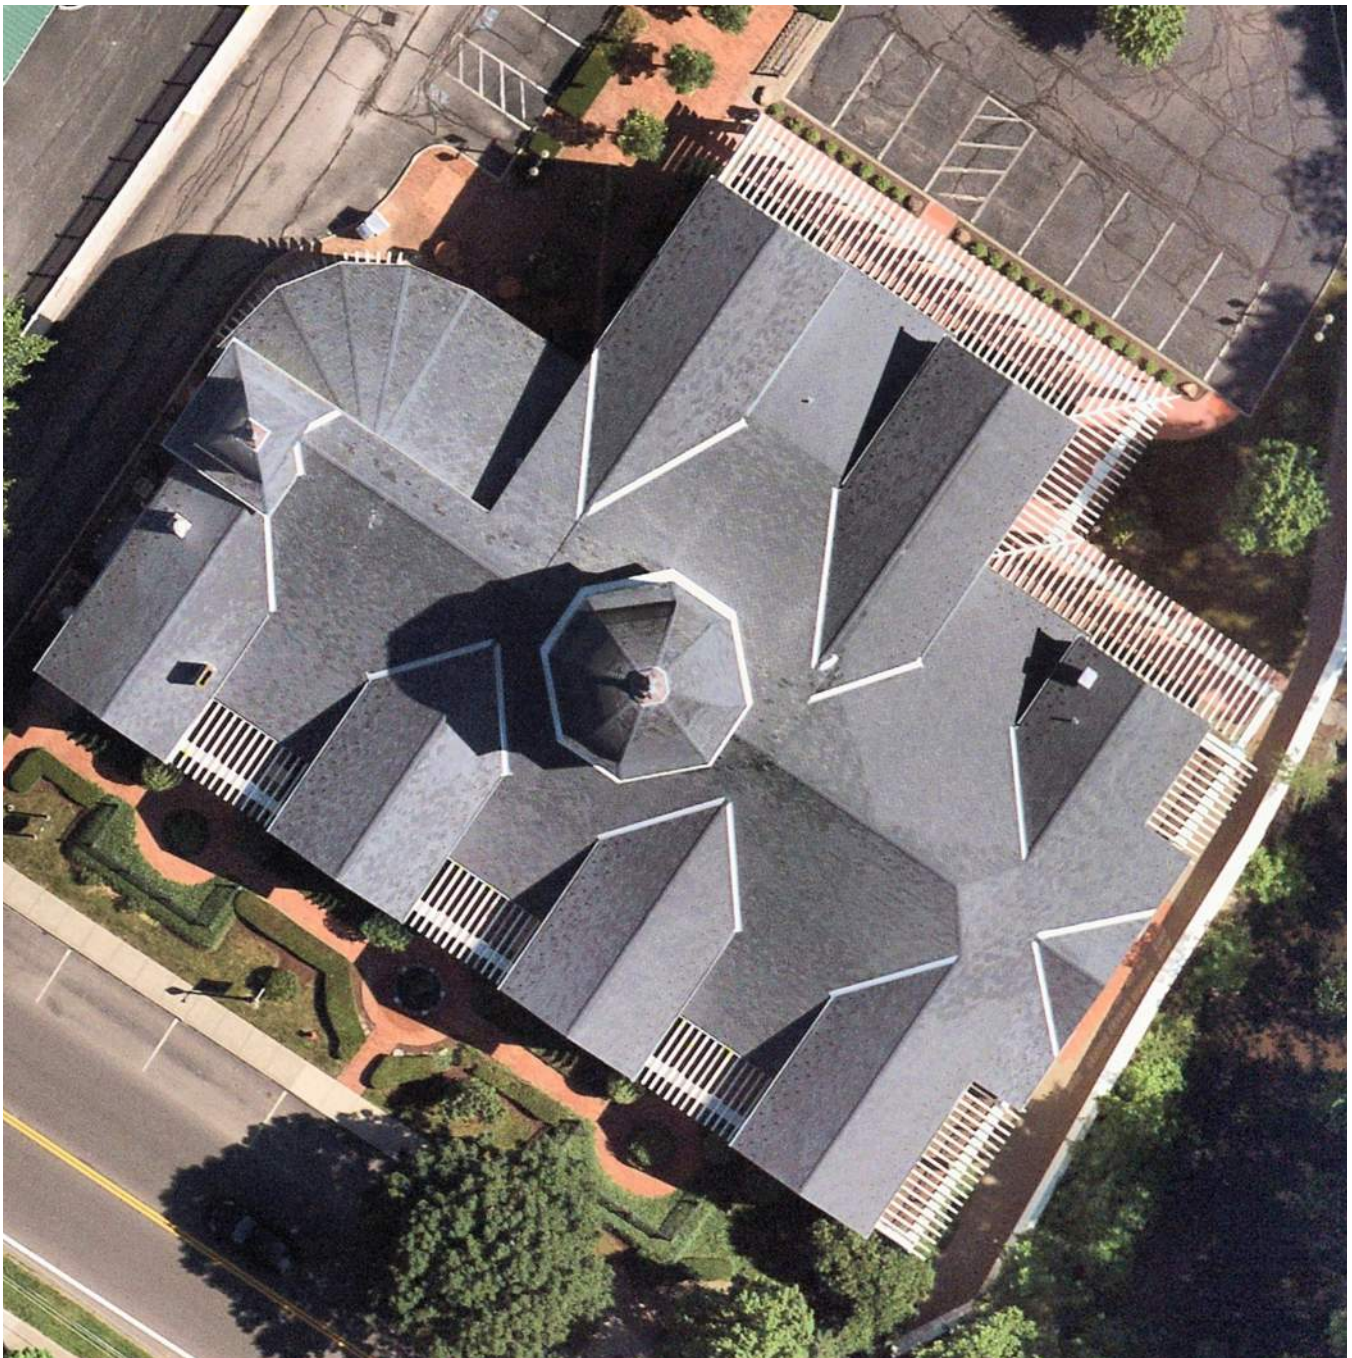
Figure A-5: Roof Aerial

Roof was not observed by Bialosky during the assessment. PLYMC utilizes a roofing contractor to maintain the roof. Refer to assessment by BSHM architects for more information regarding the roof.

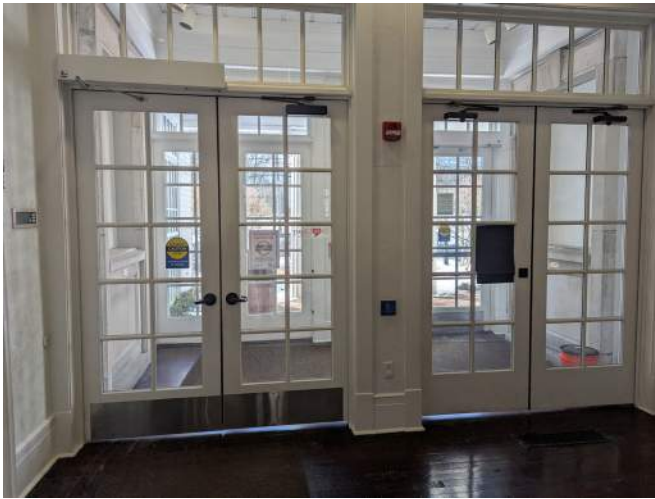
Interior doors appear to be in good condition, but the exterior doors are in poor condition due to ongoing problems with the envelope as well as poor site drainage. For more information refer to the assessment prepared by BSHM architects.

*Figure A-8: Entry vestibule*

A5.01 Replace damaged exterior doors and ensure grade slopes away from building.

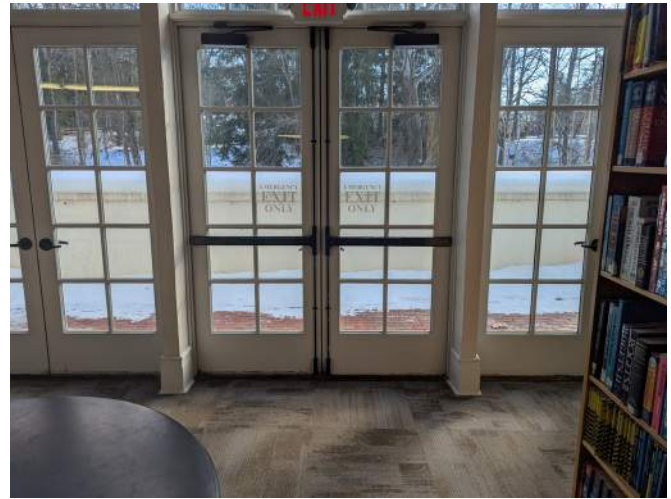
*Figure A-9: Bookstore doors*

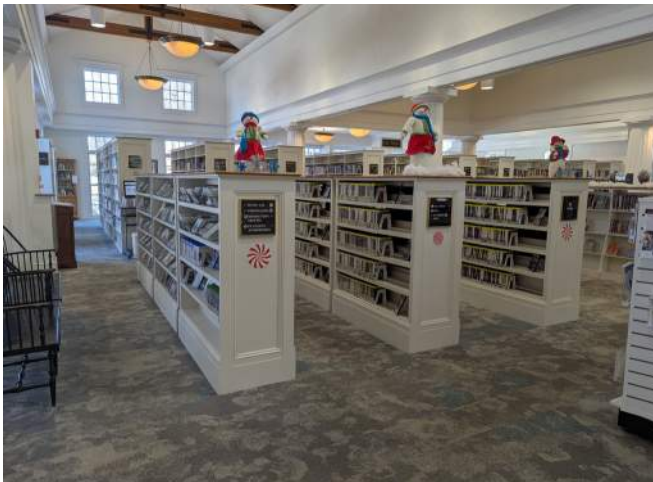
Collection is housed on metal shelving and is in good condition. Adequate space is typically provided between shelves. Collections signage is inconsistent from building to building in the system.

Figure A-30: Typical shelving

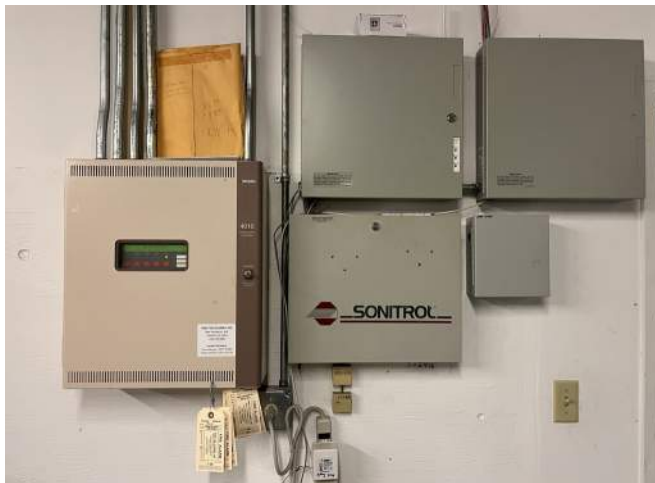
Figure E-1: Fire alarm control panel

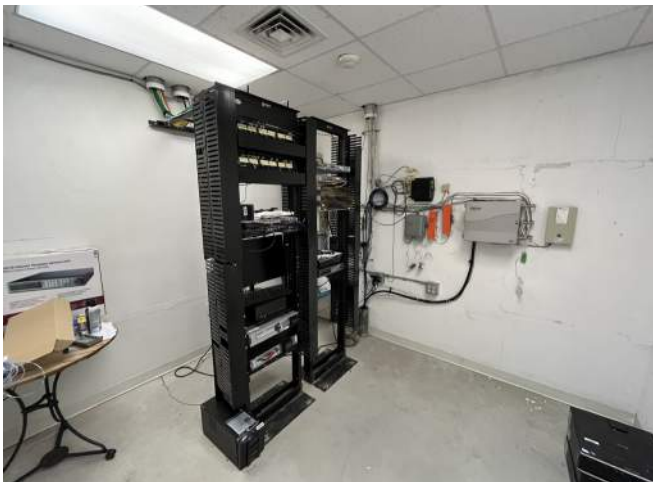
The existing overall technology infrastructure appears to be in good condition and is approximately 20 years old. There is a floor mounted rack with cable tray located in the data/network room. The primary utility service is underground and fed from the utility pole. The service enters the data/network room at the backboard. Data drops are installed in the appropriate locations and there are wireless access points present in the building. Most computer locations are served by wall outlets.

Figure E-2: Floor mounted IT rack

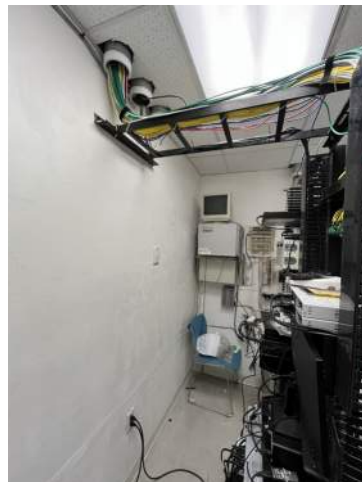
Figure E-3: Technology wiring in IT room
